# REPORT AVIATION 2024/03

***Serious aviation incident on 24 February 2020 near the Maersk Invincible (XMKI) oil rig in the North Sea involving Sikorsky Aircraft Corporation S-92A, LN-ONT, operated by Bristow Norway AS***

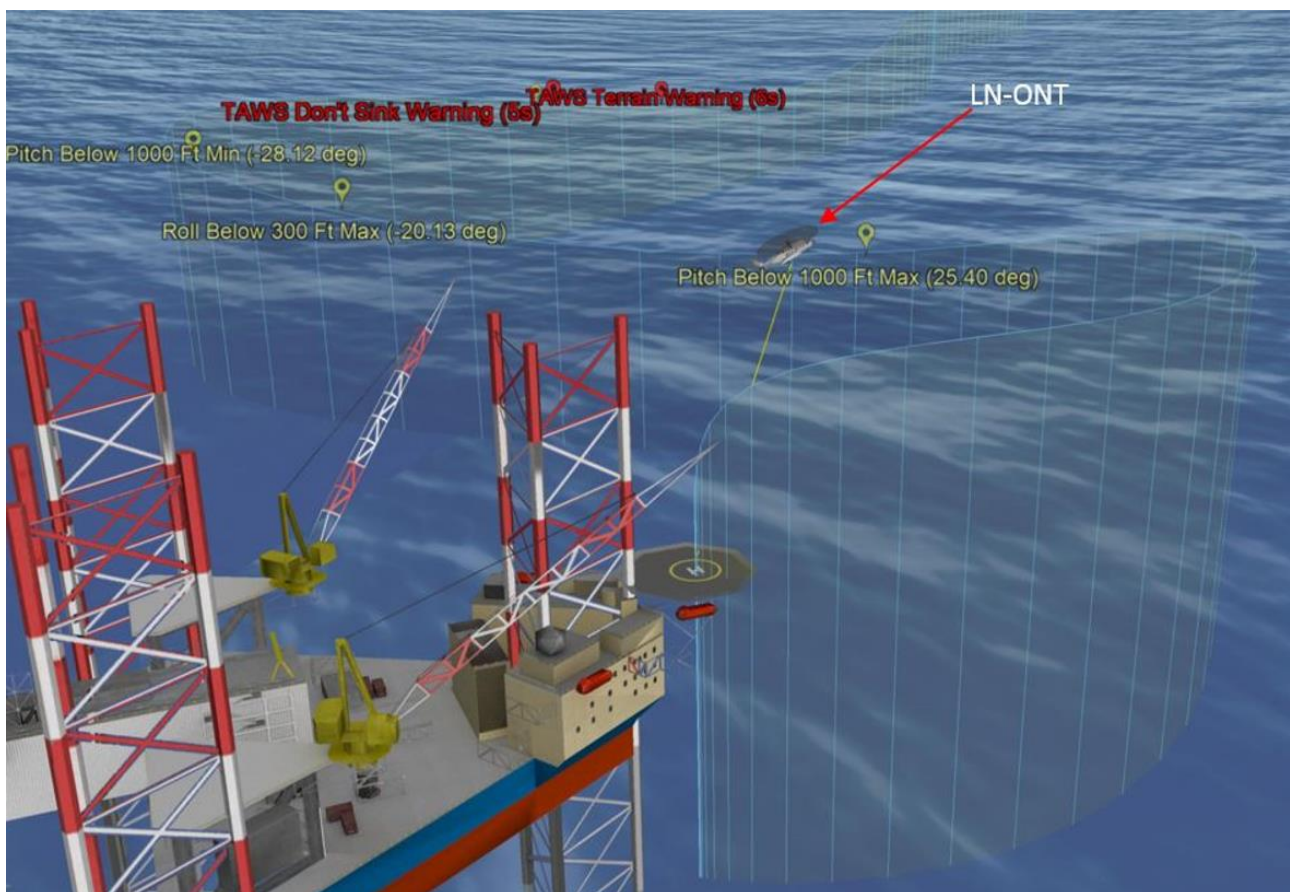
While accelerating, the helicopter had a low sink rate and the torque varied between 70 and 79%. The commander, who was pilot monitoring, has told the NSIA that he focused his attention on the vertical speed indicator. When it showed a sink rate of 100 ft/min, he called out 'We are *descending*' two times. Just after that, the voice alert 'Altitude, altitude – altitude, altitude' indicated that the helicopter was about to drop below the minimum altitude selected on the radar altimeter. The radar altimeter was set to 260 ft after the radar approach to Maersk Invincible. The commander has explained that, after the voice alert, he got the feeling that the instrument readings did not match with what he expected, and he felt that he became disoriented, see Figure 4.

Figure 4: The helicopter's departure profile during the seconds following its take-off from Maersk Invincible. Warnings from the enhanced ground proximity warning system (EGPWS) are highlighted in red. Illustration: L3 Harris Technologies UK / NSIA. Source: LN-ONT CVFDR

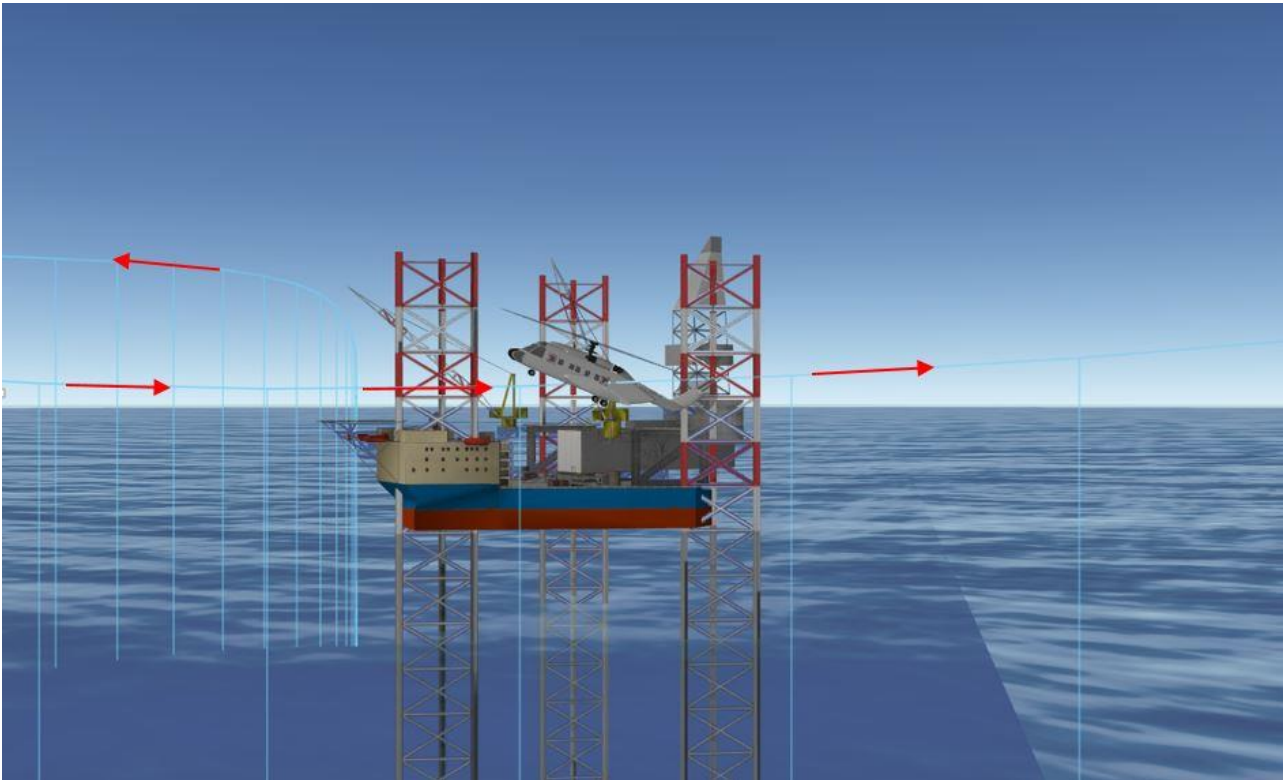
The FDR showed that the helicopter travelled backwards with a ground speed exceeding 30 kts for 12 seconds, and that the maximum recorded rearward speed was 49 kts; see Figure 5 and Figure 6. In total, the rearward flight covered a distance of approximately 210 m north of the platform. The shortest distance between the centre of the helideck and the helicopter's rearward flight route was calculated to be 201 m; see Figure 7. The lowest radar altitude during this phase was 210 ft above sea level.

Figure 5: A still image from the animation shows LN-ONT accelerating rearwards towards its highest ground speed of 49 kts. Animation: L3 Harris Technologies UK / NSIA. Source: LN-ONT CVFDR

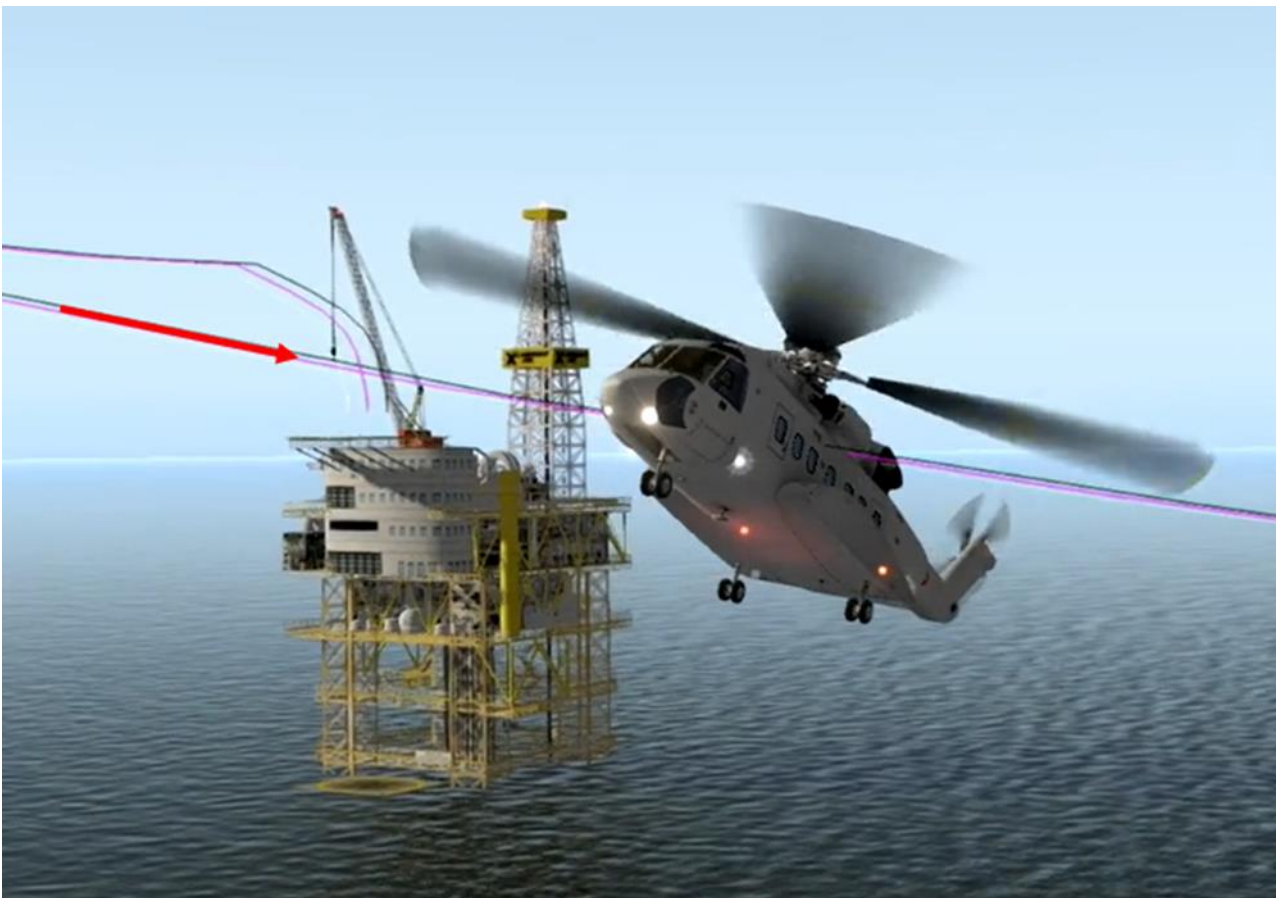
Figure 6: Animation of LN-ONT passing the oil installation while the helicopter flies backwards. (The oil installation is an illustration and not identical to Maersk Invincible). Animation: L3 Harris Technologies UK / NSIA. Source: LN-ONT CVFDR

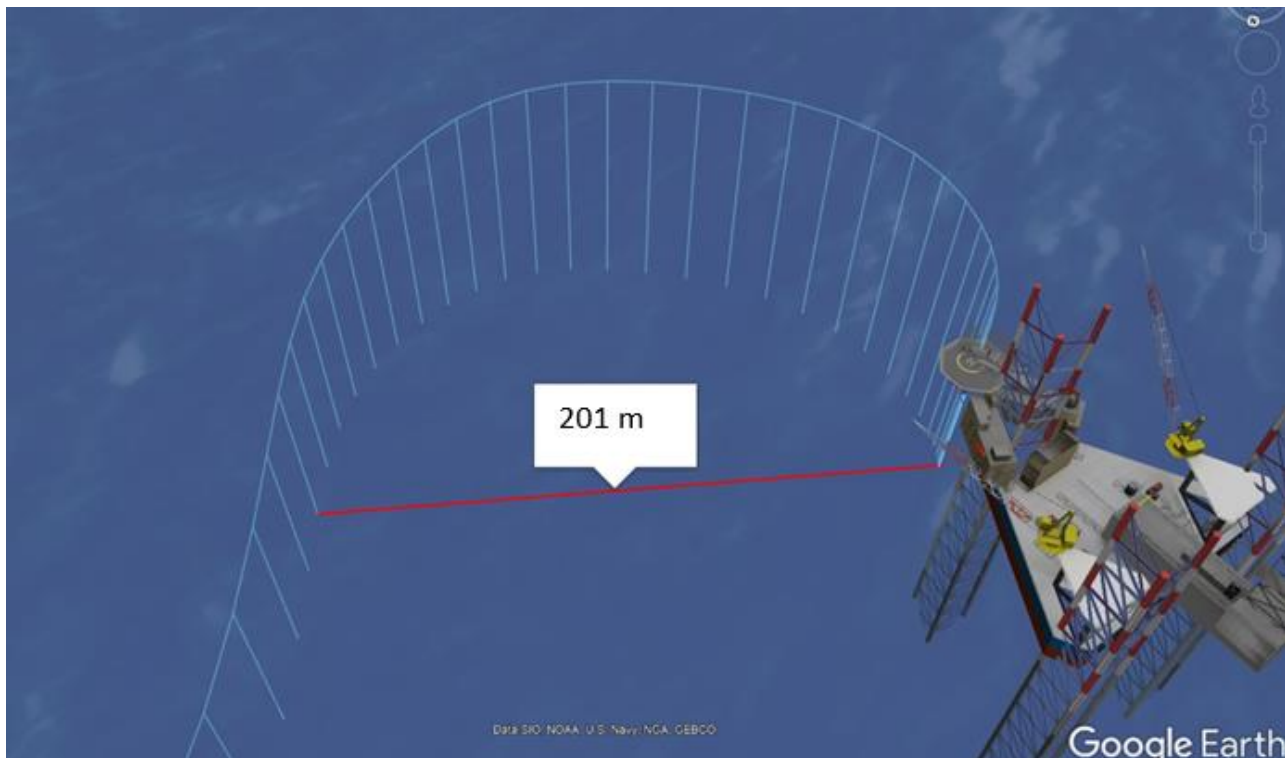
Figure 7: The shortest distance between the centre of the helideck and the helicopter's rearward flight route was calculated to be 201 m. Animation: L3 Harris Technologies UK / NSIA. Source: LN-ONT CVFDR

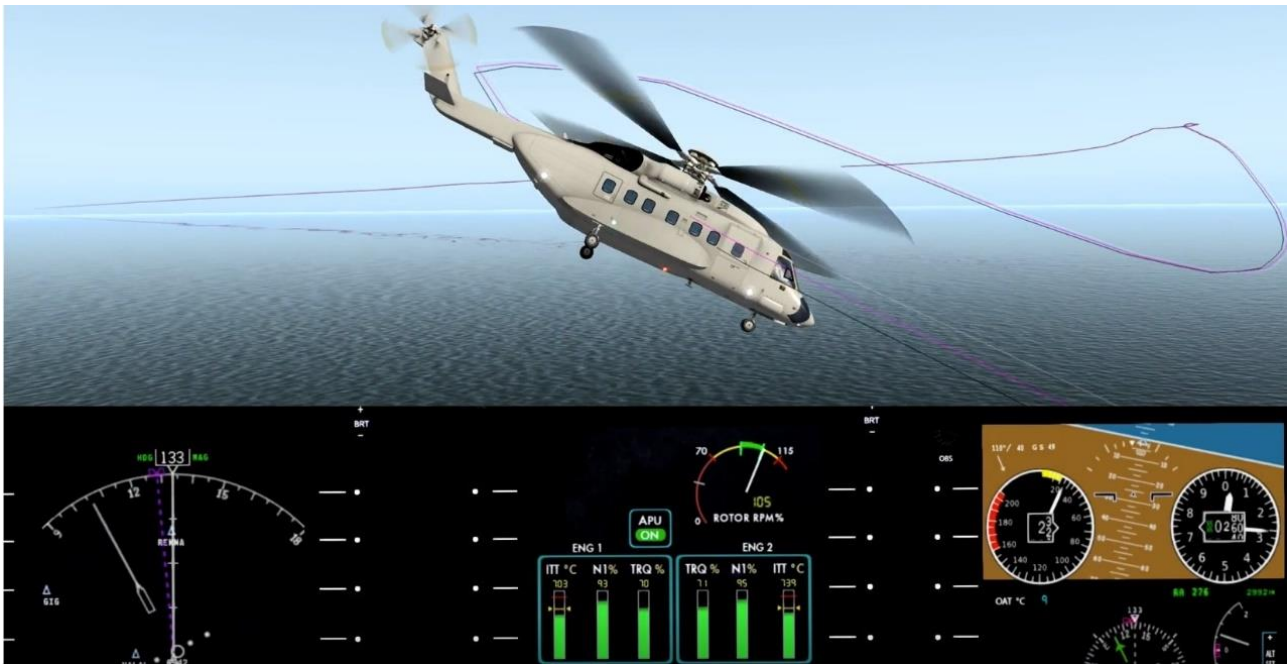
Before the subsequent acceleration, while the commander sought to regain control, the helicopter reached a maximum nose-down pitch of 28.12°; see Figure 8. The engine torque briefly dropped to 64% before it was corrected to 88% as the horizontal speed gradually increased to 90 kts.

Figure 8: While attempting to regain control of the helicopter, it developed a nose-down pitch of 28.12°. Animation: L3 Harris Technologies UK / NSIA. Source: LN-ONT CVFDR

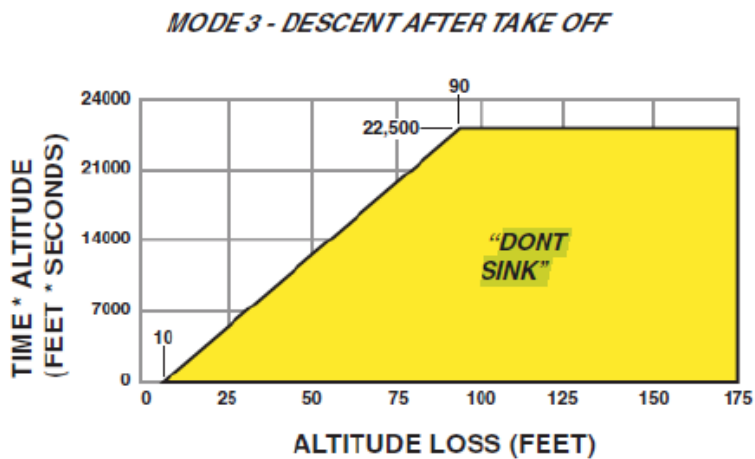
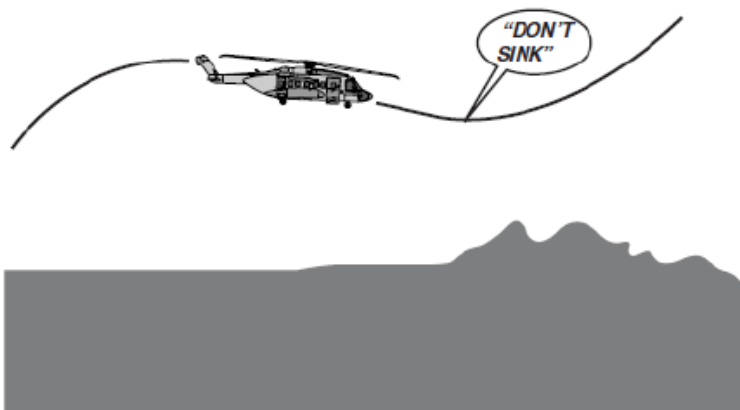
Immediately afterwards, Mode 2B issued the warning '*Terrain, terrain – CAUTION*' for one second, followed by '*WARNING terrain, WARNING terrain, WARNING terrain*' for six seconds. This indicated that the flight profile would result in the helicopter crashing into the sea unless corrections were made.

Figure 12: EGPWS mode 3 as activated in the present incident. Illustration: Bristow/NSIA

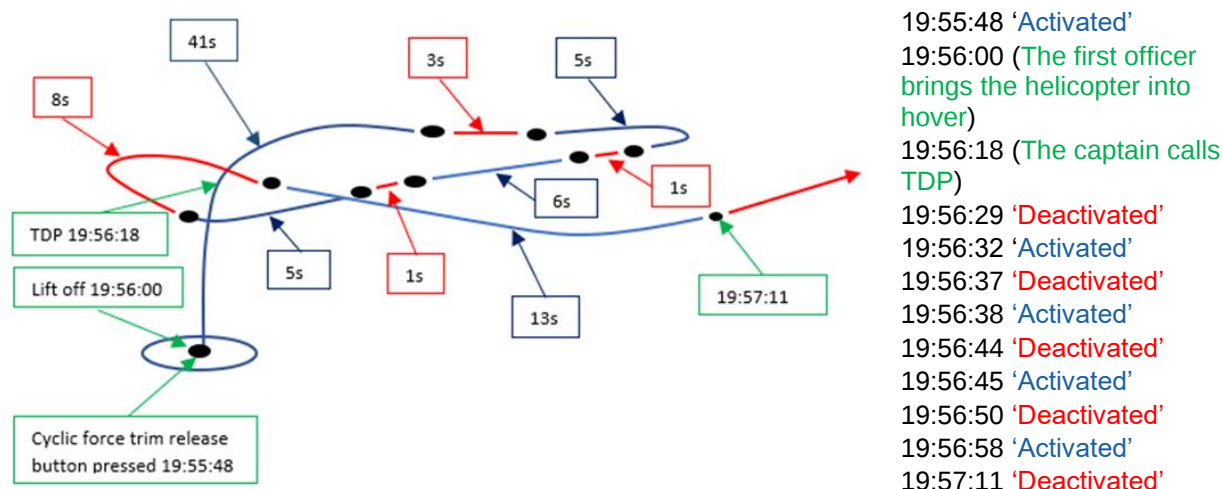
The crew has informed the NSIA that the cyclic force trim release button was last activated when the commander took over the flight controls. The button was depressed for 13 seconds and deactivated at 19:57:11; TDP + 53 seconds, after a steady climb and airspeed had been established, see Figure 16. Note that all times in this section is UTC times (local time -1 hour).

Figure 16: The departure profile and timeline for the five times the cyclic force trim release button was activated (in blue) and deactivated (in red). The illustration is not to scale. Source: LN-ONT CVFDR/NSIA.

The NSIA believes that using the cyclic force trim release button to set four new reference datums for the helicopter's attitude may have caused some overcontrolling and thus made the situation worse. The way the cyclic force trim release button was used may also have extended the period during which the helicopter was out of control.
