# Radarmålinger av snøskred ved fv. 293 Holmbuktura

Resultater fra testmålinger i 2017 og 2018

Nr. 594

### Avalanche Radar Holmbuktura 2017-2018

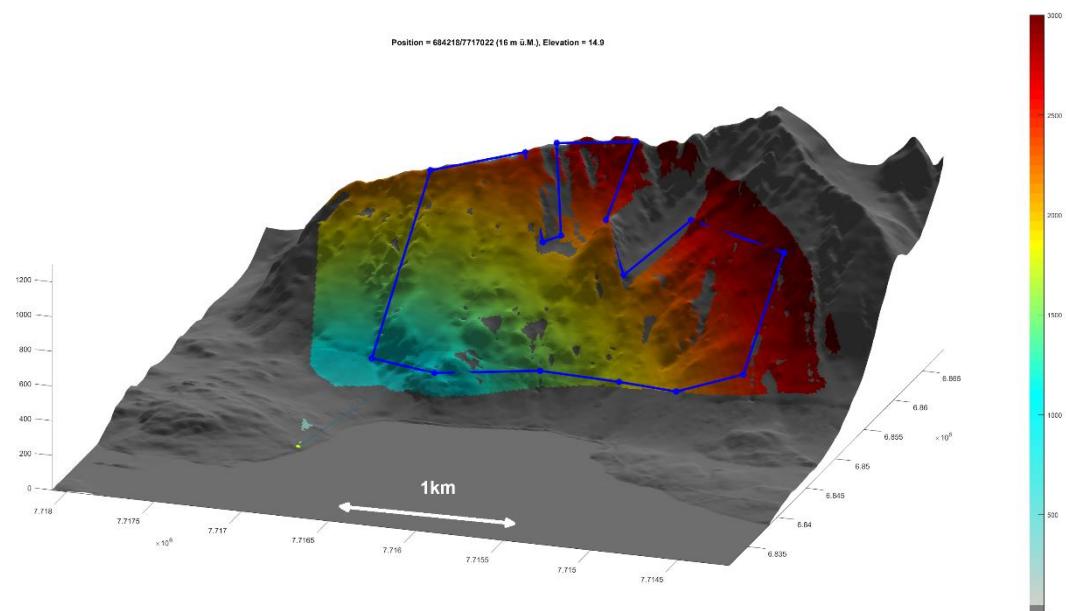
*Figure 1: Simulated radar coverage from the radar position at the northern end of Holmbuktura. Colored areas are monitored by the radar. Color indicates distance (in m). The blue polygon is the required coverage area from the tender.*

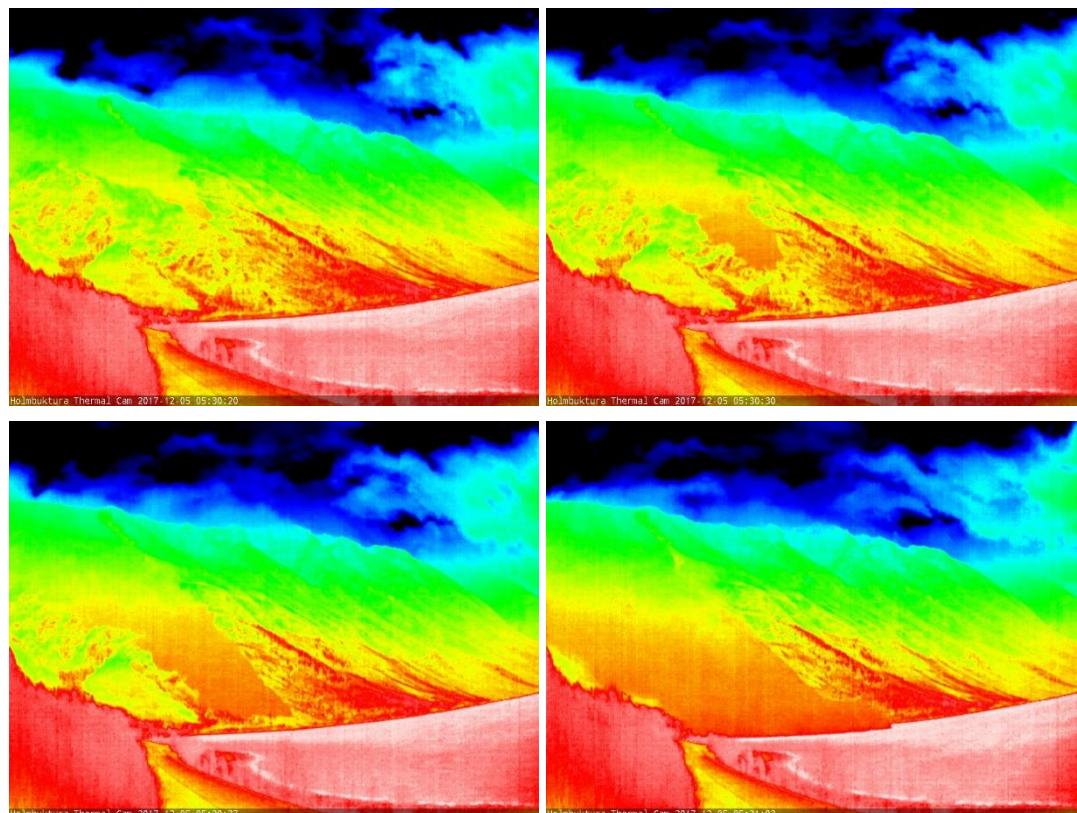
Figure 4: Thermal camera images of the avalanche on 5 December 2017 at 06:29 AM Local Time.

05.12.2017 03:50:49	05.12.2017 03:51:51	3.1	81	62				Mørkt og ikke mulig å se på infrarødt	
05.12.2017 05:29:33	05.12.2017 05:34:39	3.9	59	306	Reached Road in northern part	133990	<a href="#">Vis i regobs</a>	Ettertid (bilder av avsetninger og ev. bruddkant)

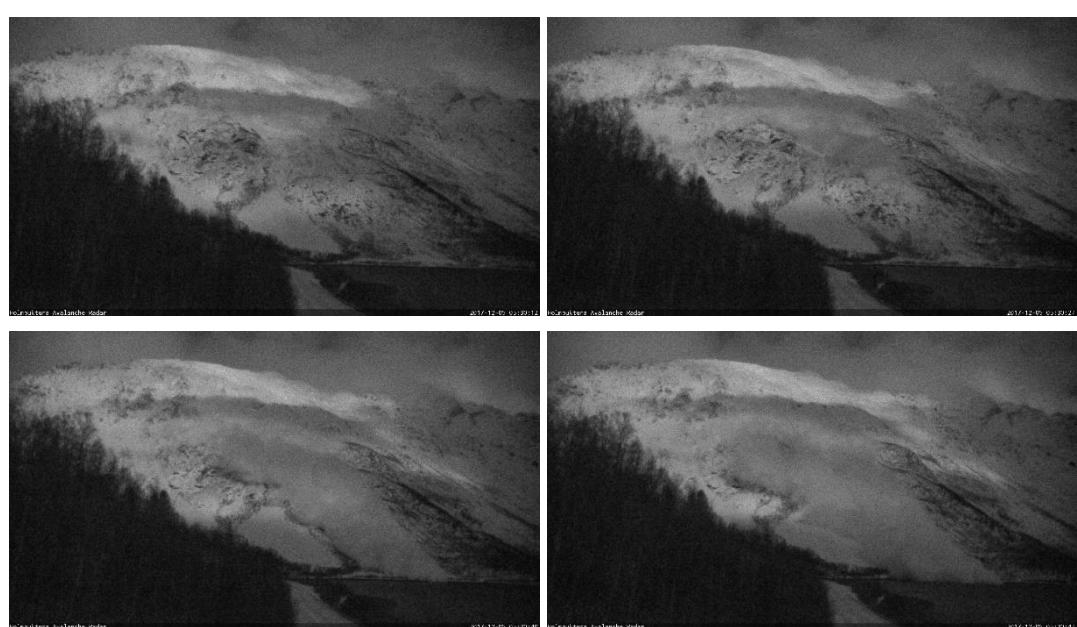
Figure 5: PTZ camera images of the avalanche on 5 December 2017 at 06:29 Local AM Time.
