PSA – Norway

Un-bonded Flexible Risers – Recent Field Experience and Actions for Increased Robustness

Project					
Project Number	0389				
Client Reference	13/600				
Document					
Document Date	31.12.2013				
Classification	Open				
Total Number of pages including appendices	78				
Document Number	0389-26583-U-0032				
Revision log					
Revision no	Document revision	Date	Author(s)	Checked	Approved
02	Issued for internal review	04.11.2013	jmu/kie/jte/kpc	sal/agj/moe	hac
03	Issued for review	05.11.2013	jmu/kie/jte/kpc	sal/agj/moe	hac
04	Issued for review	09.12.2013	jmu/moe/kie/jte/kpc	ngv/agj	hac
05	Final issue	31.12.2013	jmu/moe/kie/jte/kpc	ngv/agj	hac

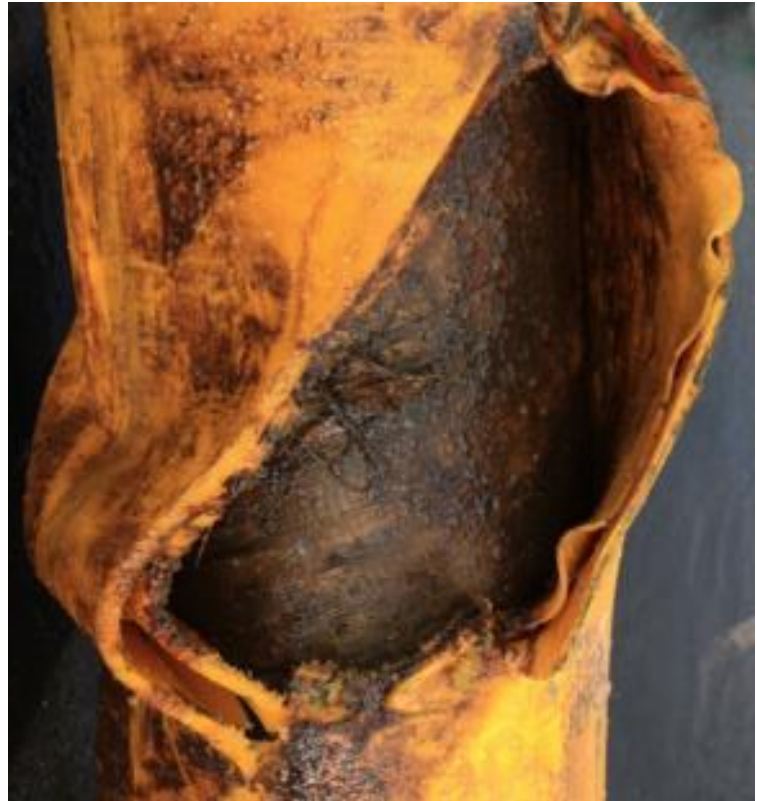
Figure 1-3 Typical external sheath failure due to pressure increase in the annulus, double external sheath (4subsea)

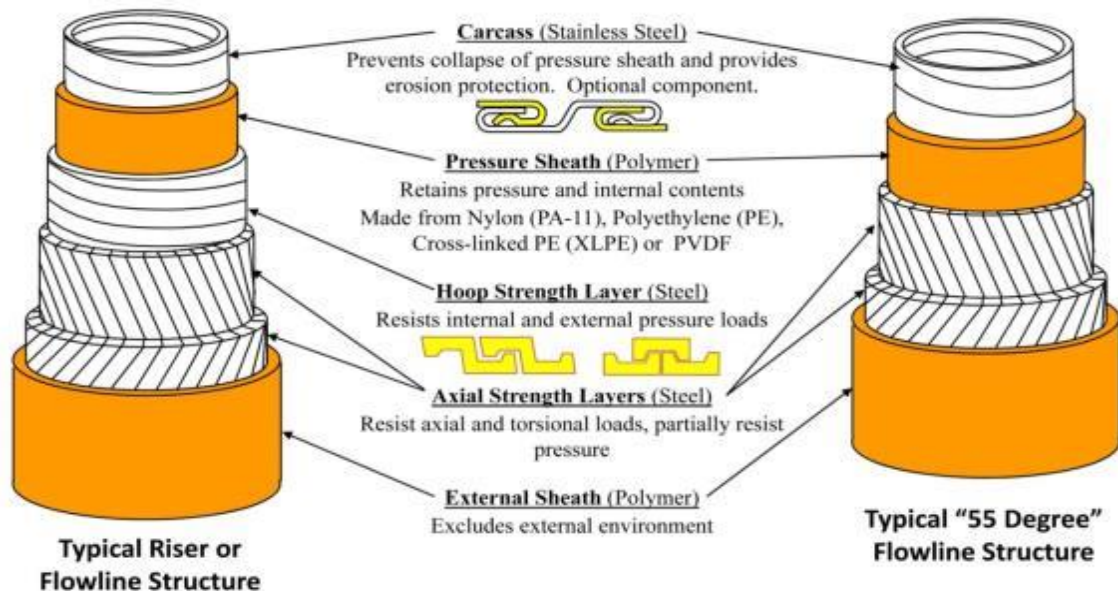
Figure 2-2 Typical flexible riser and flowline build-up’s

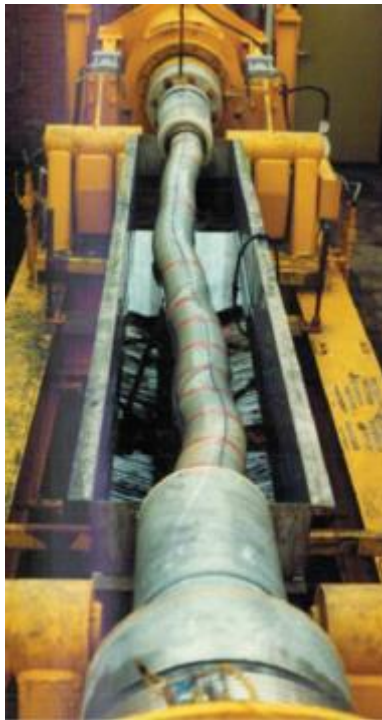
Figure 2-3 Rotating bending test of flexible riser, ref [12]

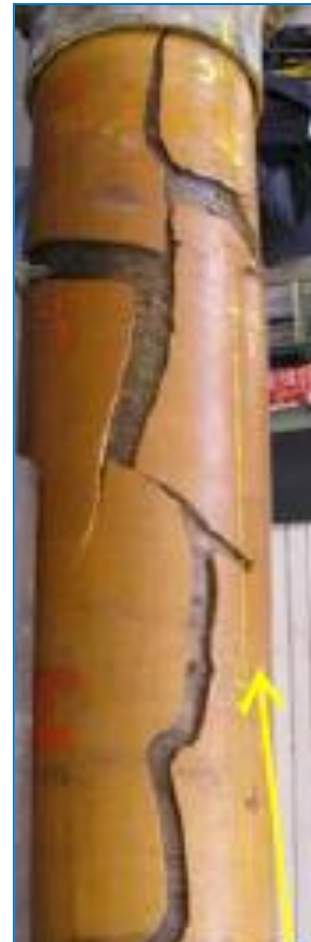
Figure 2-5 External sheath cracking due to high temperature under bending stiffer, ref [14]

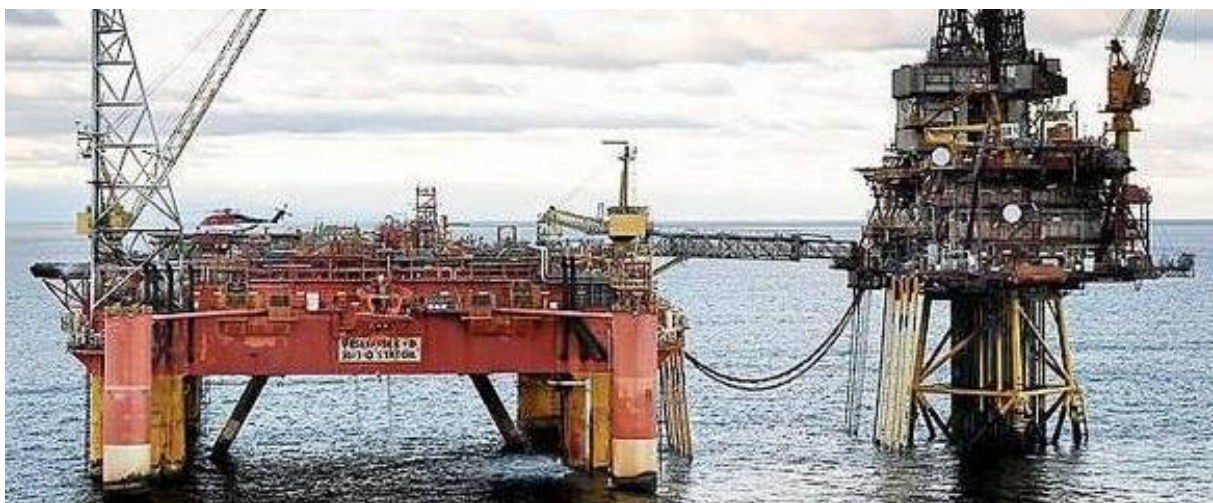
Figure 2-6 Veslefrikk A/B connected by flexible jumpers, bridge and utility lines in air suspension (Statoil)

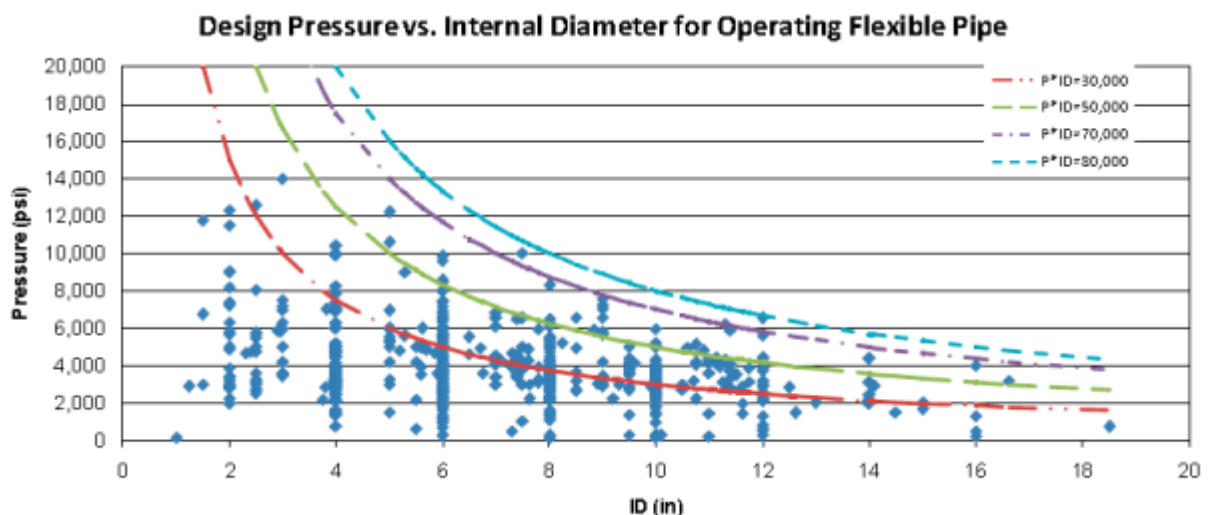
Figure 2-7 Overview of flexible pipes in use - pressure/diameter, ref [3]

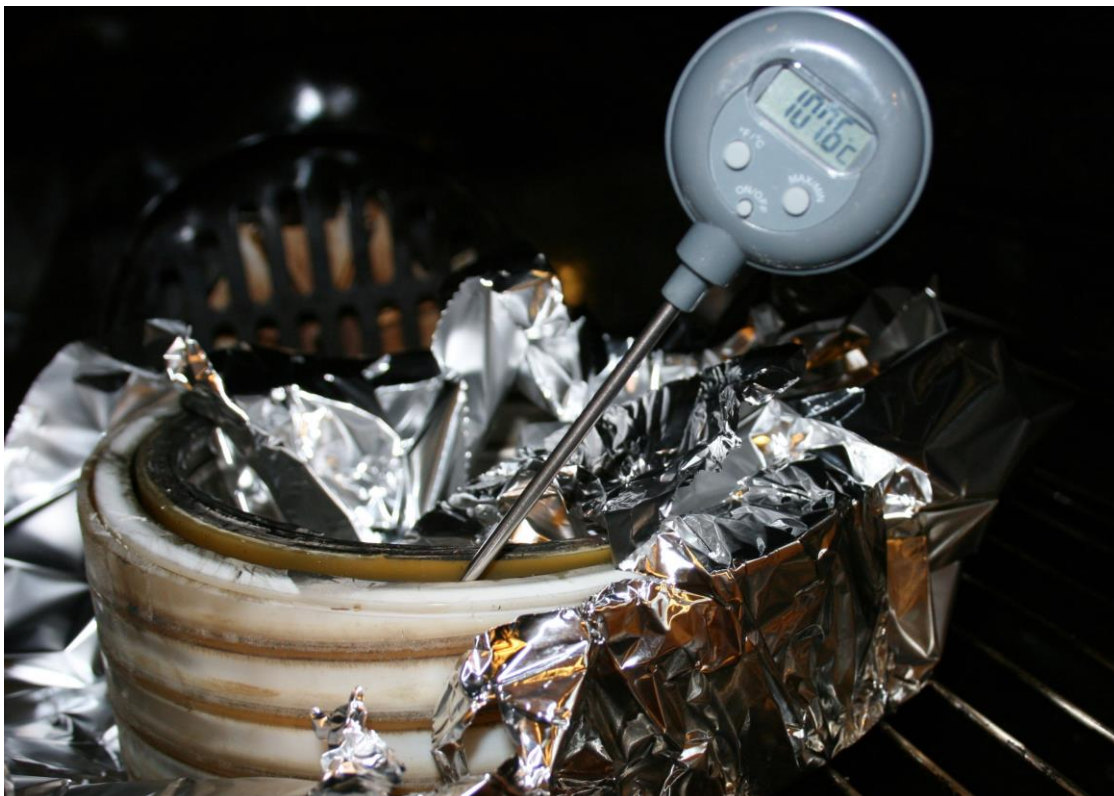
Figure 2-8 Recent PVDF testing (4Subsea)

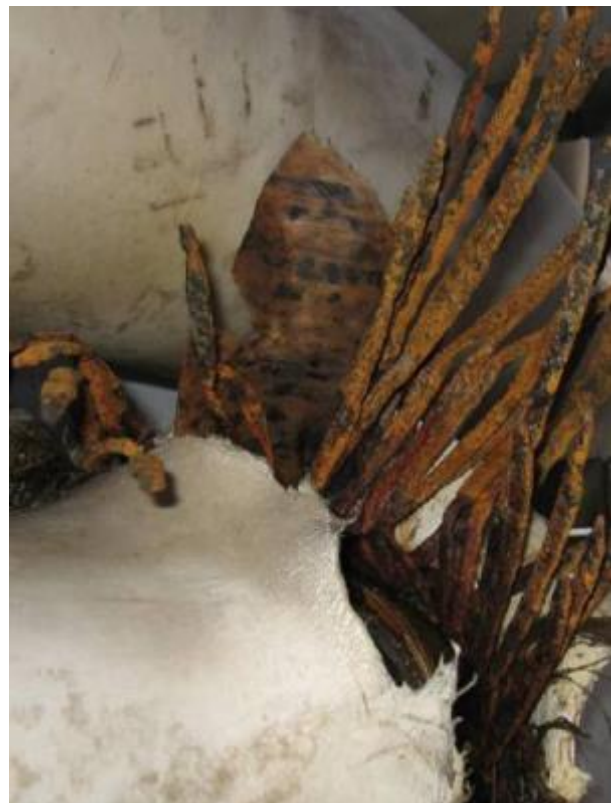
Figure 3-7 Severe corrosion lead to flexible pipe failure in Norway, however not reported as this is not a riser suspended overboard

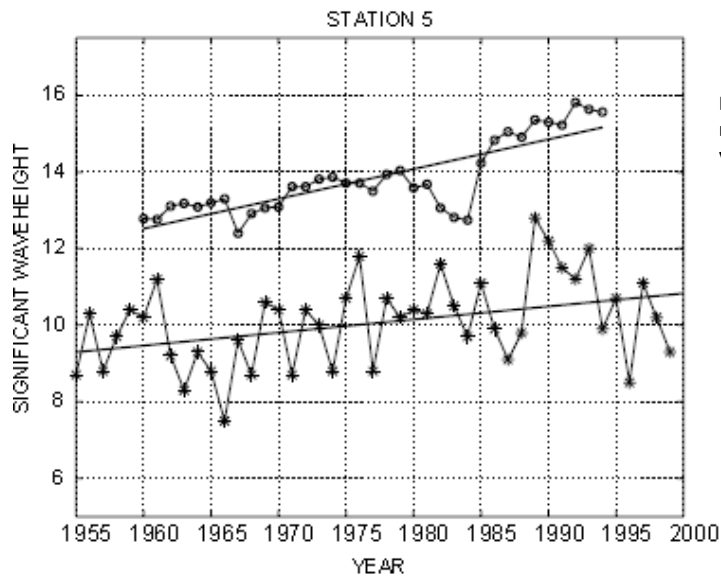
Figure 3-8 Mid-Norway, annual maximum Hs and estimated 100-year value, ref [20]

Another highly important factor now confirmed to develop unfavorably over time, is the mean significant wave height in all North Atlantic, UN report on climate change ref [7]. An increase of 0.02m/year since 1950 is identified. Knowing that the annual average significant wave height on the Norwegian shelf is in the order of 2m, an increase of 0.5m over 25 years life time of a flexible riser is significant, and should be considered in future service life assessments. It is reasonable to assume that this increase will be applicable to at least some operating floaters in Norway, as identified also for extreme waves in [20]. (Yearly maximum and 100-year estimate shown in figure)

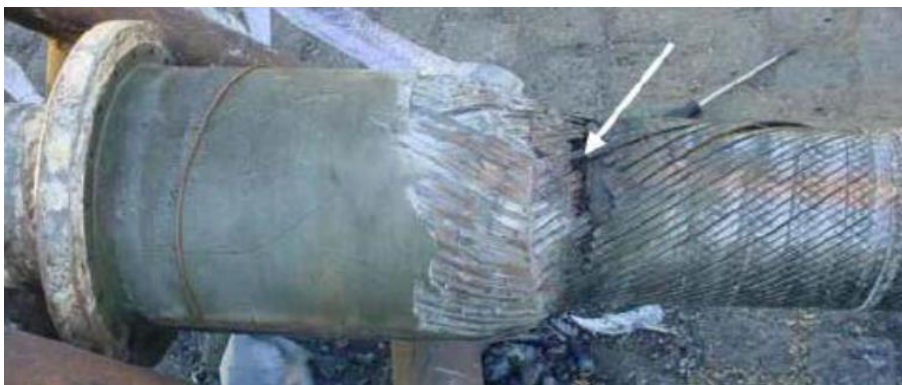
Figure 3-9 Severe armour wire corrosion / fatigue damage presented as Petrobras' experience, Ref [4]

In Brazil there seems to be incidents of tensile armour wires breaking in operations when fully loaded. See Figure 3-9. From the published reports and status updates on inspection and monitoring tool developments there seems to be corrosion near the top end fitting in combination with dynamic tension variations that are at fault.

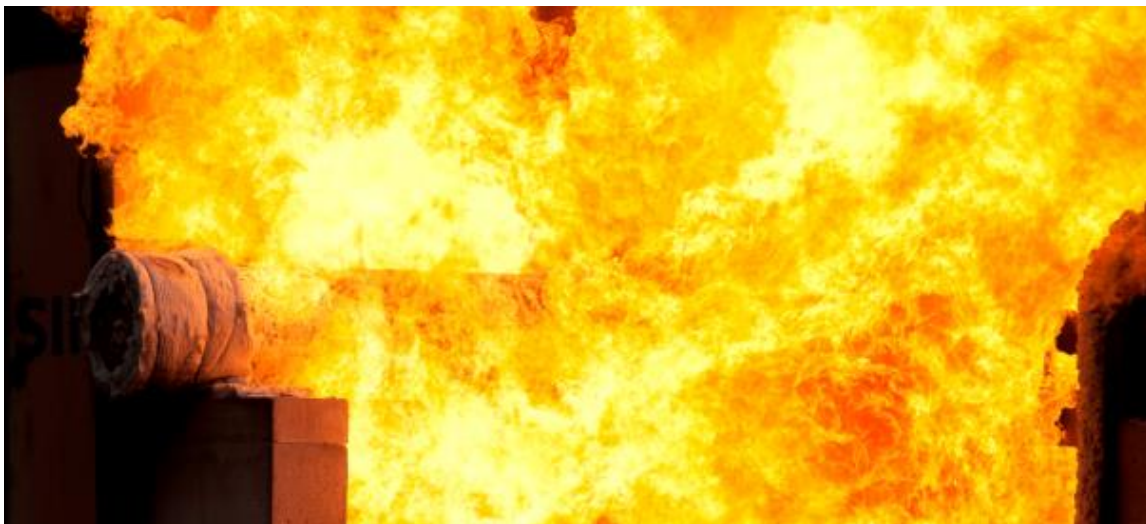
Figure 3-11 Passive fire protection test (Trelleborg)

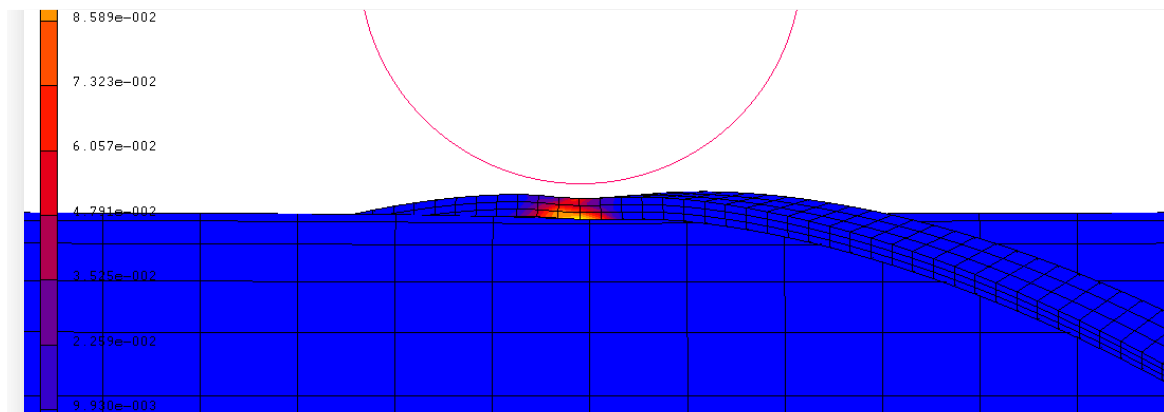
Figure 3-12 Plastic deformation of wire after simulated impact (4Subsea)

Rock dumped crossing with gas flowline on top. 55deg structure i.e. no pressure armour. Multiple hit by trawling equipment. External sheath breach. Sheath repaired by clamp. Rock berm re-installed. Continued trawling and/or breach overlooked during first repair. Anodes in the vicinity, high strength wire, seawater ingress. Small plastic deformation in armour wires leading to localized high stress with normal operation pressure. Multiple wire brittle failures initiating parting of flowline and large gas release.

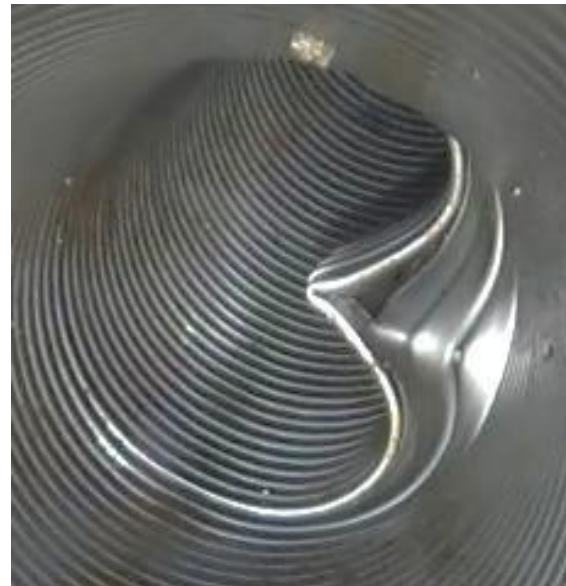
Figure 3-14 Typical small carcass collapse

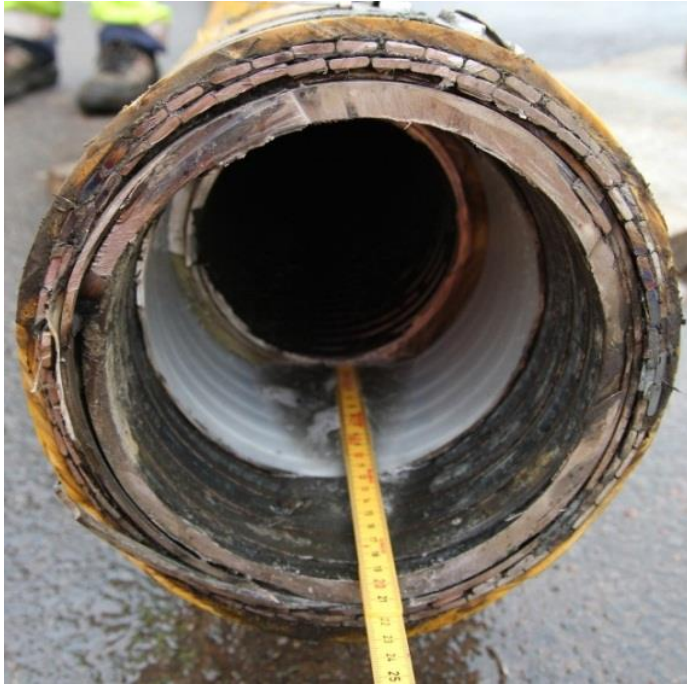
Figure 3-15 Investigation of PVDF shrinkage in a decommissioned flexible riser (4Subsea)

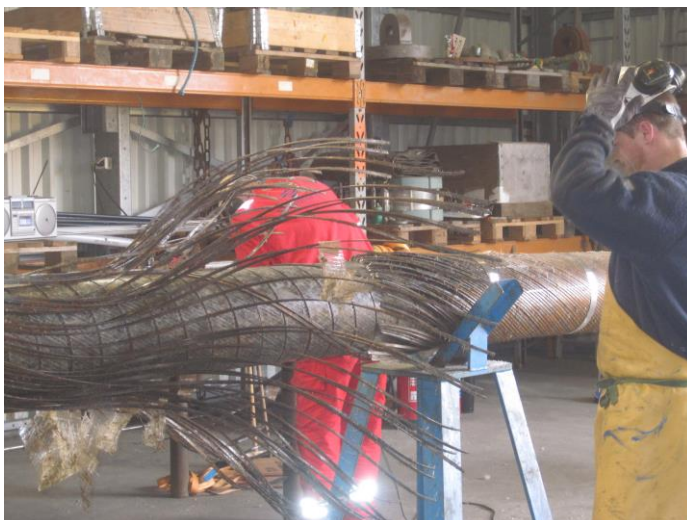
Figure 3-16 Removal of tensile armour wires for corrosion investigations (4Subsea)

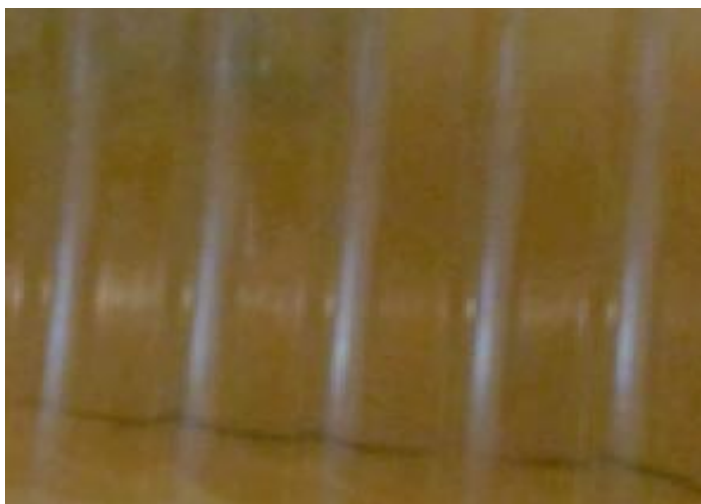
Figure 4-1 Inside of aged PA11 pressure sheath

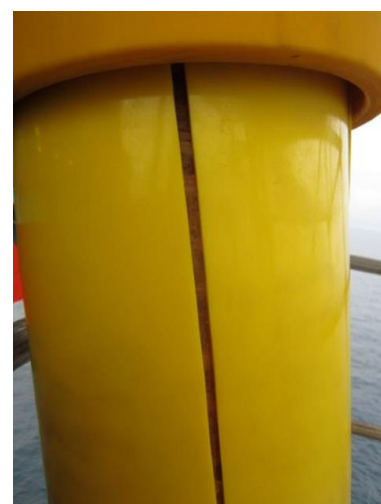
Figure 4-2 External sheath cracking

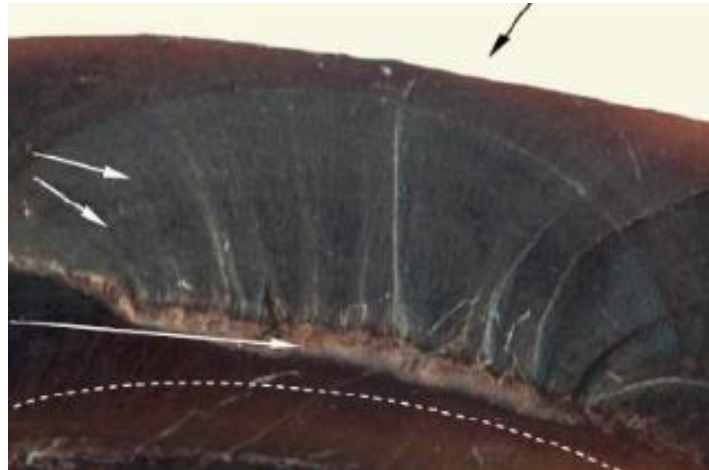
Figure 4-3 Fatigue growth in PVDF (secondary failure) after notch made by carcass failure (Talisman)

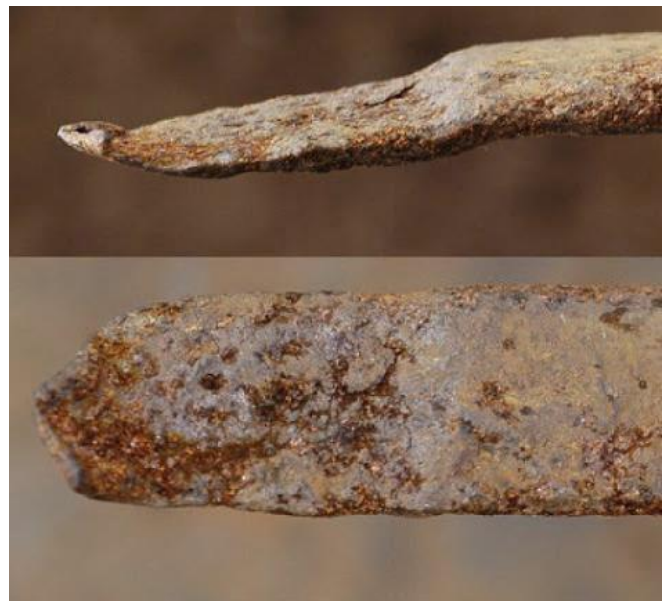
Figure 4-4 Corroded armour wire after breach of external sheath, ref [12]

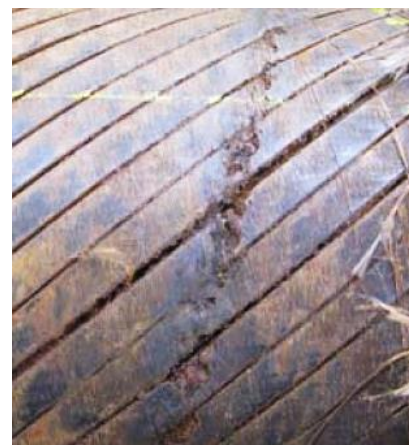
Figure 4-7 Armour wire corrosion (Statoil)

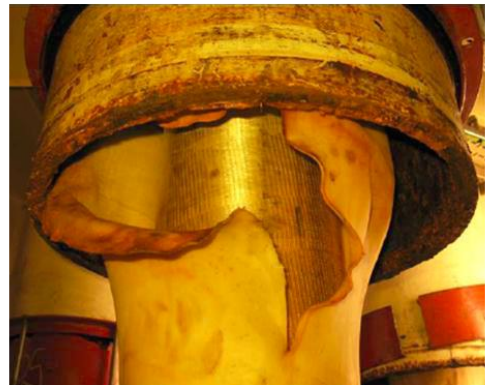
Figure 4-9 Blocked vent leading to breach in external cover, ref [12]

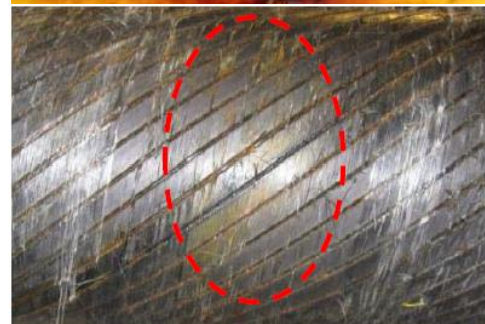
Figure 4-10 Typical external sheath cut with corrosion products on the surface, including wire inspection under the same damage, ref [28]

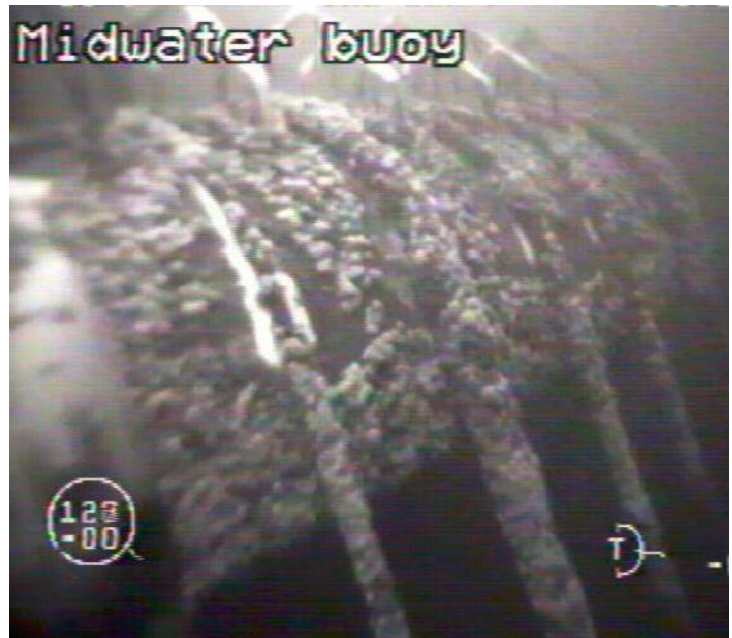
Figure 4-11 Mid-water arch with marine growth (pipe dynamics seen as white areas) (Talisman)

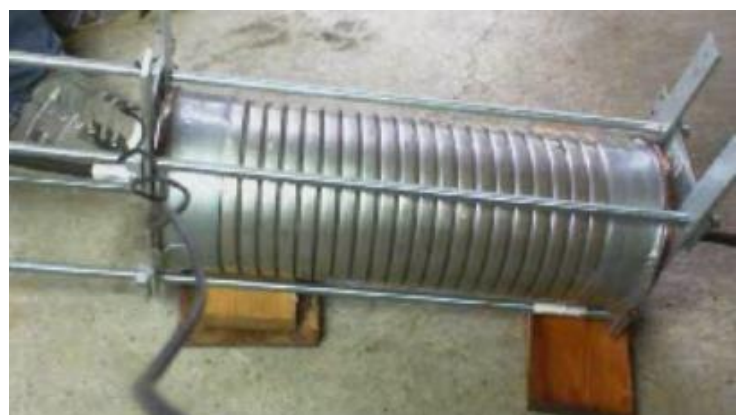
Figure 4-12 Testing of carcass radial leak rate (4Subsea)

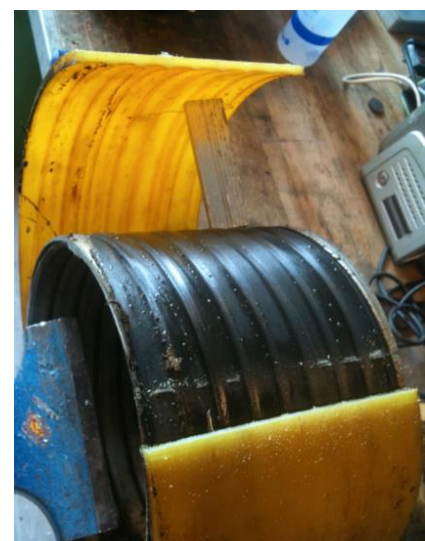
Figure 5-2 PA11 coupon extracted for analysis (Statoil), ref [28]

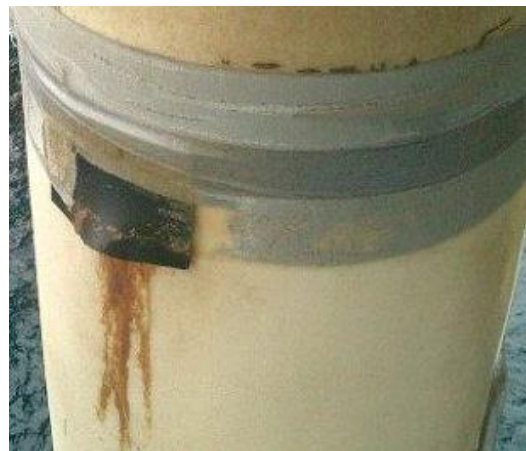
Figure 5-3 Less successful annulus vent backup system

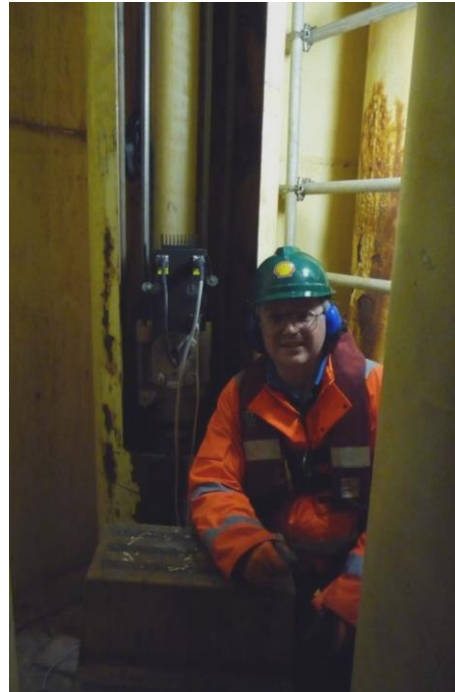
Figure 5-4 MAPS riser inspection inside guide tube, ref [31]

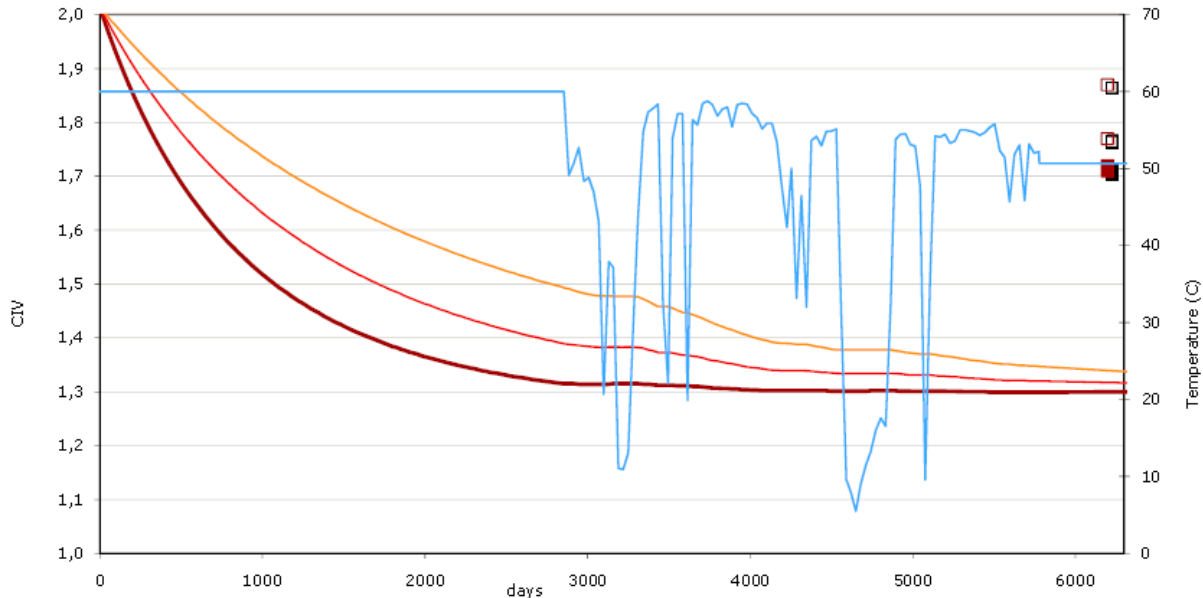
Figure 5-8 Ageing sensitivities compared to measured results, example showing conservative model results (Force)

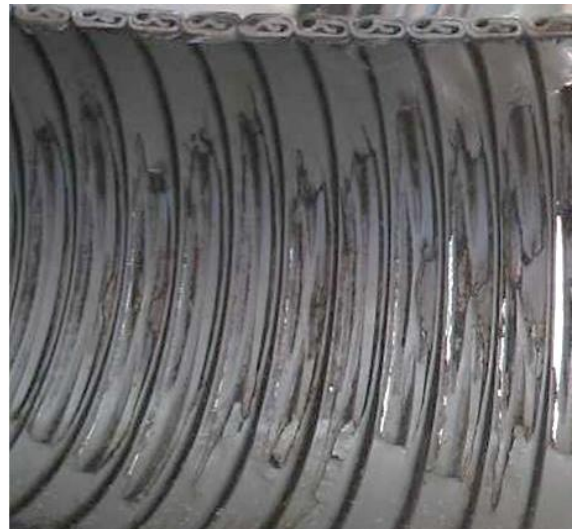
Figure 5-9 Carcass erosion, ref[12]

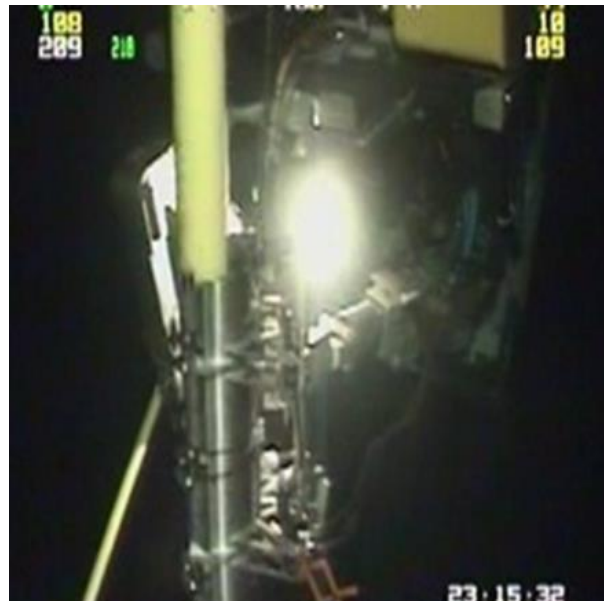
Figure 5-12 ROV installable clamp stop oxygen ingress to armour wires (4Subsea)

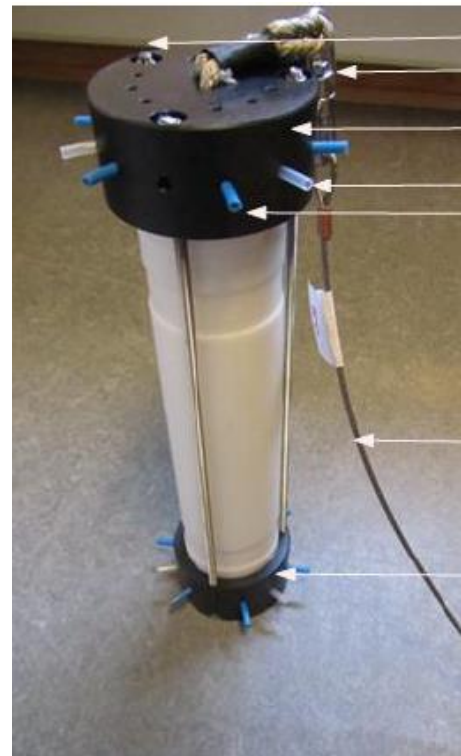
Figure 6-1 Riser response measurement sensor (4Subsea)

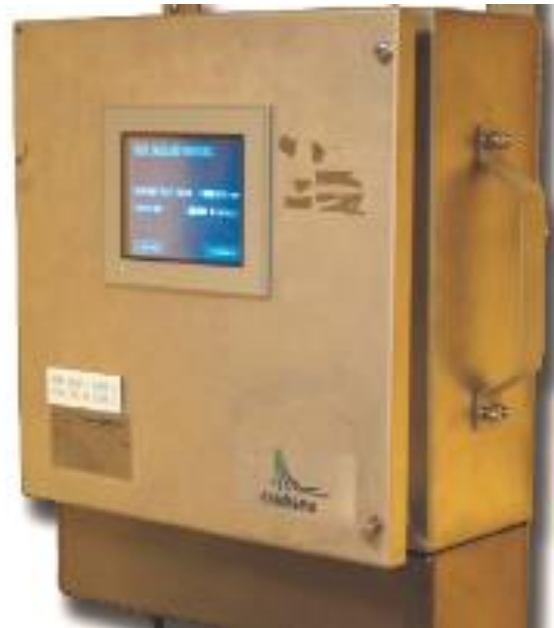
Figure 7-4 Typical online riser annulus vent monitoring cabinet (4Subsea)

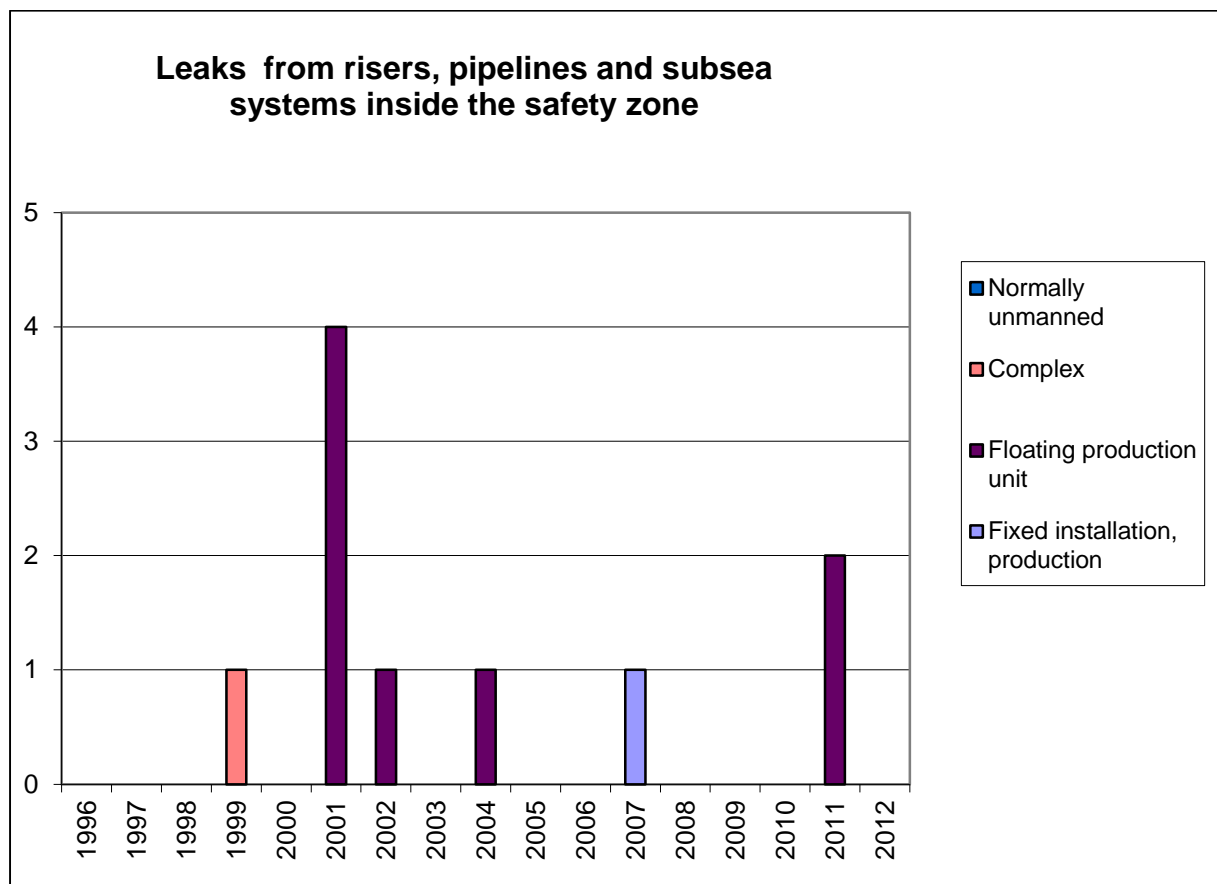
Figure 55 Number of leaks from risers and pipelines within the safety zone, 1996-2012

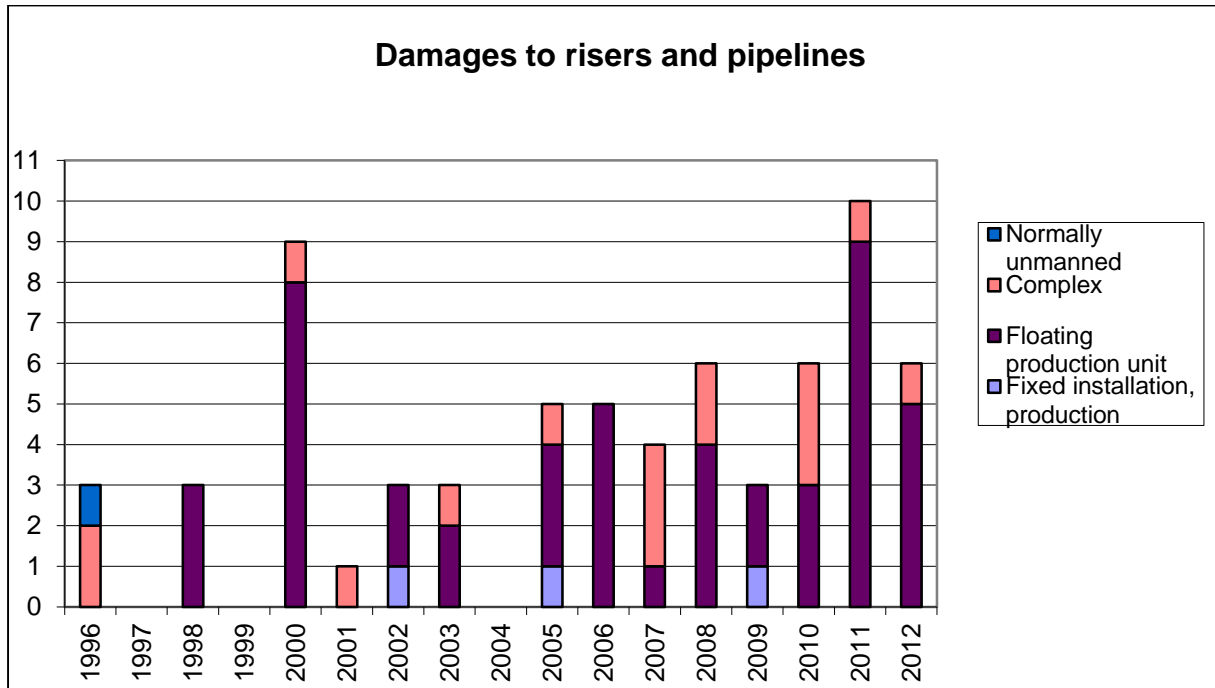
Figure 56 Number of incidents with serious damage to risers and pipelines, 1996-2012
