# Sensorteknologi for kontinuerlig bruovervåking

Evaluering av vellykkede prosjekter og beste praksis for  
sensorteknologi i bruovervåking

STATENS VEGVESENS RAPPORTER

Nr. 1053

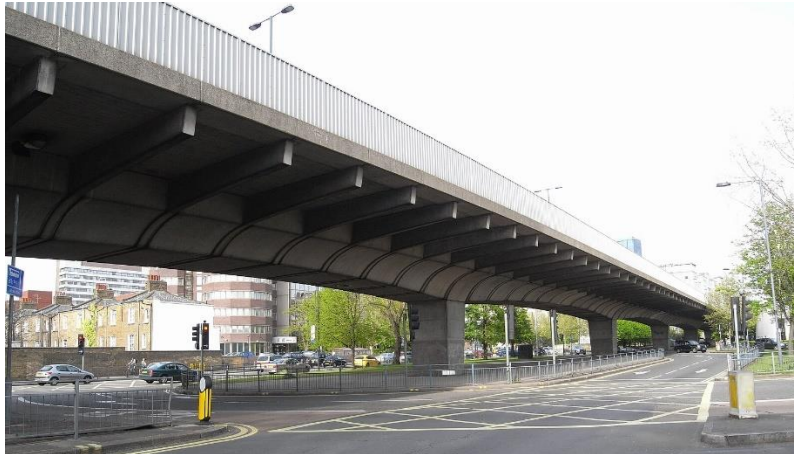
Figure 3: The Hammersmith Flyover [1].

**About:** Constructed in the early 1960s (see Figure 3)

- The primary goal of the project is to conduct condition monitoring of the bridge to identify potential structural issues.
- The SHM system has been in operation since September 2009.

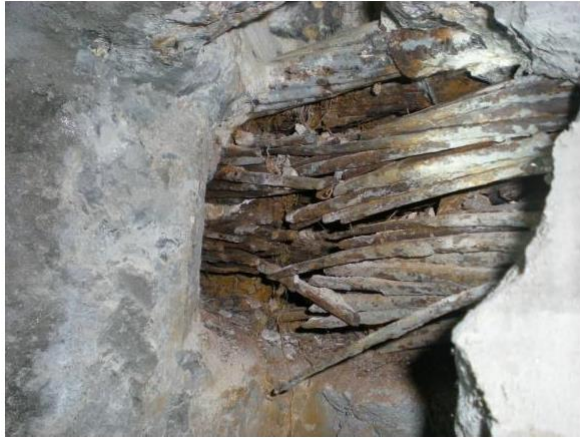
Figure 6: (a) Failed wire strands and (b) acoustic emission sensor [3]. (Courtesy: Peter Jones / James Brownjohn [3])

- Inspection of the data collected by the Acoustic Emission (AE) monitoring system revealed wire breaks in the post-tensioning tendons (Figure 6) and helped identifying deteriorating strands. It is also mentioned that the data were used to develop a deterioration model that predicts the remaining lifespan of the bridge before it loses its reserve capacity [3]. Since the data handling and model development were done by a private company, the details of these are not available.

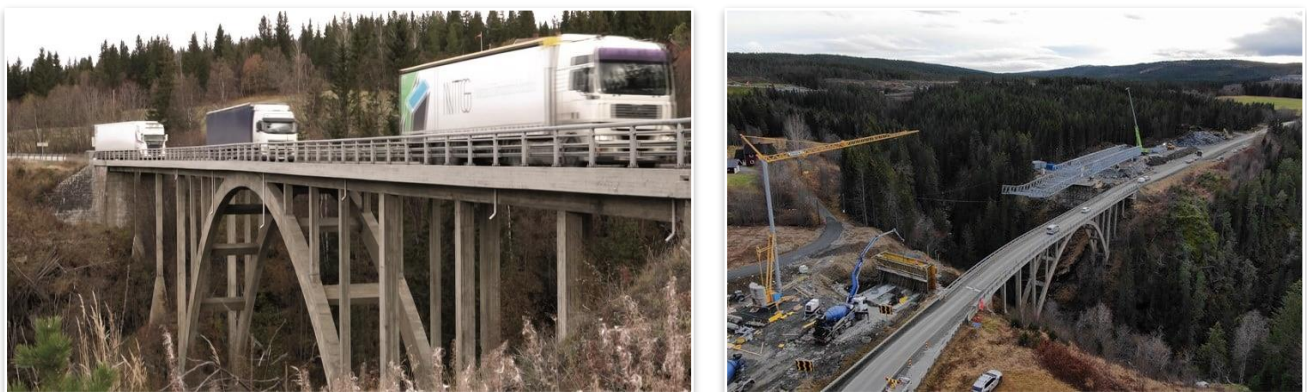
**About:** Constructed in 1942 (See Figure 7)

*Figure 7: Left panel shows trailers on their way southbound on Stavå bridge. The right panel shows photo during construction of the interim bridge just east of the original Stavå concrete bridge. [Both photos by Kjetil Sandvik Sletten/Statens vegvesen].*

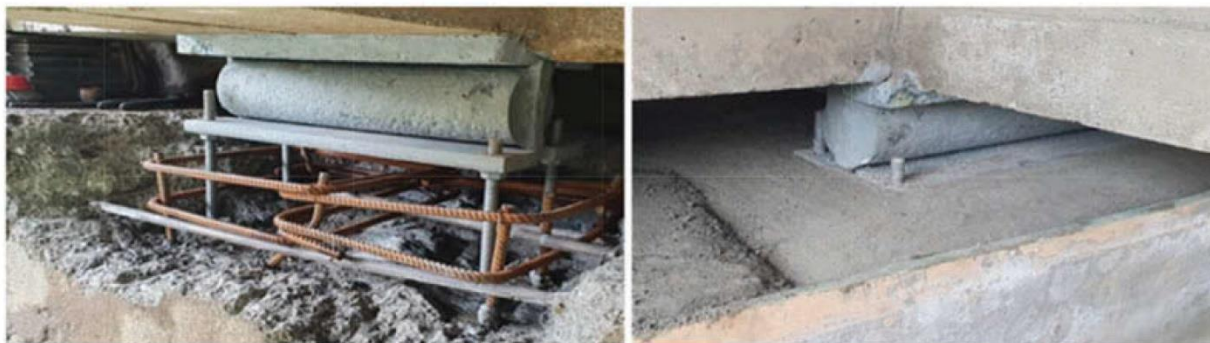
Figure 10. Damaged support (left) and repaired support (right). [7]. (courtesy of Kjetil Sandvik Sletten/Statens vegvesen)

The event of November 2018 caused concern on the safety of the bridge but also has shown that the damage could be identified using the SHM data. This led to a research project where a lot more comprehensive monitoring system has been implemented on the Stavå Bridge (as described above as system 2). Thresholds were set on the metric in a similar way as before (based on ERI metric). It is reported that the thresholds are exceeded every now and then due to heavy traffic or extreme weather. However, in April 2021, the alarms started to ring almost every hour (instead of about every 24 hours, as it did before). This indicated another novelty in the bridge. Visual inspections later found that the concrete below the bearing of the south abutment was lost (Figure 10). Such damage causes severe modification of the boundary conditions and causes peaks in the nearby acceleration signals due to the introduced flexibility.

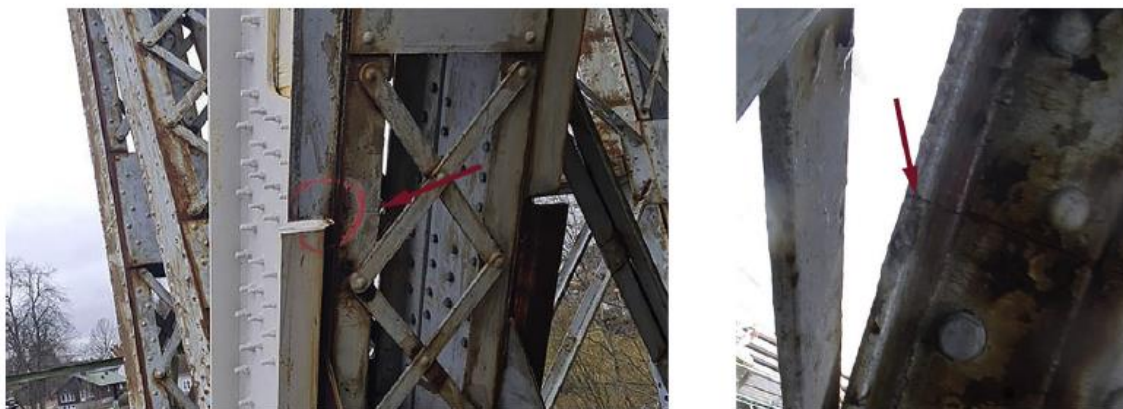
Figure 13: Detected damage [8]. The damage is a fatigue crack that has occurred at the bottom flange (and part of the web) of the angle profile shown in the picture.

- The system gave an alarm indicating a change in measurement features.
- Details of decision-making are unclear following the alarm. But it is understood that the data were examined and the need for inspection was confirmed.
- An inspection is carried out following the alarm, and the visual inspection revealed a cracked member. From the available pictures, it appears that this damage could have easily been missed even if a regular inspection was carried out.
- As a final decision, the cracked member was strengthened, and the bridge was scheduled for replacement. Although this decision-making procedure could be done without a monitoring system solely based on the damage-revealing inspection, it is likely that a more informed decision is made considering the substantial data of strain/stress and remaining fatigue life of the bridge by the monitoring system.

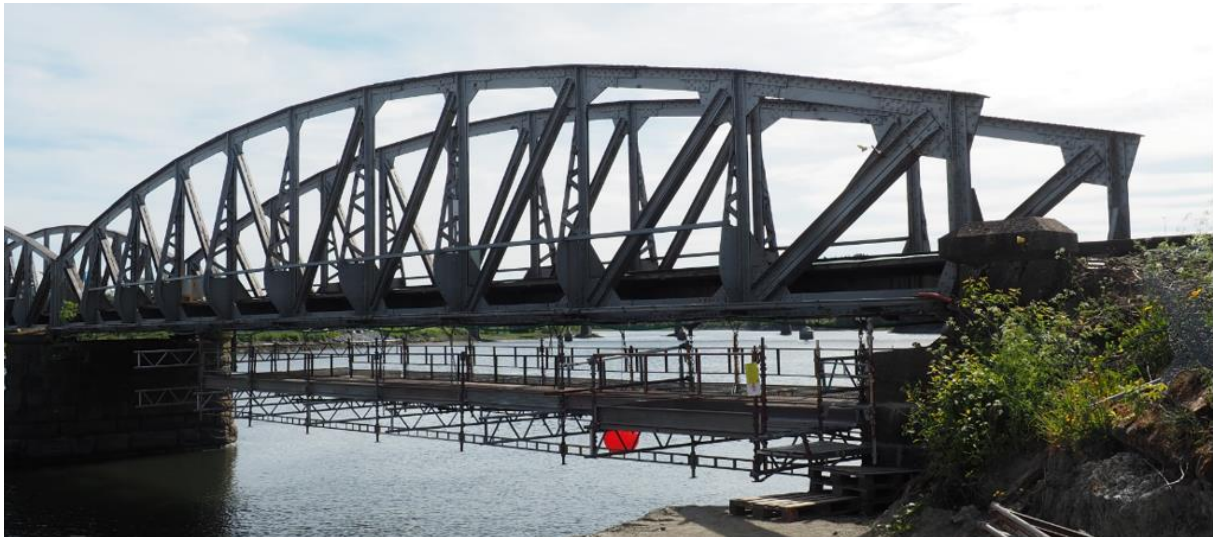
Figure 14: Hell (Stjørdalselva) Bridge [9].

- The bridge was planned to be replaced. Condition monitoring and damage detection on the old bridge for research purposes.
- Instrumented in 2016 for testing a measurement system for SHM research. After the discovery of a damage by the SHM system, the project evolved into a larger scale research project on damage detection using a span of the decommissioned bridge.

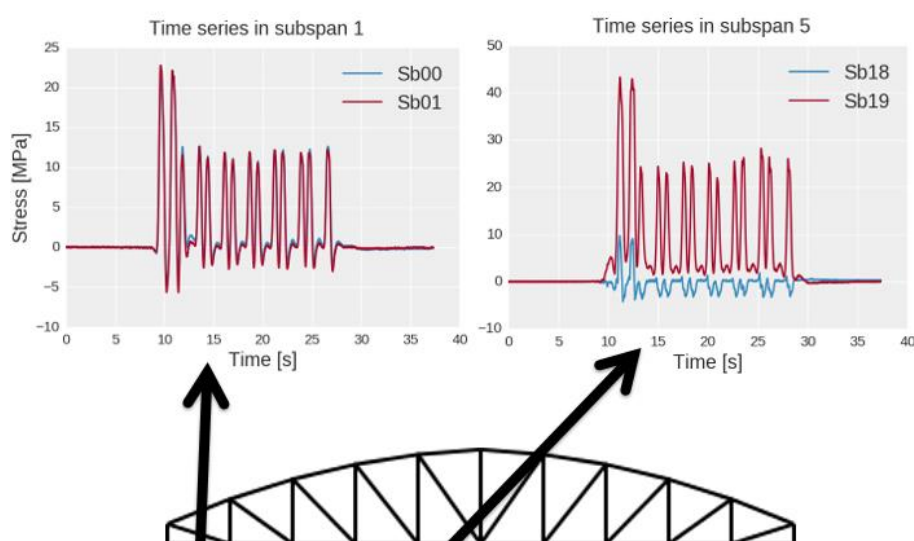
Figure 17: Stresses derived at different sub-spans of the bridge. Undamaged members have equal stress distribution on the stringers at each side of the bridge section (left). In the damaged sub-span, the damaged stringer does not carry load, where the stringer on the opposite side has increased stresses [12]. (courtesy of Gunnstein T. Frøseth)

- Initial data analysis revealed significant variations in stress levels among structurally similar members.
- Although stress levels were high, raising concerns about the structure's fatigue life, they did not pose an immediate risk to structural integrity.
- An emergency inspection was conducted, aided by monitoring data that quickly pinpointed the damage location (Figure 16).
- The inspection uncovered a crack at the connection between a cross-beam and a longitudinal beam, which had not been identified in previous inspections.
- The damage caused a doubling of stresses in the stringer (Figure 17). Such an increase in stress causes a disproportionate decrease in the fatigue life.
- Given that the bridge was already scheduled for replacement and no additional cracks were found, the bridge owner decided to proceed with the replacement as initially planned.

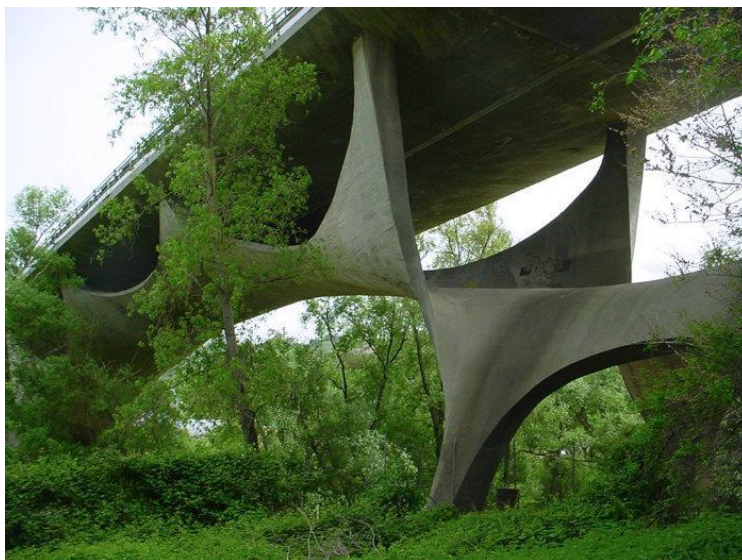
Figure 18: Musmeci Bridge [13].

**About:** Constructed from 1971 to 1976, located in Potenza, Italy (see Figure 18)

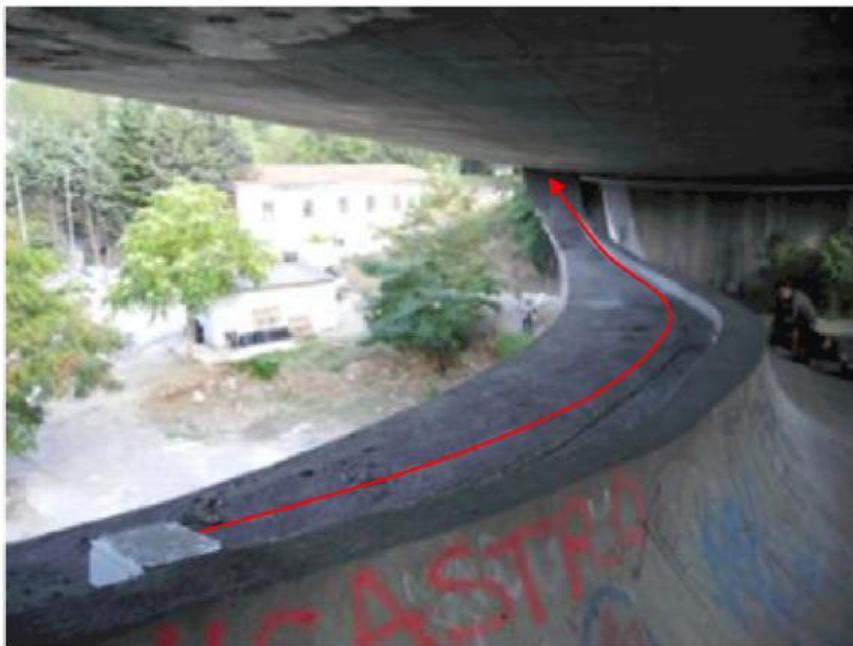
Figure 19: Instrumentation of optic fibers [14].

average strain over 1 m is obtained. It is also reported that a single measurement takes about 1 minute, meaning dynamic effects cannot be captured.

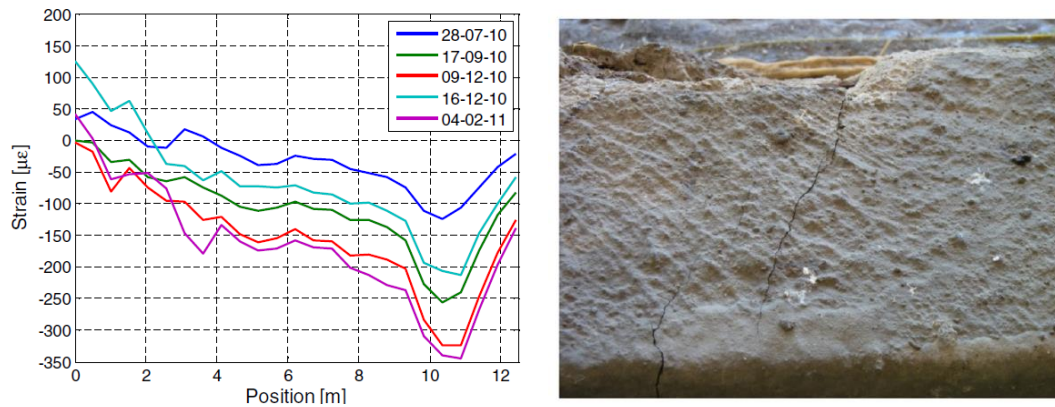
Figure 20: Detected damage [14]. The damage is successfully localized by the help of monitoring. Although a rather small crack, the discrepancy is apparent in the data (left), despite the low resolution (close to 0.5 m).

- Analysis of sensor signals revealed an increase in the compressive strain at the position  $z \approx 10.5$  m of the fiber (shown in Figure 20).
- The measured strains were due to temperature changes.
- A crack was found at the location of the increased strain.
- We do not know if this led to a decision.

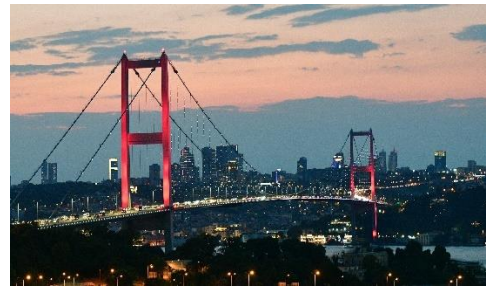
*Figure 21: The bridge (a) with inclined hanger [16] (b) with vertical hanger after the hanger replacement operation (the original image is resized) [17].*

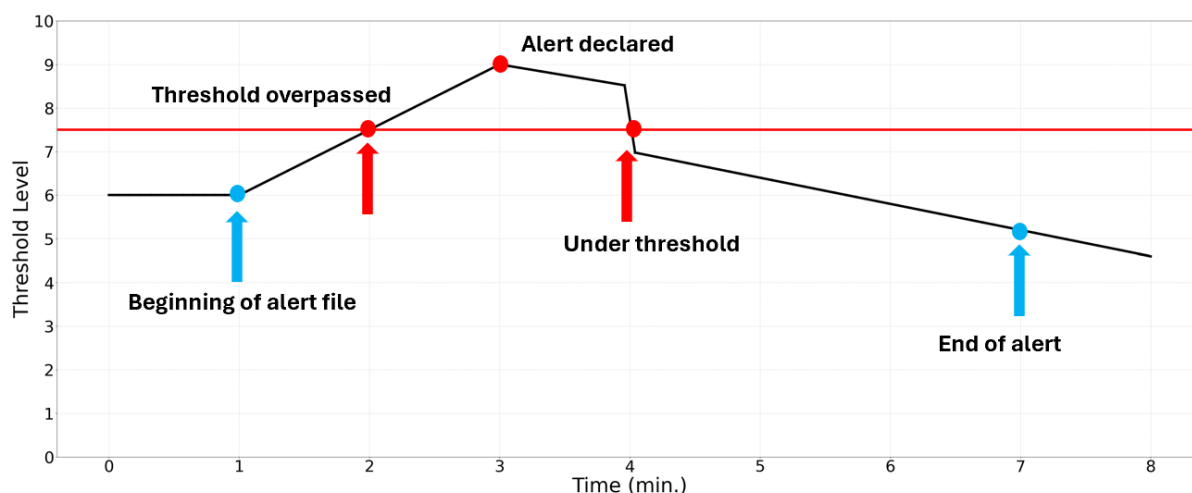
Figure 22: An illustrative example generated to represent the data recorded before and after an alert on a channel. For the original figure, see [18].

The primary reason for monitoring is to identify critical structural responses and determine whether they exceed predefined threshold values for each bridge component. When a threshold is exceeded, the system generates an alert as demonstrated in Figure 22, gathers and processes the relevant data, and produces a preliminary report for the bridge authority. The system tracks anomalies and triggers alerts, helping to manage the bridge's operation.

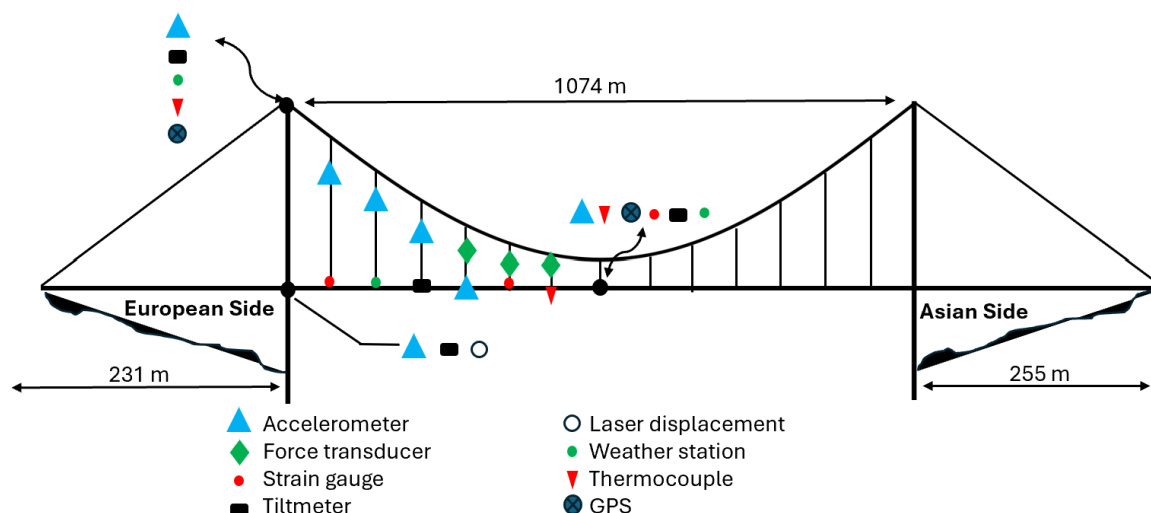
Figure 23: An illustrative example generated to represent sensor arrangement of the SHM system of the First Bosphorus Bridge characteristics. For the original figure, see [15].

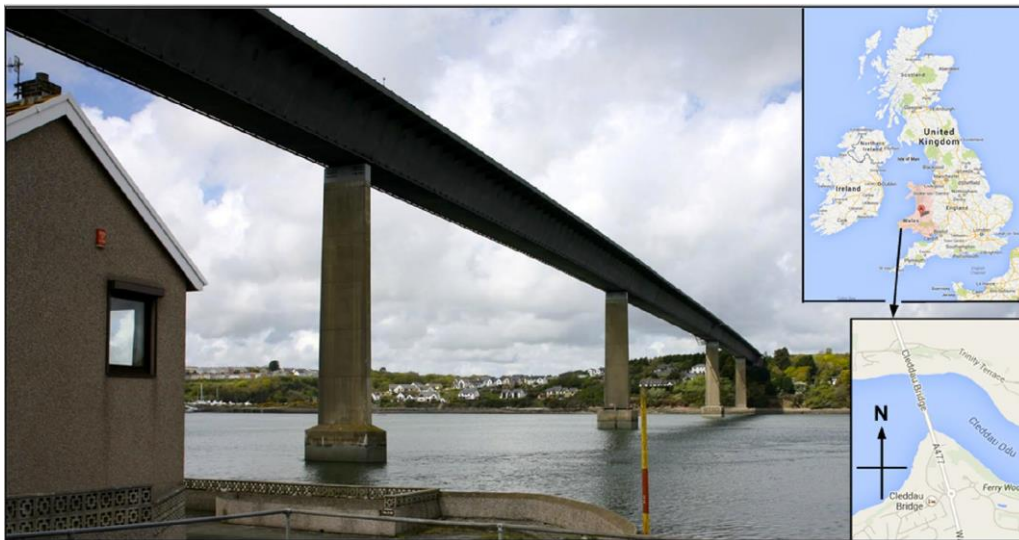
Figure 24: The Cleddau bridge [3]. (Courtesy: James Brownjohn & Pembrokeshire County Council)

**About:** Constructed in 1975 (see Figure 24).

- After nearly forty years in operation, the bearings were nearing the end of their service life. Monitoring the bridge was aimed at detecting any adverse behavior in the bearings.
- The SHM system was initiated in October 2011.

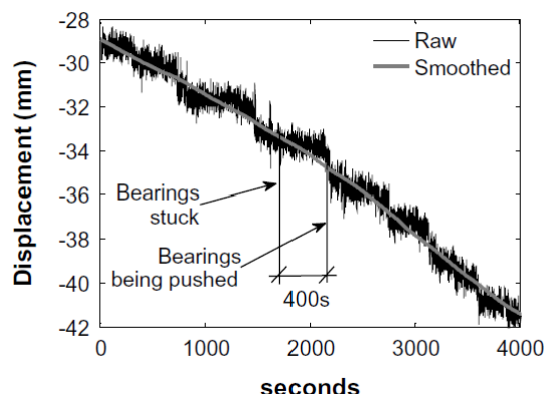
Figure 26: Measurements over a one-hour period showing bearing locking and release [3].  
(Courtesy: James Brownjohn)

- The engineers manually post-processed the data, focusing on time histories of temperature measurements. This analysis revealed that diurnal variations in ambient conditions can create complex temperature distributions across the bridge. Specifically, transverse temperature gradients lead to plan bending, which induces twisting at the bearings. The twist magnitude was calculated by measuring the difference between displacement readings at the inner and outer ends of the bearings [23].
- When examining bearing lock, the displacement data showed that movements occur incrementally, with friction playing a significant role. Bearings were observed to briefly lock and then release, particularly during rapid temperature fluctuations [23], as shown in Figure 26.

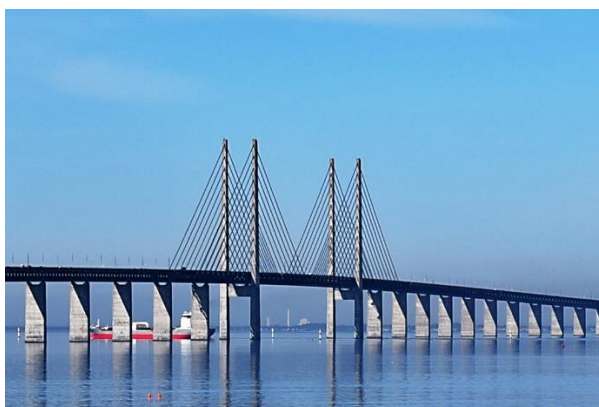
Figure 27: (a) Cable-stayed part of the Øresund Bridge (the original image is resized) [24]. (b) Cross section of the cable-stayed bridge spans [25].

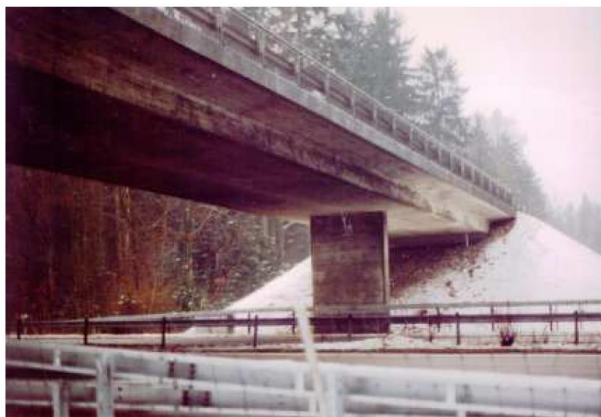
Figure 28: The Z24 bridge [29].

**About:** Constructed in 1963 (see Figure 28)

- Before its planned demolition, the Z24 Bridge was extensively studied as a test case for Structural Health Monitoring (SHM) research, becoming one of the most analyzed bridges in SHM history.
- The SHM system was in operation from November 11, 1997, to September 10, 1998.
