**Adapting a Riverine  
Litter Indicator for  
OSPAR Monitoring: A  
Framework for  
Norwegian Conditions  
M-3080|2025.**

1098

Miljødirektoratet/ Norwegian Environment Agency

Marte Haave (SALT) and Gaute Velle (NORCE)

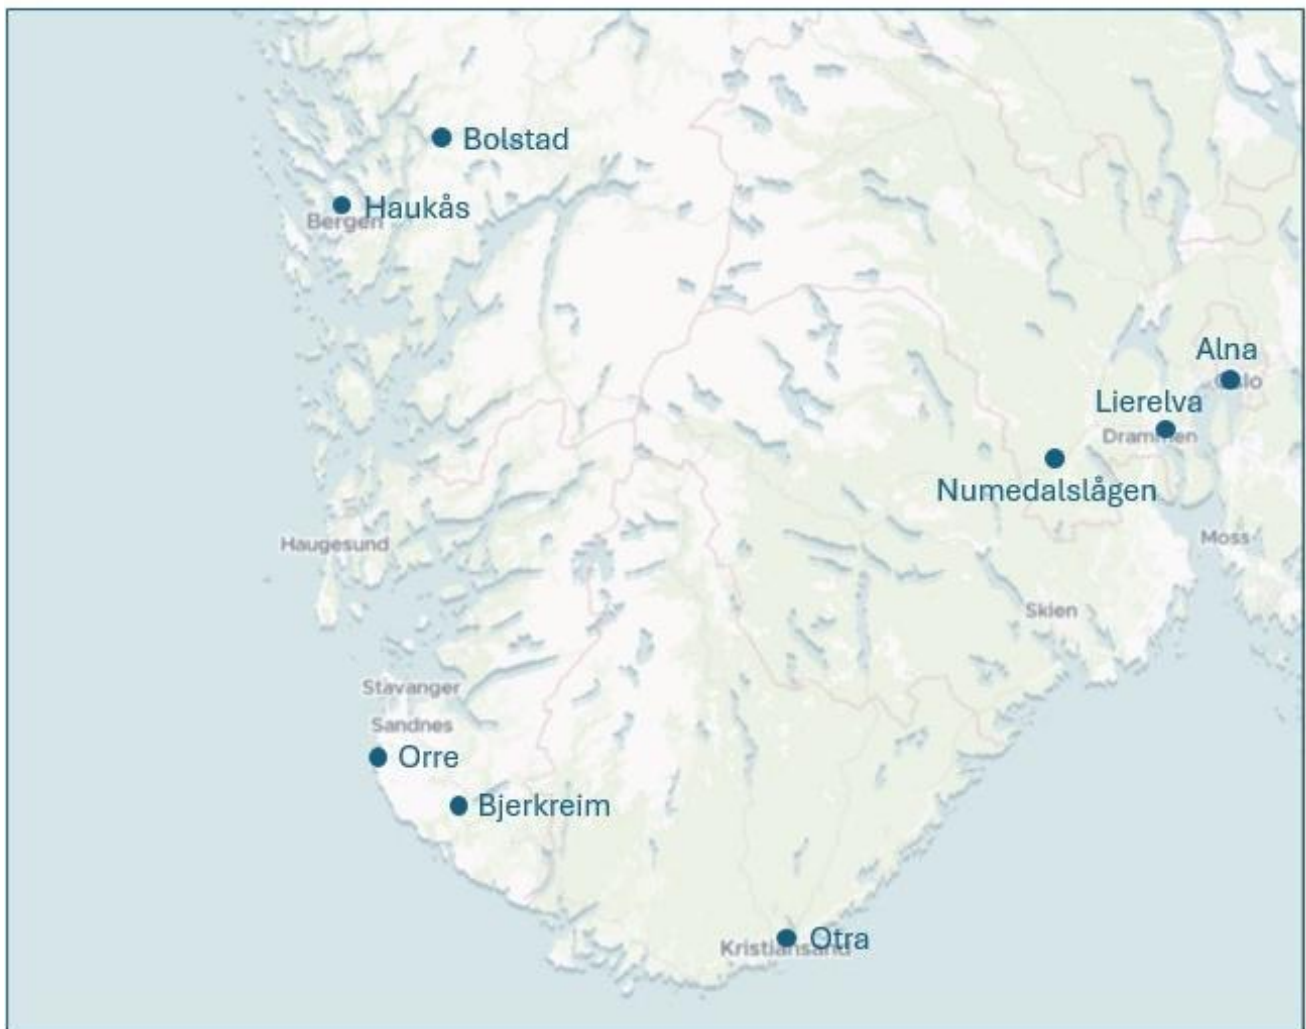
**Figure 1:** MAP showing selected rivers in southern Norway investigated for the development and testing of an indicator for riverine litter monitoring

The area selected for the project covered southern Norway between Bergen and Stavanger in the west, Oslo in the east and Kristiansand in the south (Figure 1).

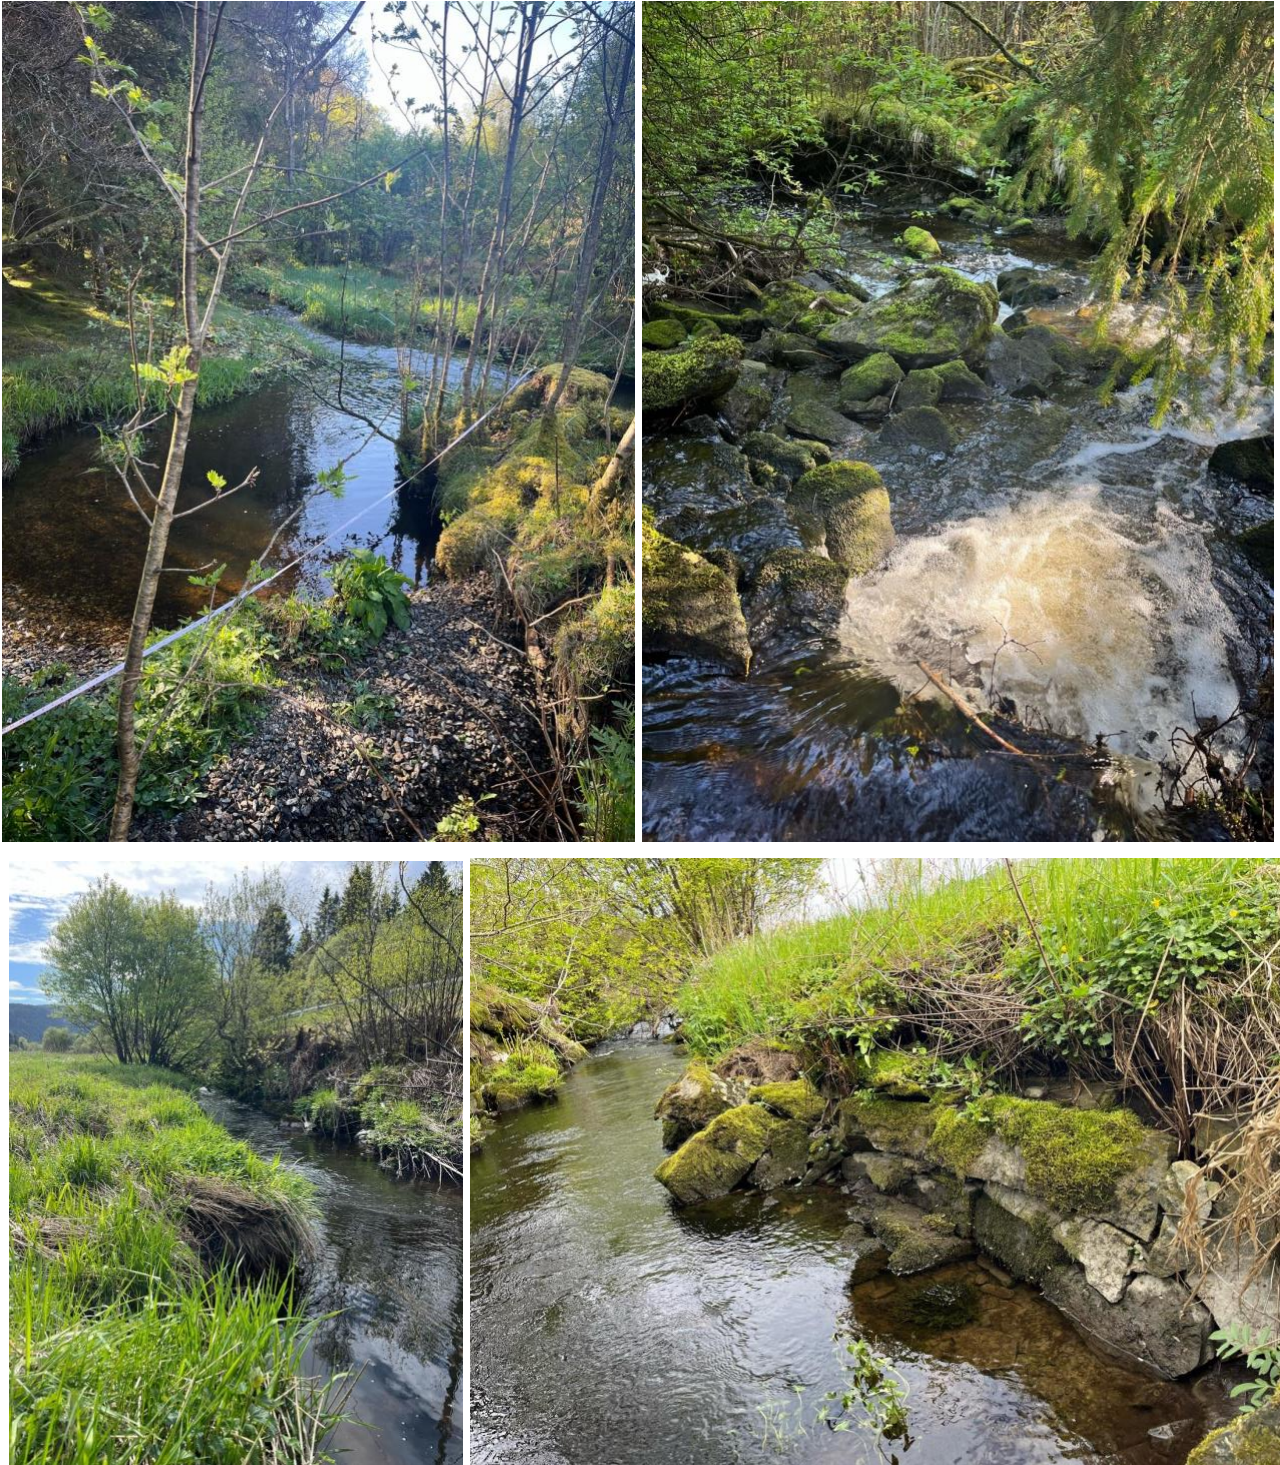
**Figure 4:** Images from Haukås segment A (top), showing variation in the riverbank and vegetation properties. Segment B (bottom) where the riverbank is steep and supported by boulders (riprat). Images from the fieldwork in May 2025.

Despite the densely vegetated and erratic riverbank, our observation is also that Haukås A will trap and collect litter. Finding litter items in such conditions may be challenging, especially when the foliage is fully developed, and the surveys must take the necessary time to search for all items. However, if monitoring is carried out before foliage and vegetation develops, we believe this segment could be suitable for monitoring under OSPAR.

The segment Haukås B is downstream from Haukås A (Figure 3). At segment B, the river runs between the motorway and farmland. The previously plastic polluted area had been cleaned some time before the survey in May, and there was hardly any litter to be found. The riverbank is in part supported by boulders (riprat) as bank-protection walls, and the riverbank is steep, straight and

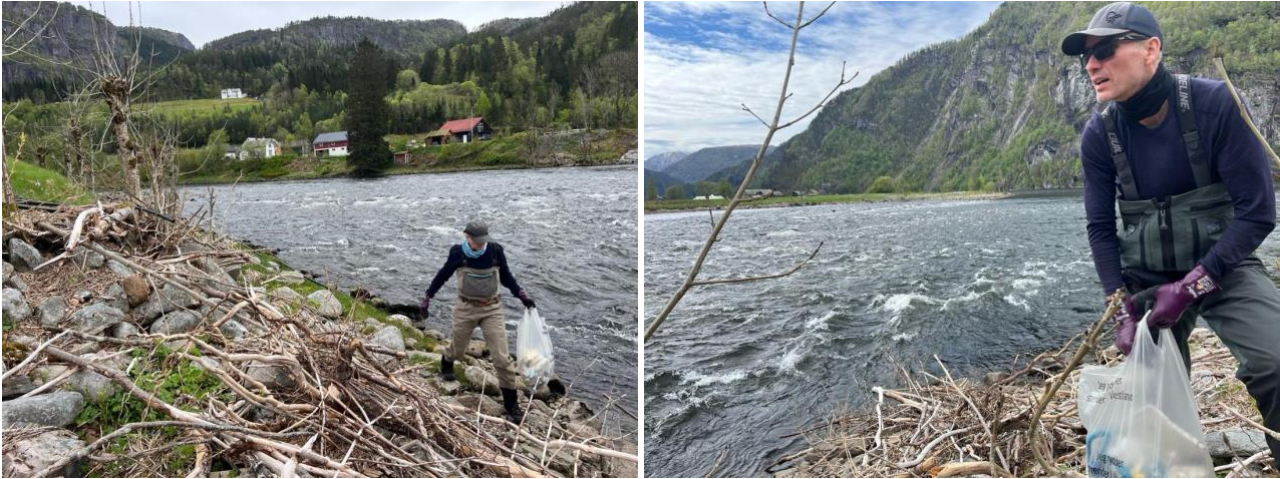
**Figure 6:** Photos from the riverbank at Bolstad segment B close to the river mouth, during the fieldwork in May 2025

Bolstad B was placed downstream of segment A, in an area with good access to the riverbank, and about 100 m upstream of the river mouth to prevent registering marine litter that could have entered the river at high tide (Figure 6, right). Bolstad River segment B was also easy to walk and relatively easy to observe and collect the litter from the rocky riverbank. There were no overhanging vegetation or large obstacles. In Bolstad B there was a high number of litter from a variety of sources, such as building/construction, agriculture, personal use and hygiene products that indicated how litter from several origins had been deposited at this site. The items of expanded polystyrene and Litex-bathroom wall plates were small, indicating that the items were not recently deposited, or that they may have travelled far and had been exposed to high mechanical force before deposition on the riverbank. Accumulation of organic riverine debris marked the flood line along the riverbank clearly, where the majority of the small litter items were found. The riverbank was high, and overflow would require a high flood. In May we observed 679 items and 3.9 kg of litter in this segment (Table 2). With the varied sources of litter, the clear signs of accumulation, the good overview and access to the riverbank we consider Bolstad B a typically suitable area for monitoring (Table 2, Figure 19, Appendix 2).

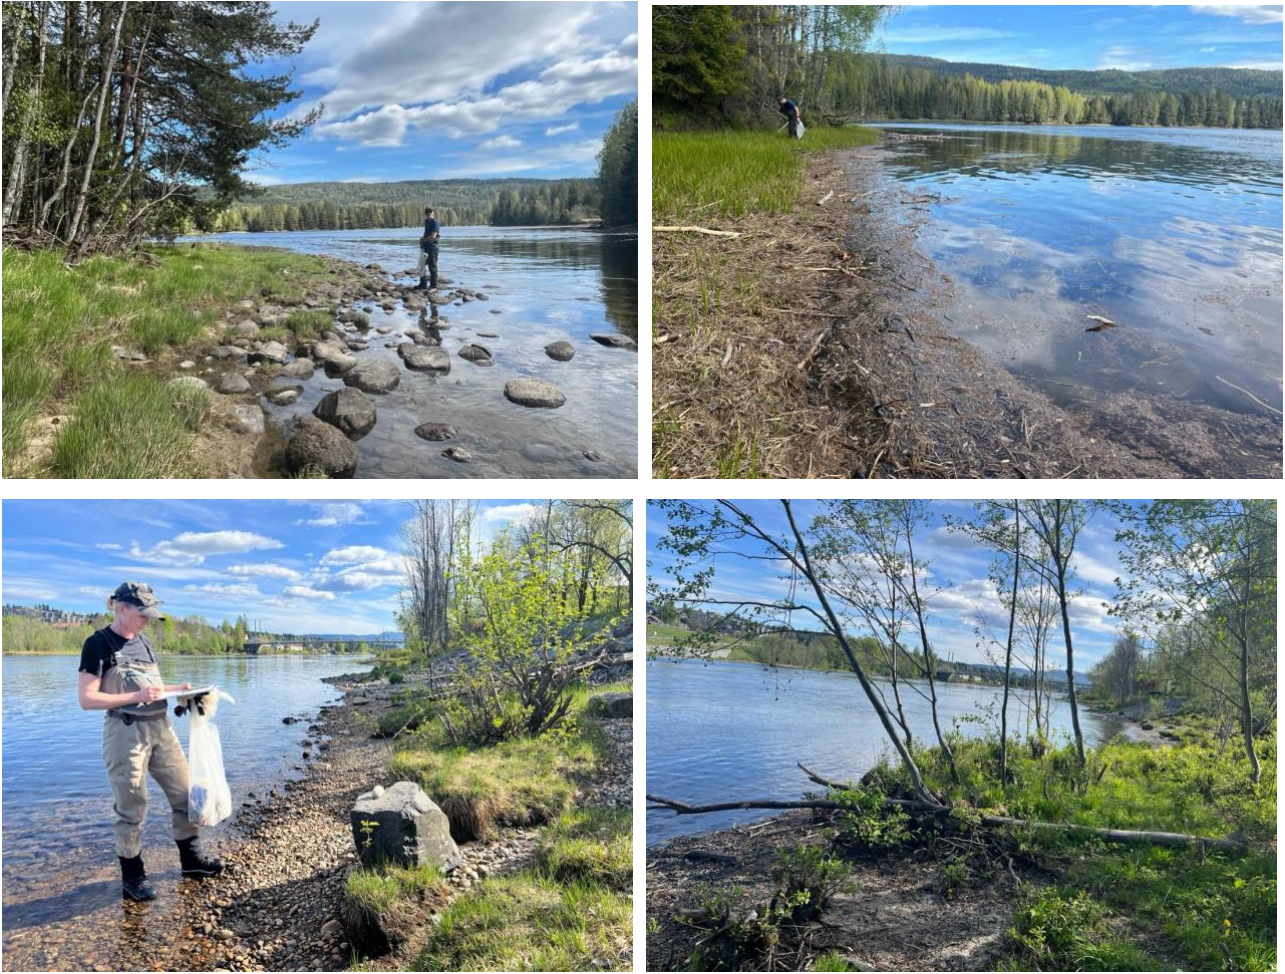
**Figure 8:** Map of Numedalslågen with segment A near the settlement Lampeland (top) and segment B (bottom) near the city of Kongsberg.

Numedalslågen River segment B (Figure 8, bottom) was in the city of Kongsberg. The nearest power station is Pikerfoss power plant, about 8 km upstream. The segment was easily accessible and easy to walk and clean, and with a discharge of about 50 m<sup>3</sup>/sec. The pebbles and short grass and the few trees along the riverbank were not seen as obstructions, despite the vegetation being quite developed at the time of the survey. The segment was in the vicinity of a museum, and we observed families playing by the water near the monitoring area during the survey. The museum park by the river was also well maintained and the grass had recently been trimmed. It is likely that such locations will be cleaned by by-passers or the museum wards. Both littering and removal of litter is likely to occur inside the segment. For that reason, we do not recommend setting up monitoring areas close to parks and recreational areas, corresponding to avoiding popular beaches in beach-litter monitoring.

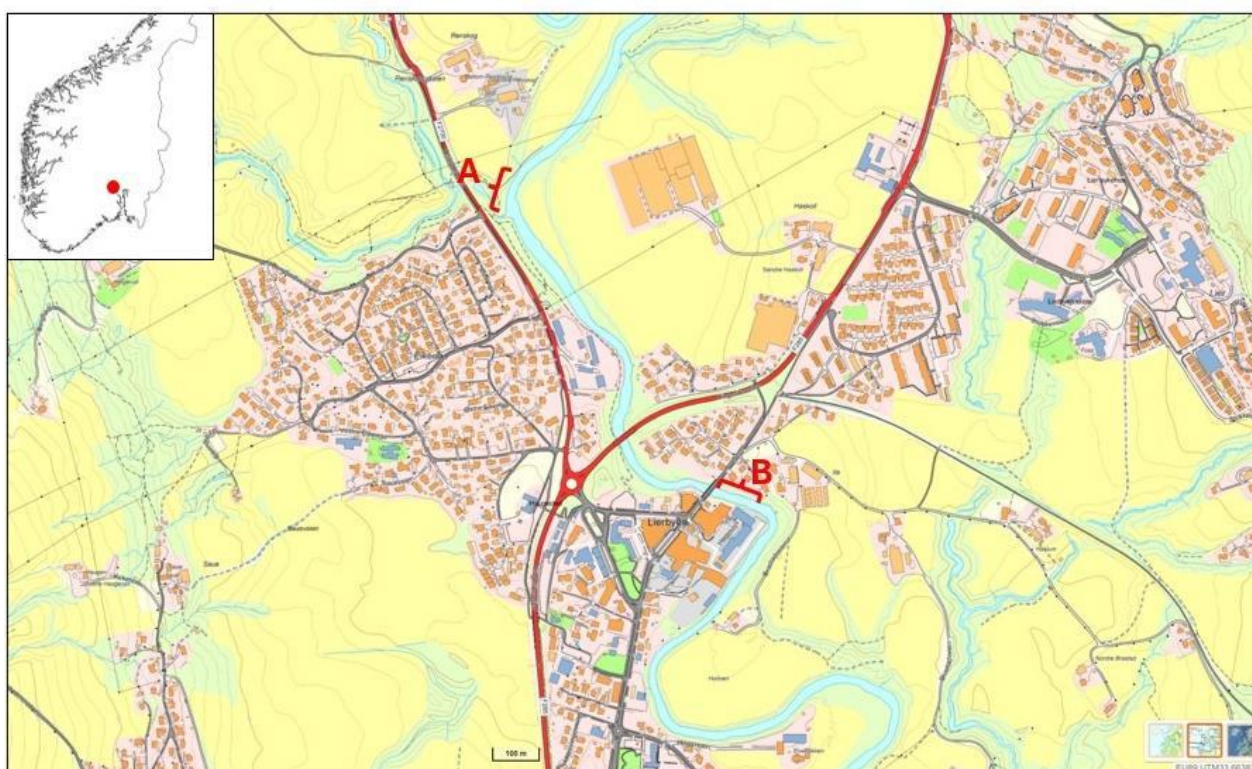
**Figure 9:** Map over Lier River with segments A and B, running through agricultural landscape and the town of Lier.

The Lier River is a medium-sized river that flows through the municipality of Lier (Figure 9). The river passes through agricultural areas, urban areas and industrial areas before flowing into the Drammensfjord. The Lier River is particularly well suited to testing and developing new methods for monitoring plastic litter in rivers because it is easily accessible and has parts with varying degrees of

In Lier segment A (Figure 9, Figure 10) the vegetation was quite developed, which to some extent obstructed visibility and cleaning. The riverbed and steep riverbank were sandy or muddy, and the water was not easily accessible from the riverbank. Therefore, the segment was only cleaned and monitored on land. Signs of a recent flood line was visible among the trees well above the water. In October the discharge was higher than in May (about 7.5 m<sup>3</sup>/sec at Opsal). A recent flood event (85 m<sup>3</sup>/sec at Opsal) had removed a lot of vegetation at the riverbank. Some litter was visible in the trees but had not accumulated on the ground.

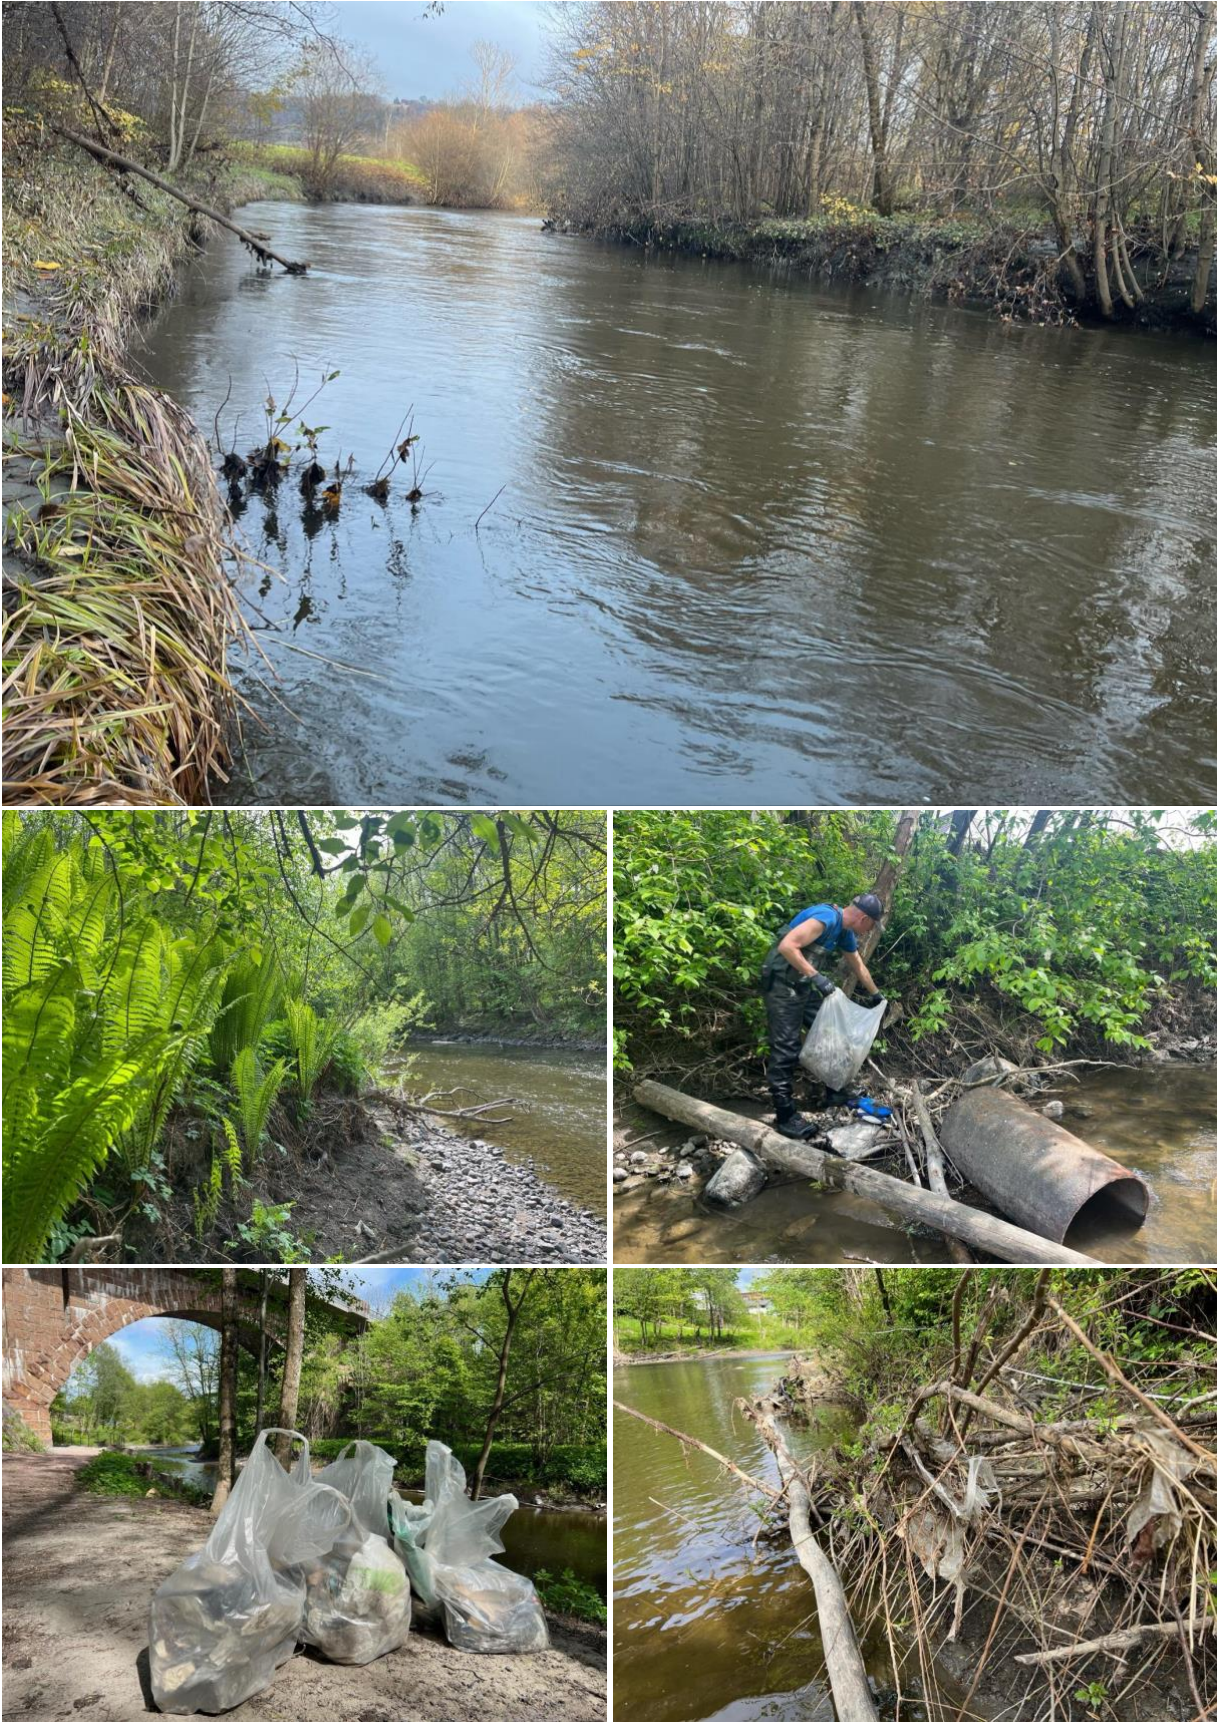
**Figure10:** Segment A in October when the discharge was higher than in May (top). Segment B (middle and bottom). Large items that cannot be removed must be noted in the registration form (middle right). A cleaning - event took place at the day of the survey in May (bottom left), litter still present within the river system on the day of the cleanup (bottom right).

Due to the steep and sandy riverbank with a drop to the water, we do not believe the segment to accumulate litter except at floods, and do not recommend Lier segment A for monitoring purposes.

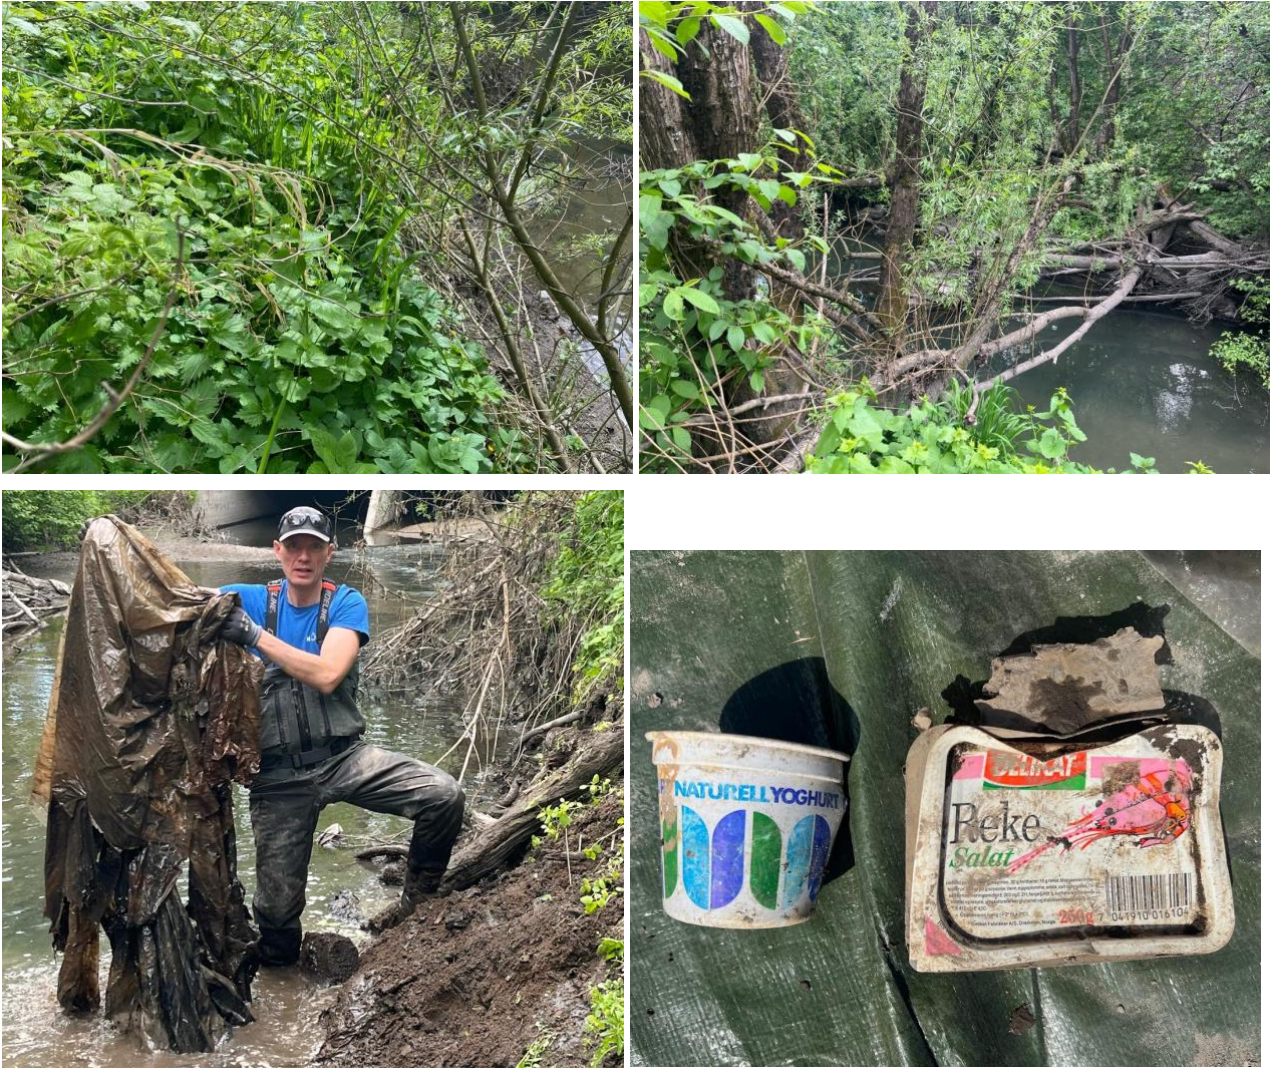
**Figure 12:** Photos of Alna A at the time of the survey showing the dense vegetation on the banks(top) and examples of old litter buried in the riverbank, indicative of an old dumpsite along the river (bottom). The recognizable design places this food packaging in the 1980's (bottom right).

At the date of the survey, Alna segment A had a moderate to low discharge dominated by glide. The vegetation was highly developed, which made it difficult to observe litter on the ground (Figure 12). Less than 100 metres from the culvert it was also difficult to pass the trees closest to the riverbank, and therefore to clean and monitor litter along the entire length of the segment (Figure 12, top). There have been several cleanup initiatives in the Alna River following the mapping of plastic in Norwegian rivers in 2024 (Velle et al. 2024). The position, amount and age of litter in segment A indicate, however, that this segment has not been cleaned recently.

Past events of sewage overflow were evident from several sanitary waste items on the riverbank. Sewage overflow and fertilization is also highly likely to have contributed to the dense vegetation at Alna A. The soft soil on the riverbank slopes and overhanging vegetation (Figure 12, top) made this area particularly difficult to walk along for monitoring, and there was a danger of sliding into the river. At a higher discharge, it will be difficult to access the water. The presence of a dumpsite, as well as the dense vegetation and steep slopes makes Alna A not recommended as a monitoring site.

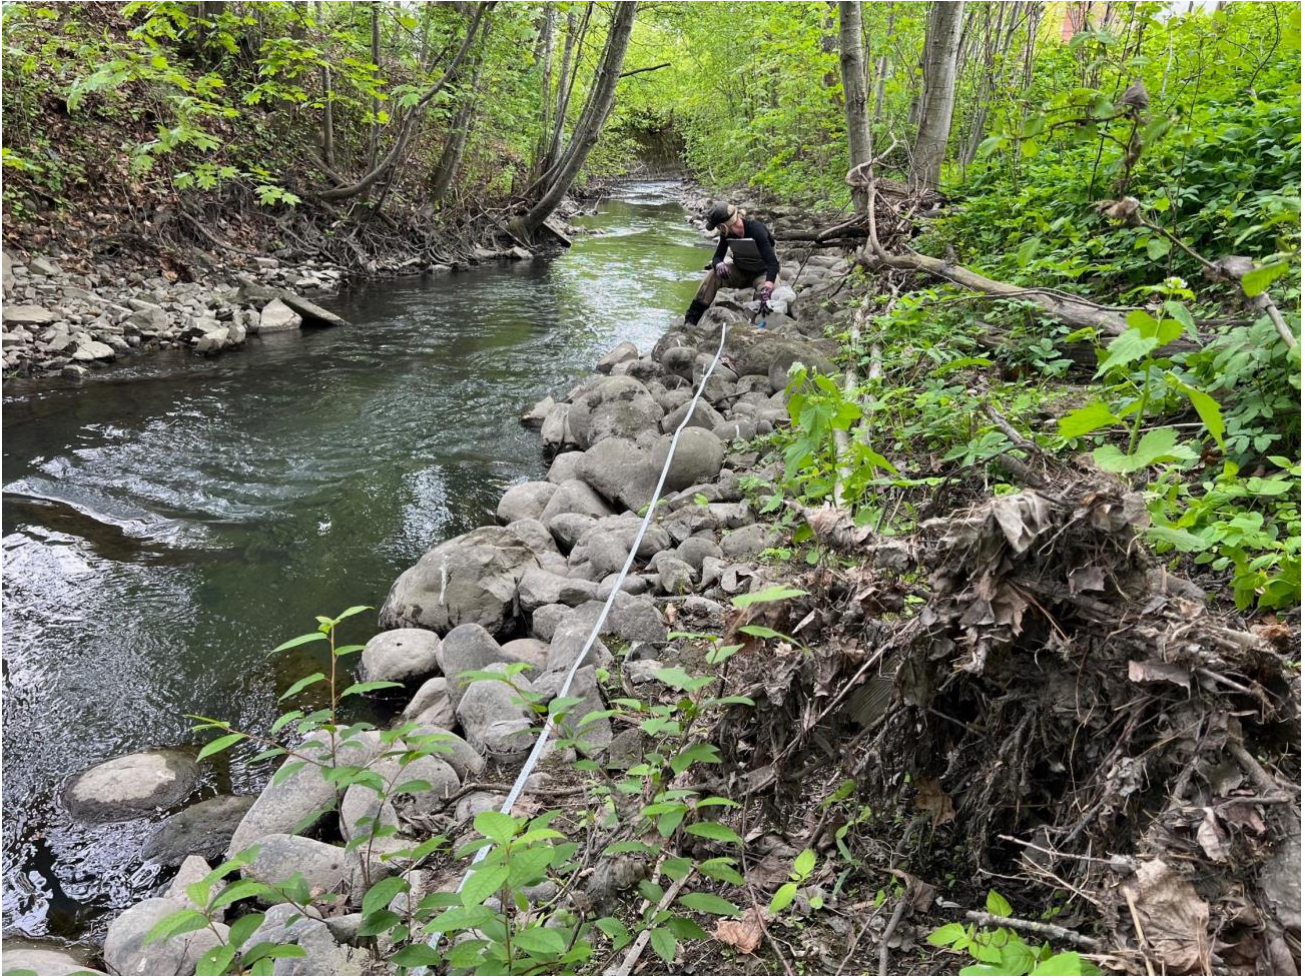
**Figure 13:** Photos of the urban river segment Alna B, a rather undisturbed stretch of the river running between a residential area and the train-tracks.

The Alna River segment B started outside a culvert where the river exits from underneath traffic, running behind a residential area for about a kilometre (Figure 11 and 13). There might be grates in the culverts upstream of this segment, which needs to be validated. The segment is otherwise easy to travel and clean and has boulders that may trap litter between the rocks and in the vegetation on the riverbank (Figure 12). 100 metres of rather undisturbed riverbank for monitoring in an urban area can thus be found here. The riverbank is high, and the river is not very likely to overflow. We observed 103 items and 4.9 kilos of litter in segment B (Table 2). As such this segment is suitable for monitoring. The amount of annual littering , and previous cleanup activities are unknown.

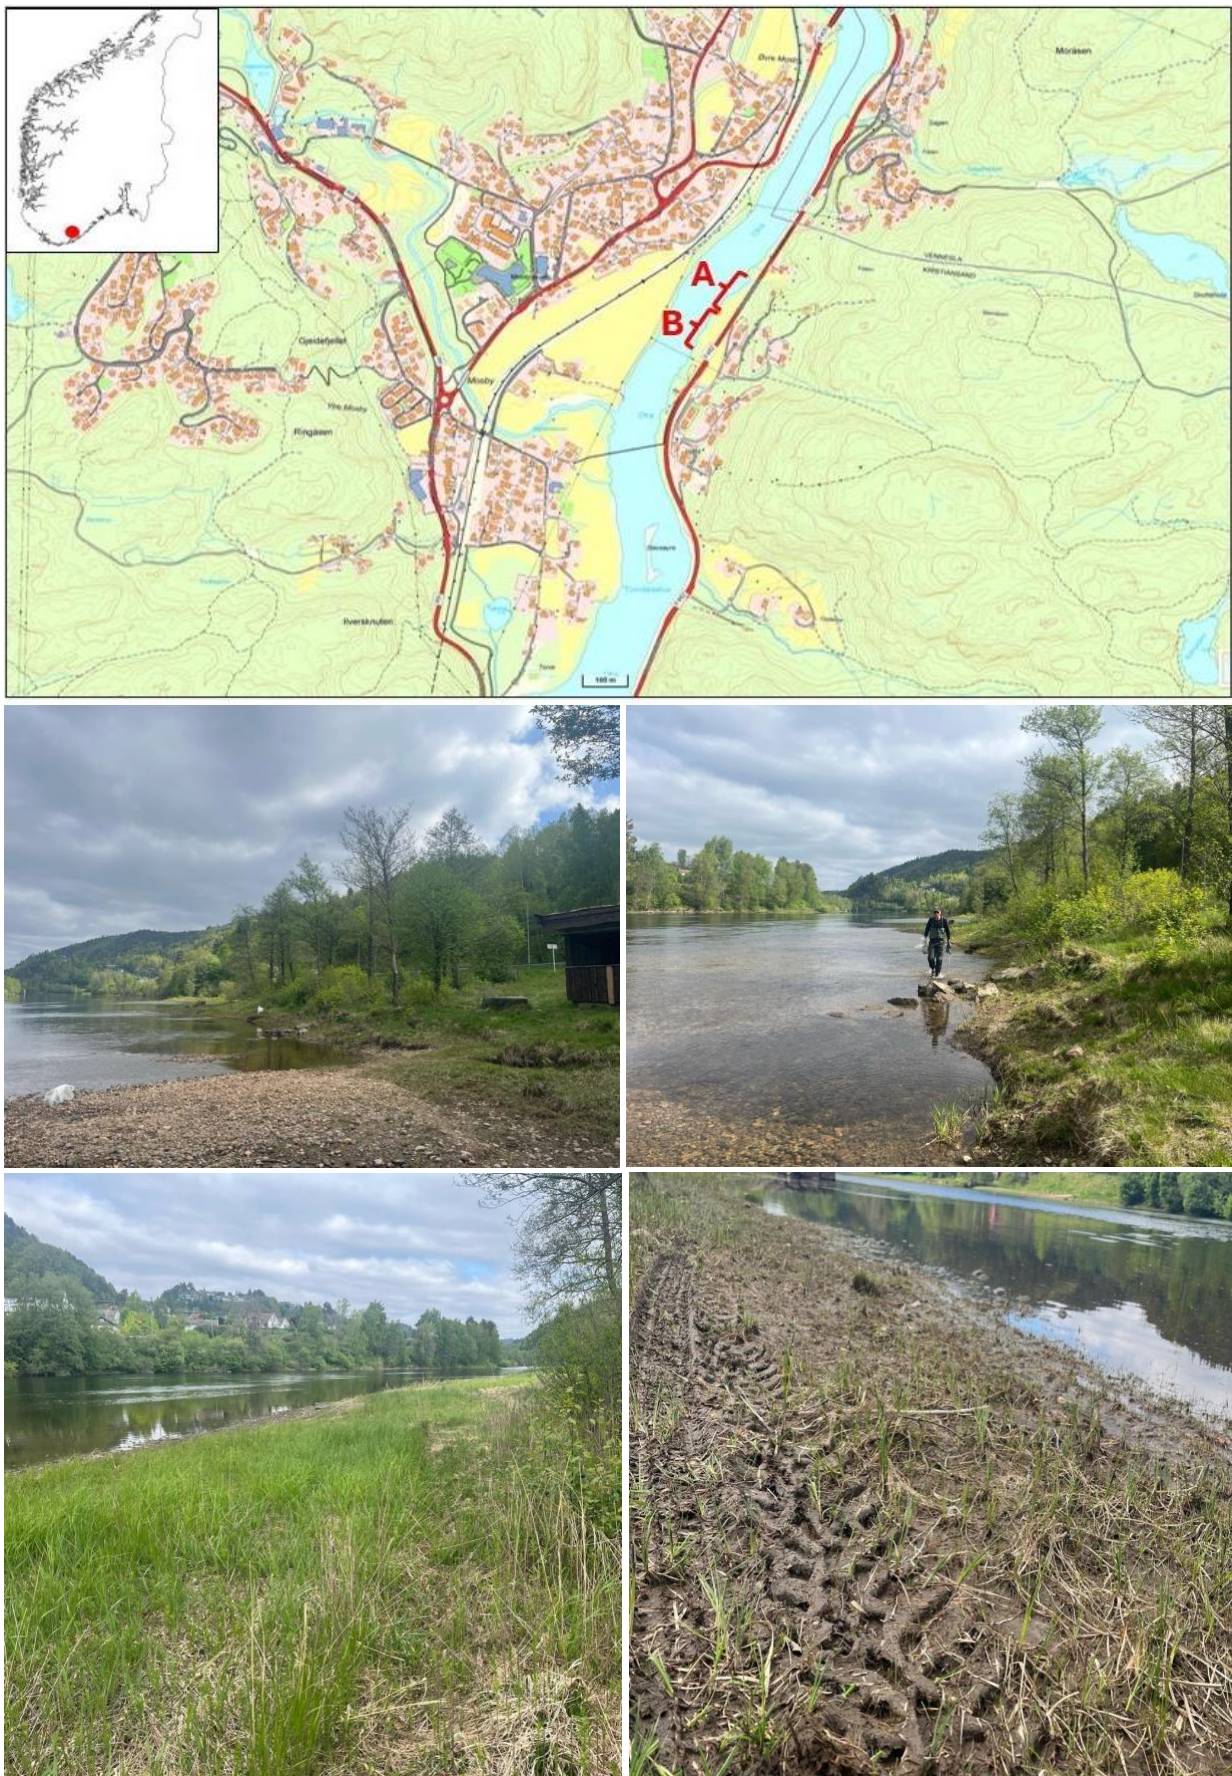
**Figure 14:** Map over Otra with the two segments A and B (top), segment A (middle) with a fishing hut and segment B (bottom) with a wider riverbank and tyre tracks along the riverbank (bottom right) indicating launching of boats or jet-skis.

On the day of the survey in May, the discharge relatively low (100 m<sup>3</sup>/sec 5 km upstream at Heisel), but a mark from higher water levels could be seen on the riverbank in segment B, indicating the necessary width of the monitoring segment to include all potentially deposited debris and litter. Segment B had a wider riverbank than segment A, more grass cover and with less shrubs (Figure 14 bottom), which will impact deposition of litter.

Also, tyre-tracks on the riverbank in segment B indicated that boats or jet skis had been launched by use of motorized vehicles. Such use of the river may increase the chance of littering from recreational use but may also lead to a risk of cleaning of the segment outside of surveys. We advise finding similar and accessible segments for monitoring, that are not affected by sports and recreation such as fishing, camping or launching of jet skis and boats.

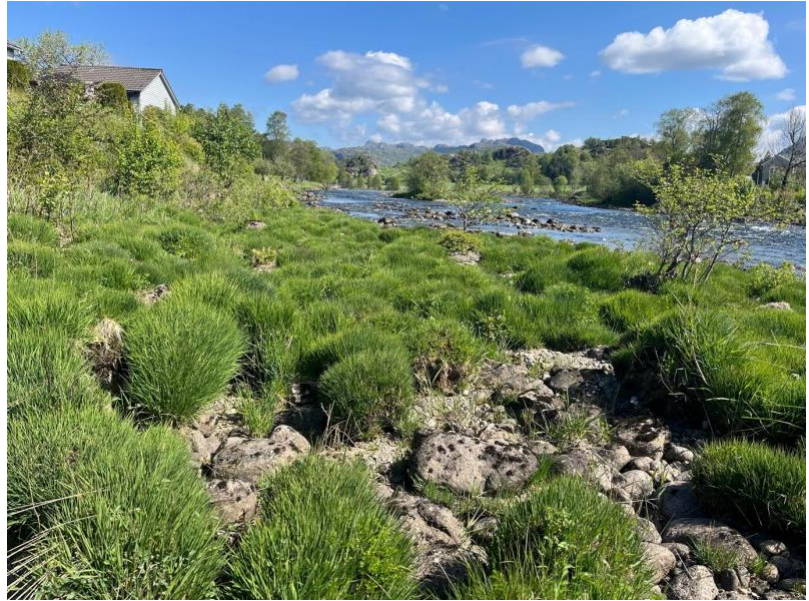
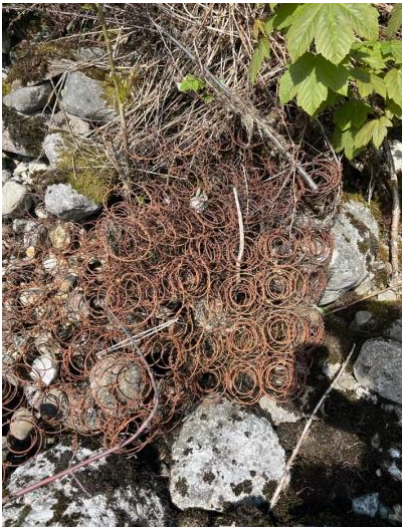
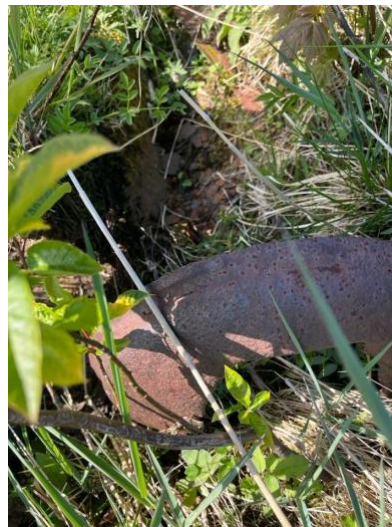
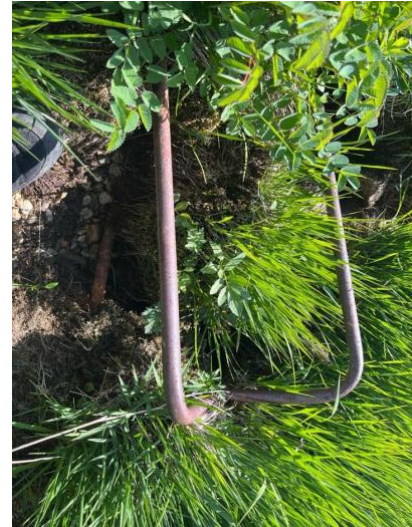
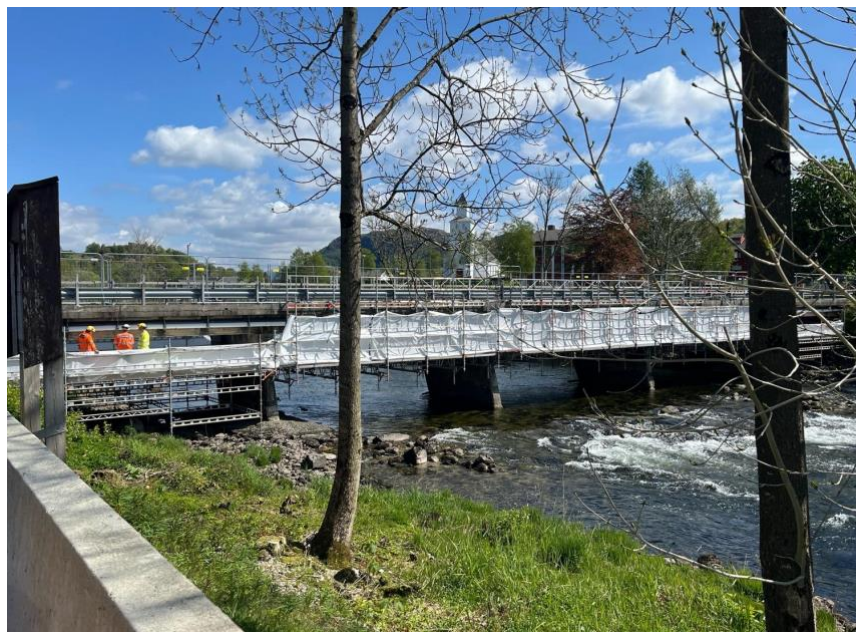
**Figure 16:** Photos of the riverbank at Bjerkreim segment A at the day of the survey (top), with large boulders and mounds of grass, metal scrap that could not be removed (middle), and the bridge by segment B under maintenance (bottom)

Bjerkreim segment B was downstream of a nearby bridge under maintenance (Figure 16, bottom). We observed metal and plastic litter from the maintenance-job. On the day of the survey the discharge was moderate, and the water ran fast past segment B, and we found little evidence of accumulation zones on the riverbank. The riverbank down to the river was wide and easy to walk, with some well-developed grass, herbs and shrubbery that required a thorough search for litter. The minerogenic zone was narrow, and the accumulation of litter along the riverbank seemed less likely, although a flood line was visible on the riverbank. Above the riverbank and flood line there is a shop and a parking lot, and the litter on the riverbank was dominated by food packaging from snacks and ice-cream that were likely thrown or wind-blown towards the river from the shopping area and/or bridge but had not yet reached the river. In this project we monitored the entire riverbank from the water to the levee, and therefore all the litter on the riverbank was included (Table 2). Such dominance of litter from nearby shops will be worth noticing when selecting sites for monitoring (Appendix 1). Including only the litter below the latest flood line will also exclude most of such litter thrown from nearby shops, unless it has passed the level of the flood line.

Although maintenance of the bridge contributed to littering on the day of the survey, this will be a temporary contribution. Bridges often contribute to littering from pedestrians and cars. As a potential important source of litter to rivers, we recommend including segments downstream of bridges in monitoring. However, the presence of a bridge near a monitoring segment should be noted in the description of the area. The segment should also have other properties that will permit deposition and accumulation of riverine litter. In sum, Segment B receives litter from upstream sources as well as from the bridge and the shop, but it does not appear to be a strong accumulation zone. It is therefore only a moderately suitable monitoring segment.

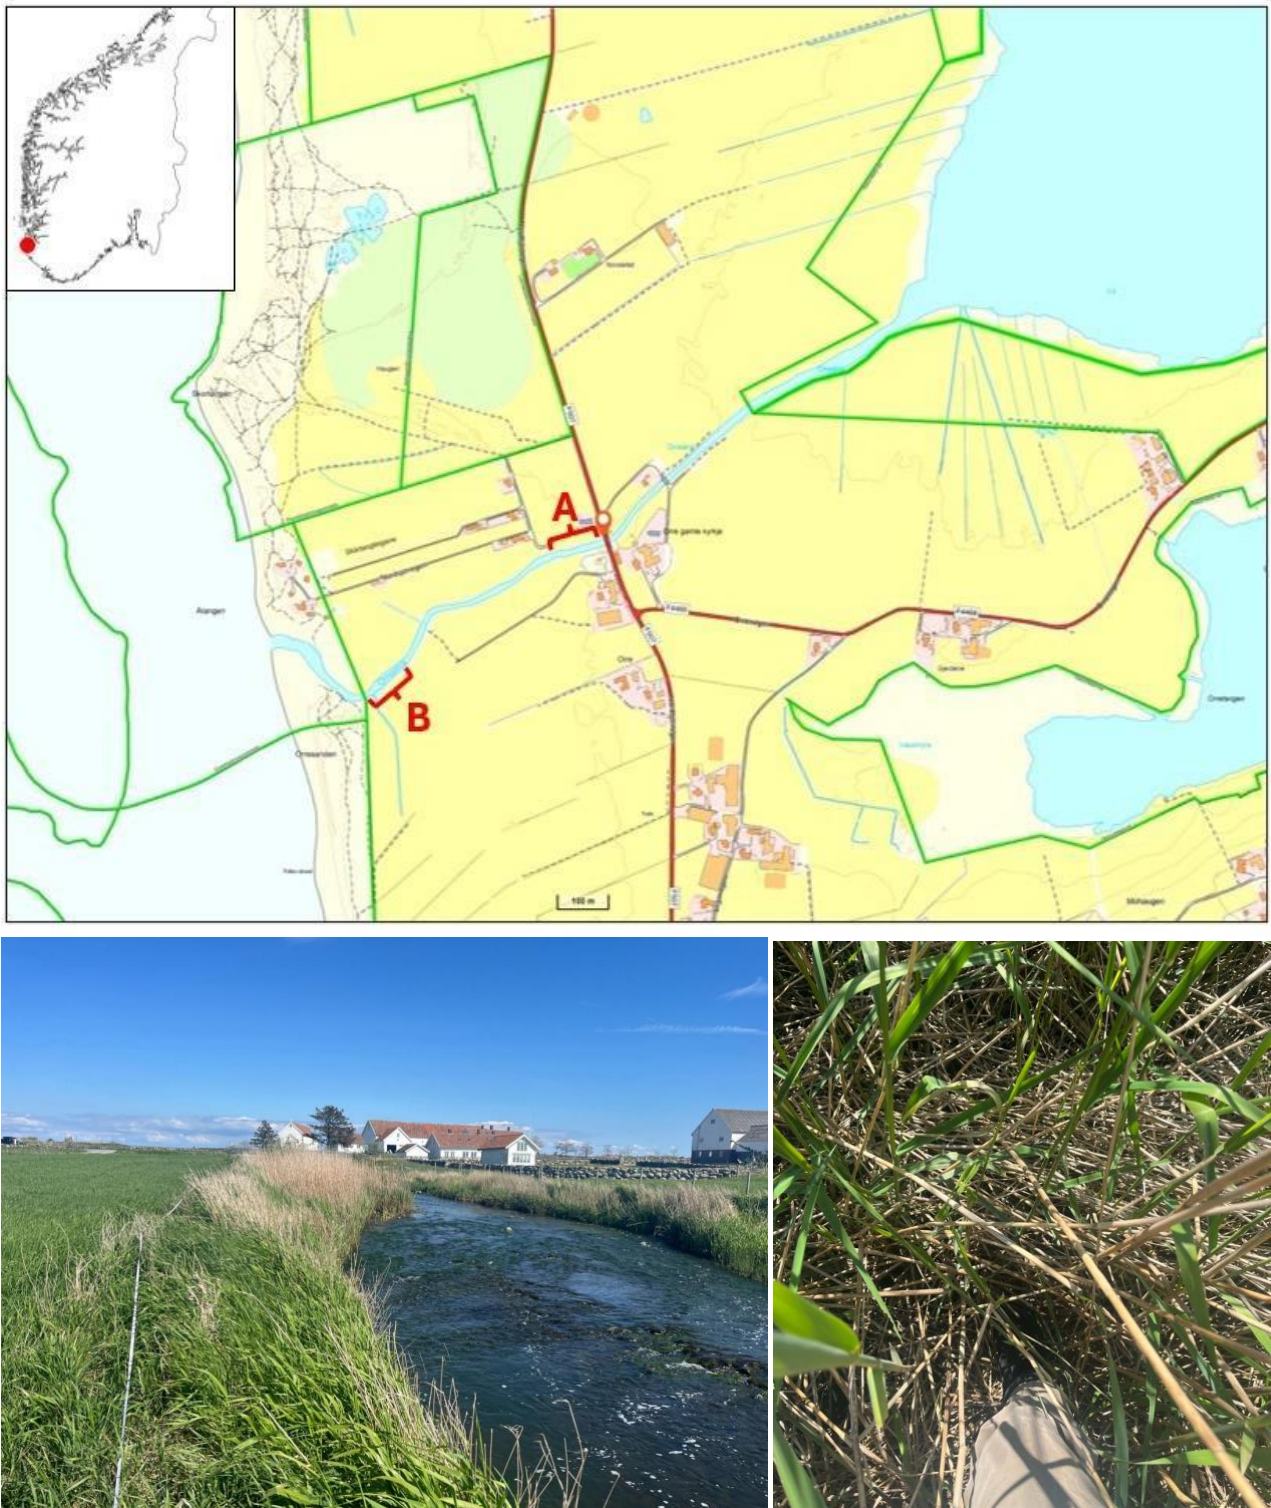
**Figure 17:** Map of Orre River Segments A and B (top). Photos of Orre River segment A (bottom) with dense reeds along the riverbank, potentially hiding litter. May 2025.

The shifting sand dunes cover and uncover litter over the course of a year. We observed a few litter items that may have been deposited by the river, such as bottlecaps and lids and small pieces of rope and rubber belts. However, at the start of the river segment over 100 meters upstream from the ocean we found several pieces of net-cuttings that are undoubtedly of marine origin. This indicates that the bottlecaps may also have come from the sea, as bottle caps and lids are frequently found along the Norwegian coastline (Haave et al, 2025). Strong winter storms and winds may transport marine litter up the river, and this may affect the litter types and numbers in the monitoring area. For that reason, the location does not seem suitable for monitoring of riverine litter.

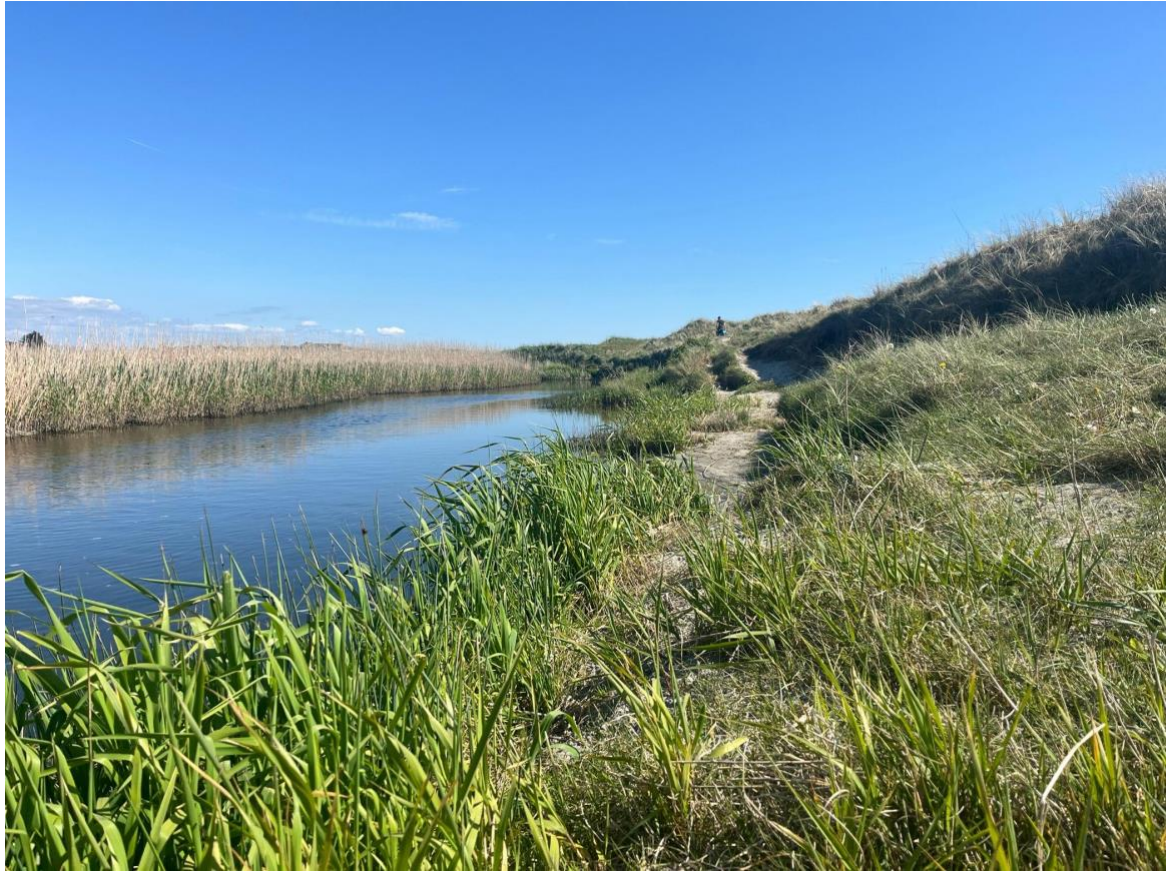
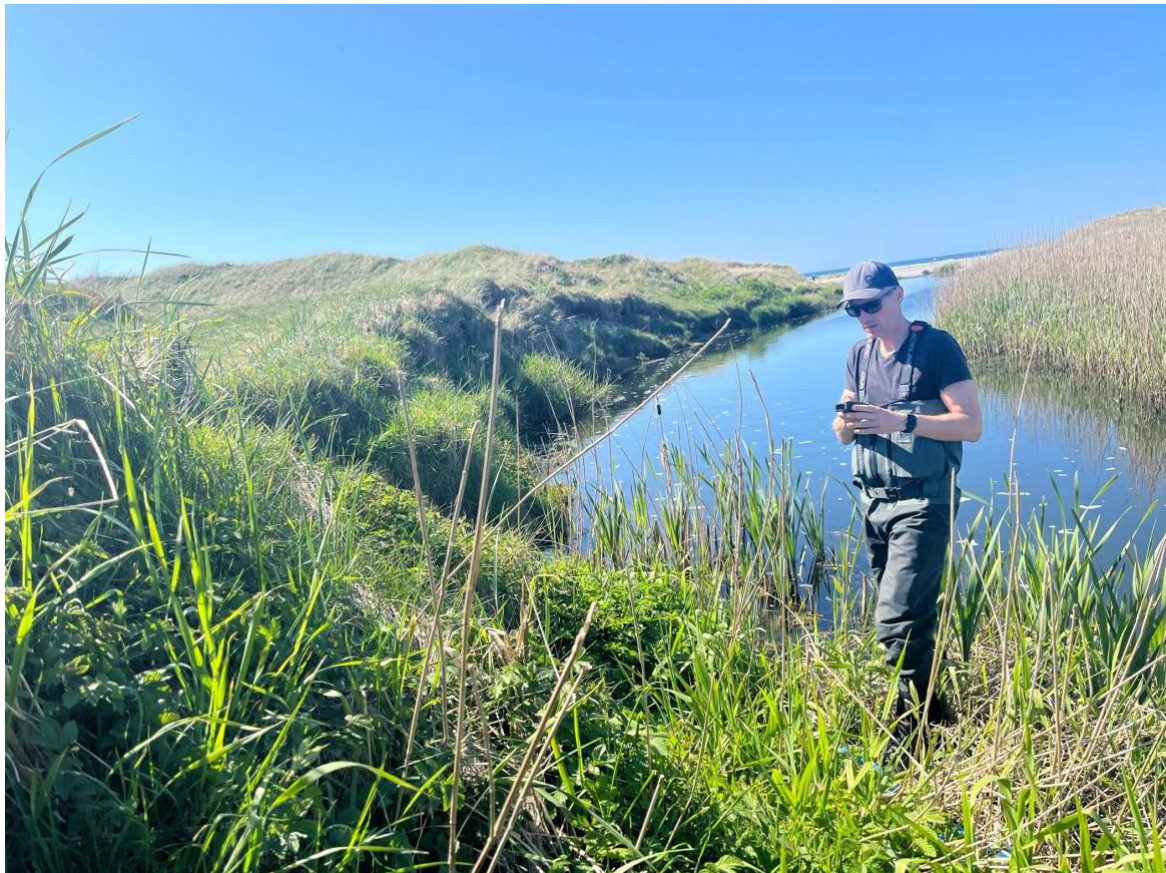
**Figure 18:** Orre River Segment B near the outlet at the sandy Orre beach, in May 2025. Bottom: Using the nIR tool for measuring the width of the riverbank.

The riverbank was dominated by sand, and the slopes were of variable inclination and some places steep. The discharge was normal to low and the water speed slow at the day of the survey. Segment B was monitored from land.
