Assessment of Methods for Inspection and Instrumentation of Grouted Connection

Doc no.: 90394
Ver: v1
Date: 14.09.2020

Document name:	Document number:
Assessment of methods for inspection and instrumentation of grouted connection	90394
Project name:	Project number:
Petroleumstilsynet – Grouted Connection	320-20083
Project manager:	Department:
Julle Ekeborg	12280

FORCE Technology Norway AS has performed an assessment of the maturity and quality of available methods for inspection and instrumentation of grouted connections between jacket and pile.

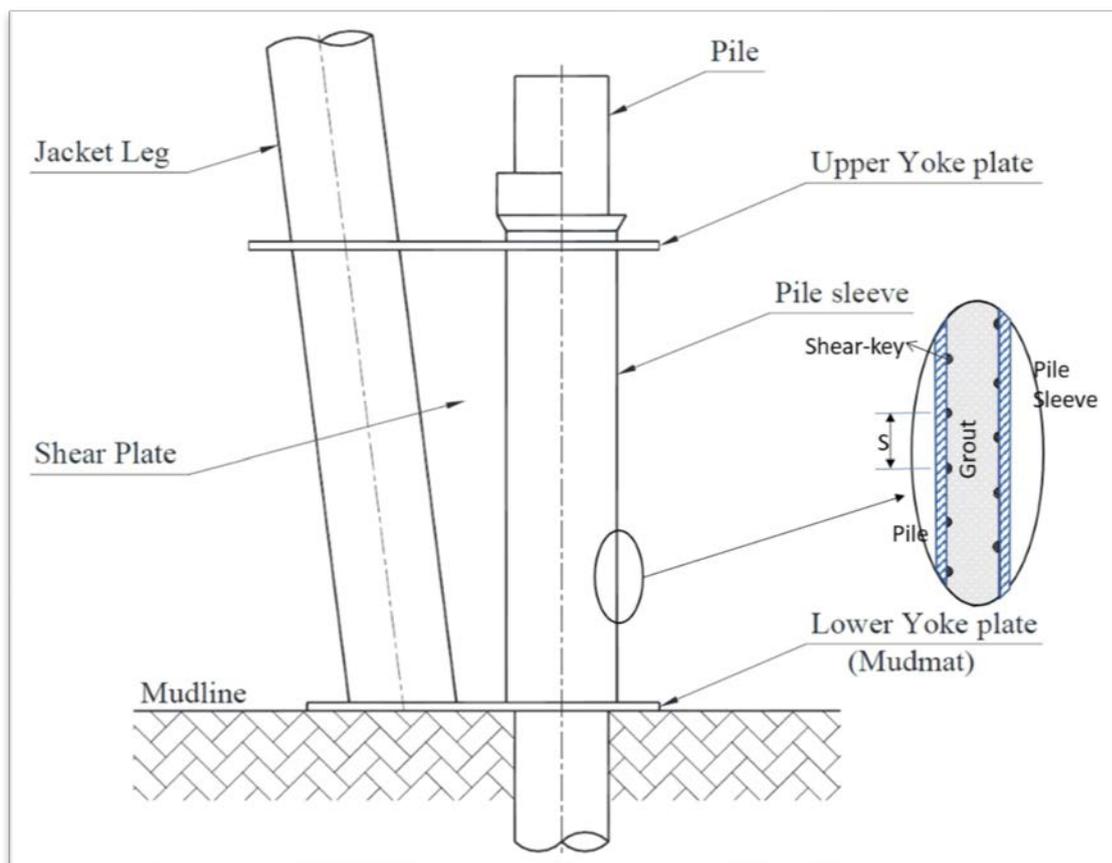
Figure 2-1 Pile / sleeve connection showing the jacket leg, the upper and lower yoke plates, the pile, and the insert showing the weld beads and the pile and the pile sleeve forming the shear keys. Illustration from N-004.

A typical grouted connection between pile and sleeve for an offshore jacket structure is showed in Figure 2-1. The space between pile and sleeve is filled with grout and weld beads (shear key's) are made on both pile and sleeve to increase the load capacity of the connection.

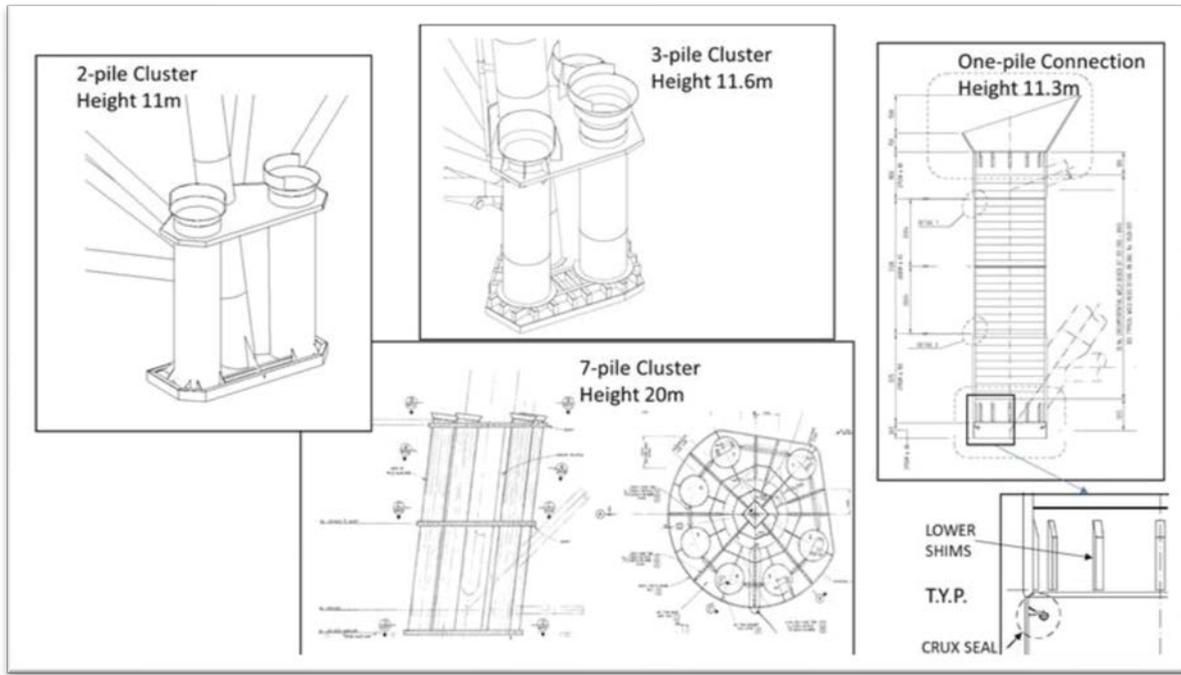
Figure 2-2 Different pile clusters showing a “one pile” connection top right, to a 7 pile cluster connection at down centre. Note the pile heights ranging from 11m to 20m for these real cases. The insert shows the lower details of the “one pile” connection with the Shims (centraliser) and the Crux seal. Illustration from Aker BP & Equinor.

There are different designs of the pile sleeve connections ranging from a single pile per leg to 2 or 3 piles per leg or for instance 7 as shown in Figure 2-2. The method to transfer the load from the jacket to the pile differ between designs to achieve a robust jacket design, for instance by braces or through the use of shear plates as shown in the Figure 2-2.

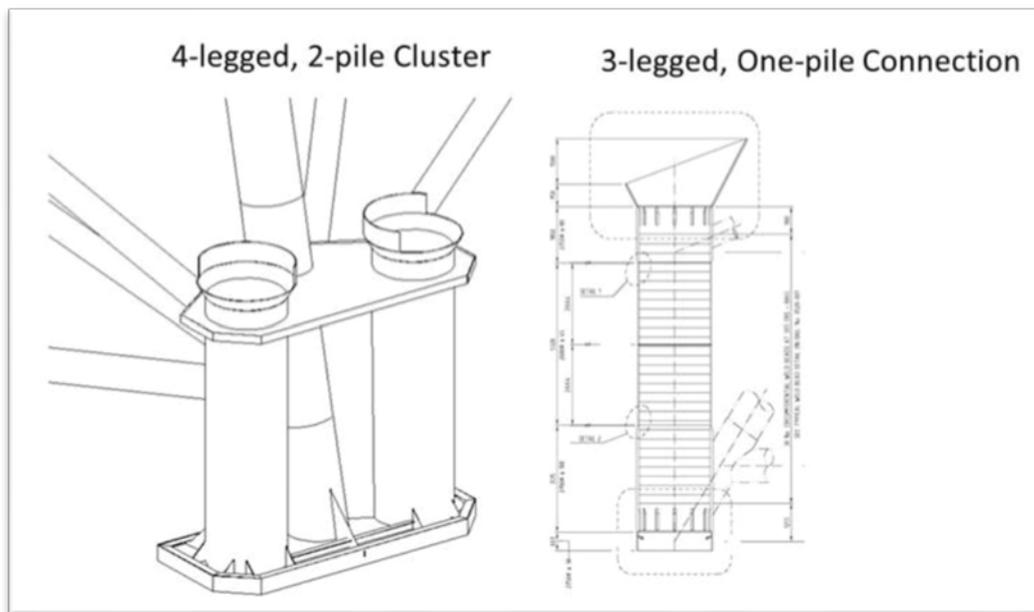
Figure 2-3 For a “one pile” connection on a 3-legged jacket, the main brace is typically directly connected to the sleeve (right), but for a “multi pile” cluster on a 4-legged jacket the connection to the main brace is through Yoke and shear plates (left). Note the horizontal lines of the weld beads in the “one pile” connection. Illustration from Aker BP & Equinor.

The main difference between a “one pile” connection and “multi pile” connection is shown in Figure 2-3. For the one pile connection the platform main bracing is connected directly to the pile sleeve while for more piles a pile cluster arrangement is applied and the load transfer is applied through Yoke and shear plates.

Figure 2-3 illustrates two different jacket designs, a 3-legged jacket and a 4-legged jacket. Depending on depth, environmental conditions like waves, current and wind, weight, soil conditions, purpose of the jacket, etc., jackets are designed with different number of legs and different number of pile connections per leg. The behaviour of these jackets will be different, and this difference should be taken into account when the appropriate inspection or instrumentation method is evaluated. It is expected that a failure of one grouted connection on for instance a 6-legged jacket, with one or more grouted connections per leg, will be much more difficult to detect than a failure of a grouted connection on a 3-legged jacket with one pile per leg due to symmetry and redundancy. If a failure occurs on a 3-legged jacket, it will be visible in the global behaviour of the jacket, and it is essential to know in advance that this is developing. For a 6-legged jacket the other connections may take up part of the load, and hence it will be more difficult to detect loss of a connection, and the loss may be less critical to the integrity of the jacket.

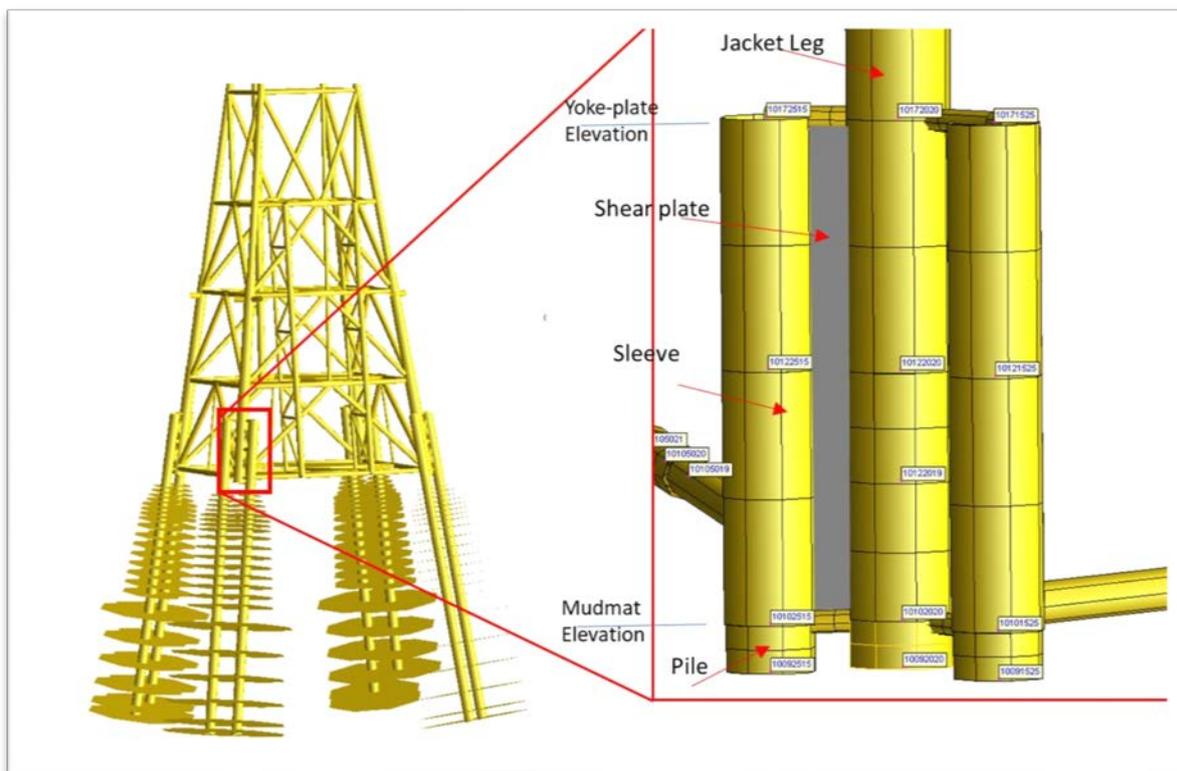
Figure 2-4 A pile model (left), and the pile and sleeve nodes (right) for a 4-legged jacket with 2-piles at each leg used in the model to characterise changes in the natural frequency with degraded grouted connections. Illustration from FORCE Technology.

Figure 2-4 show a typical Pile/Sleeve connection for a 4-legged platform with 2-piles in each corner.

In the analyses the pile and sleeve are modelled as separate beam elements and connected by nodes using master-slave coupling. The pile nodes as master nodes and sleeve nodes as

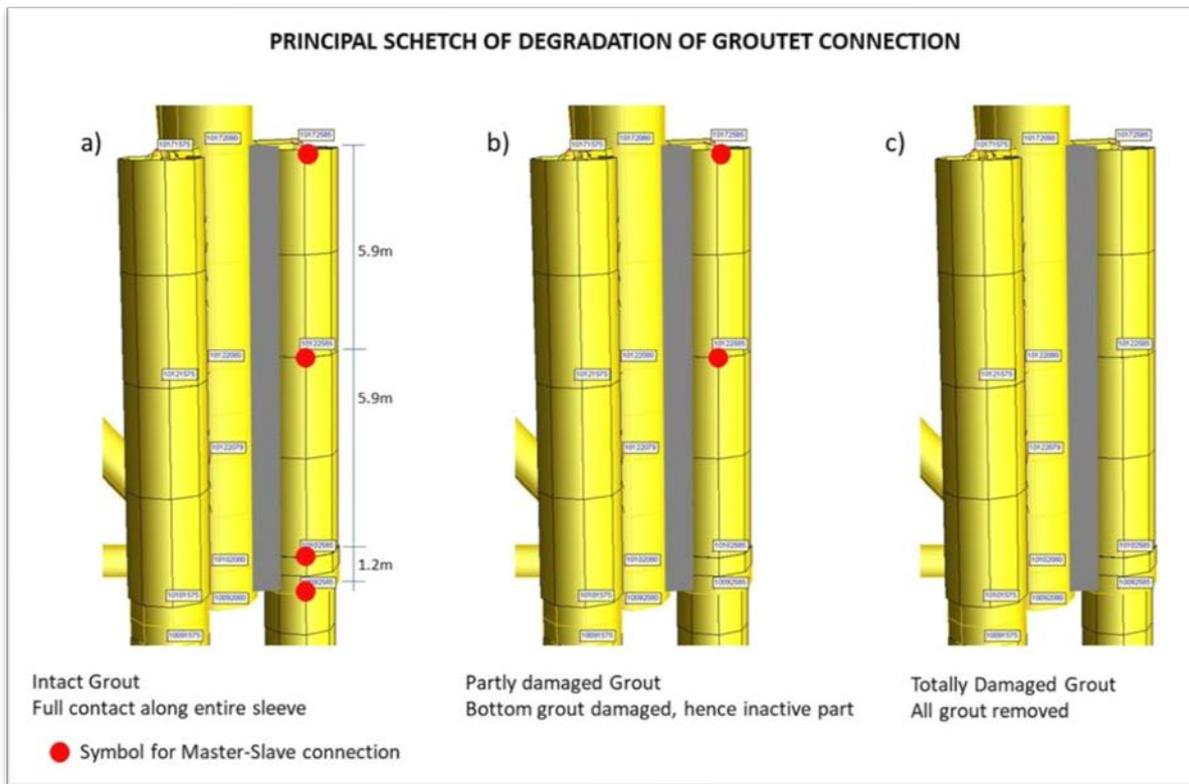
Figure 2-5 Different levels of degraded grouted connection, from the Intact grouted connection (left), the partially damaged grouted connection (middle), to the fully degraded connection (right). The example is for the 4-legged jacket with two piles per leg. The red dots illustrate master-slave connection nodes between pile (master) and sleeve (slave) used to simulate the change in grouted connection at the node. Illustration from FORCE Technology.

slave nodes. The slave node's degrees of freedom (DOF) may be fully dependent on the master's DOF, or fully released, i.e. in order to model intact and total damaged grout respectively, ref a) and c) in Figure 2-5.

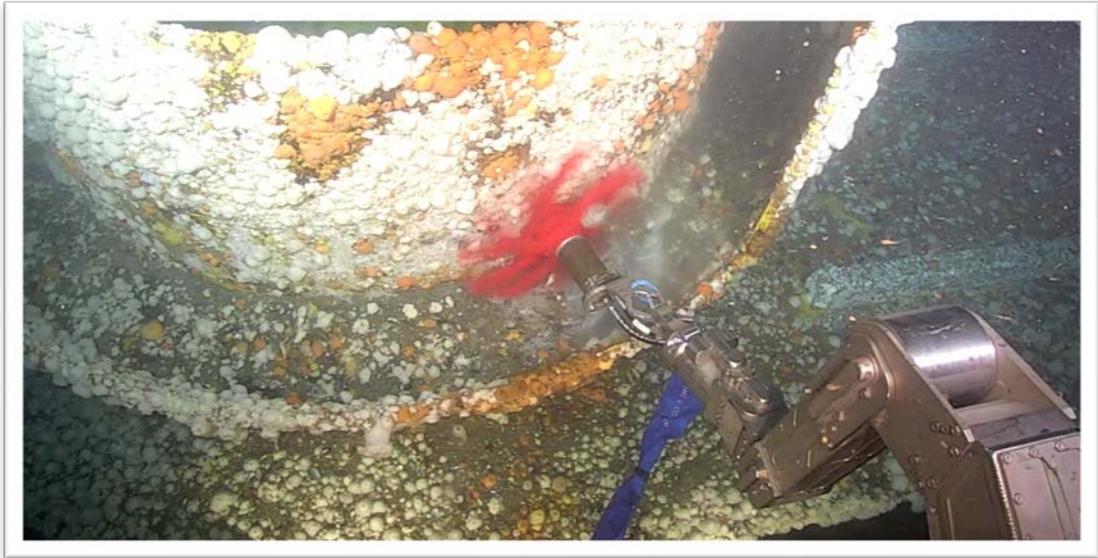
Figure 3-1 Cleaning of grouted connection for close visual inspection using ROV. Picture from DeepOcean.

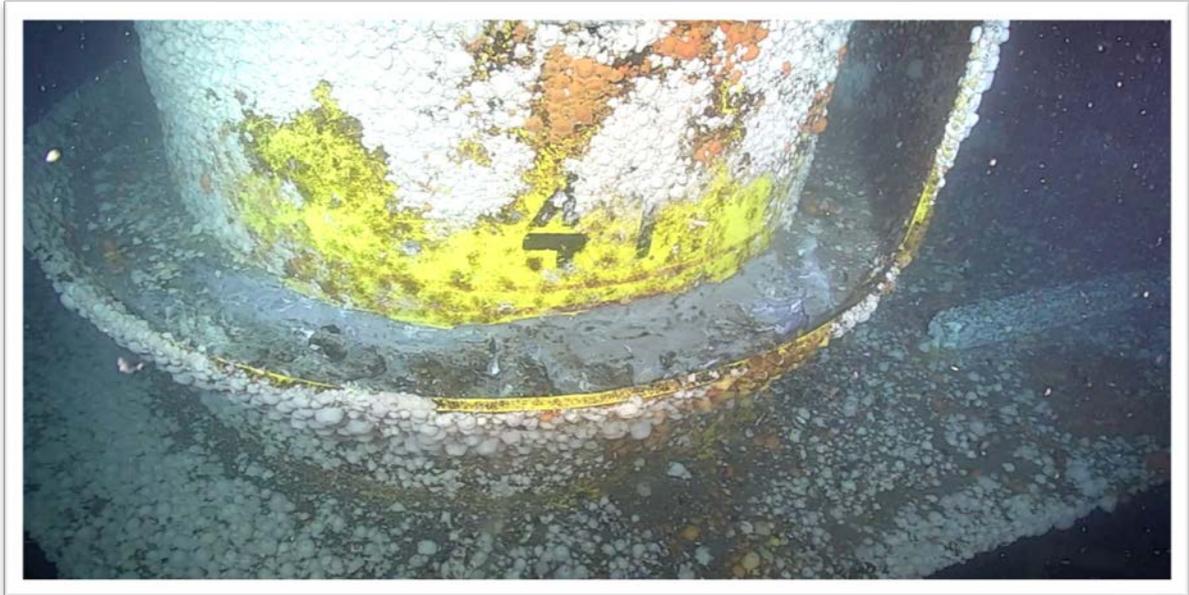
Figure 3-2 Area cleaned and ready for visual inspection. Picture from DeepOcean.

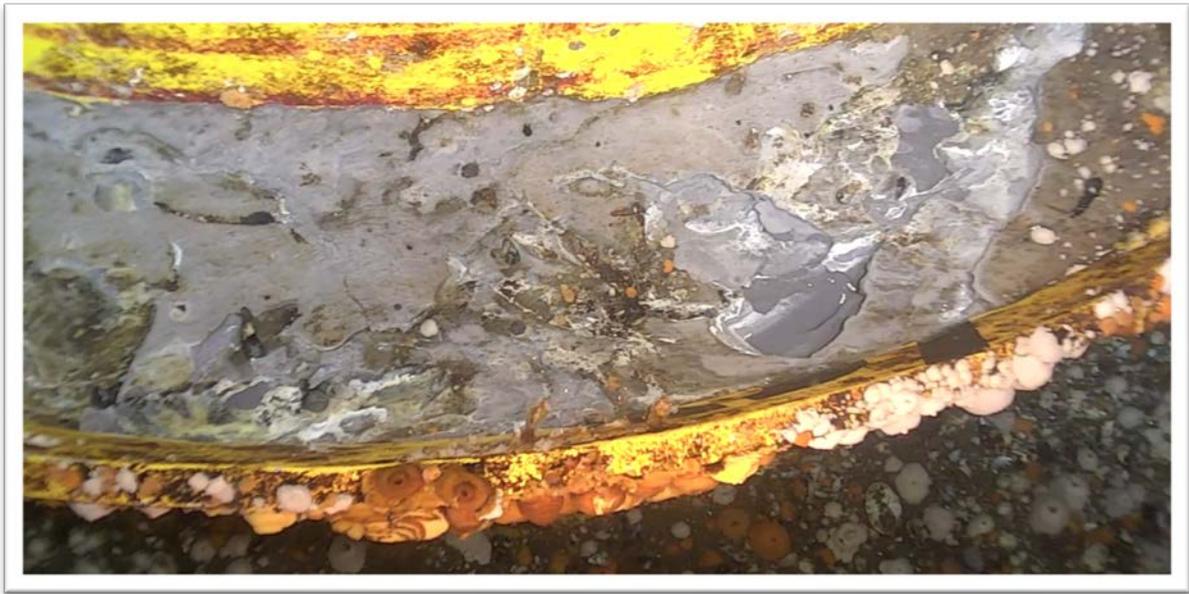
Figure 3-3 Close up of photo #2. Picture from DeepOcean.

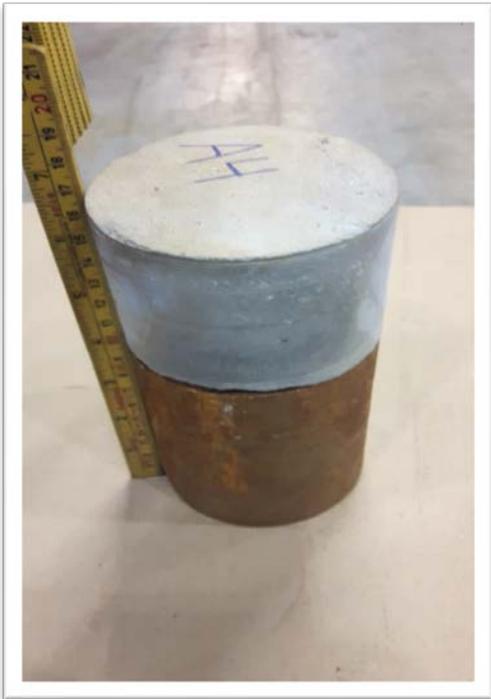
Figure 3-4 Core sample of steel and grout from a grouted connection. Picture from IK Norway.

Retrieving core samples of the grouted connection has been used to get physical sample coupons of the connection, making it possible to inspect the adherence between grout and steel, observe any indication of crushing or hairline cracks in the grout, or lack of filling and voids at the sampled location, and to test and verify the quality of grout in compression.

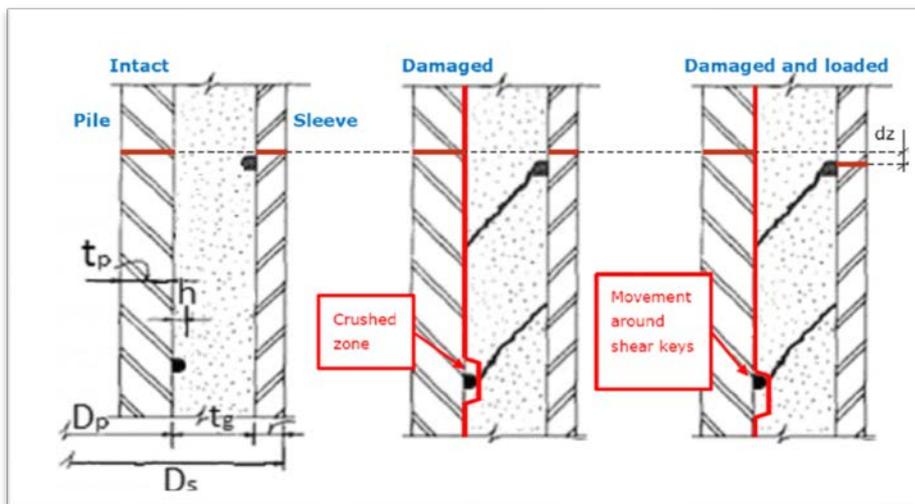
Figure 4-1 Illustration of pile sleeve connection with grout degradation for Damage Case 1 showing the intact connection (left), local crushing of the grout at the shear keys with the diagonal shear (middle) and the loaded connection with resulting relative movement between pile and sleeve(right). Illustration from Ramboll.

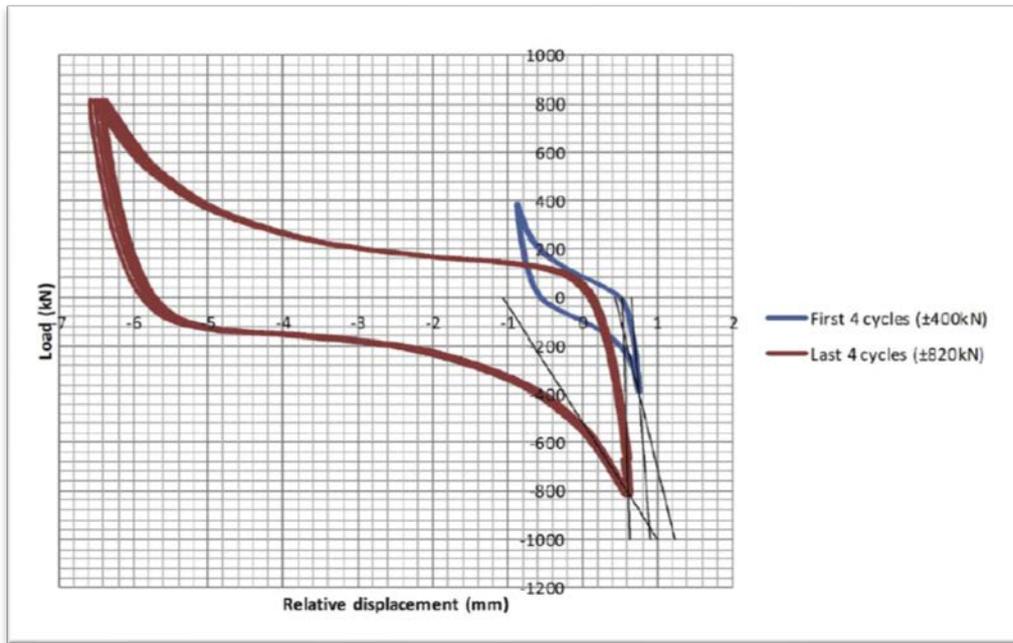
Figure 4-2 The load response hysteresis curves for the four first load cycles on a grouted connection (blue), and the last 4 load cycles before failure (red) used in Damage Case 2. Illustration from [4].

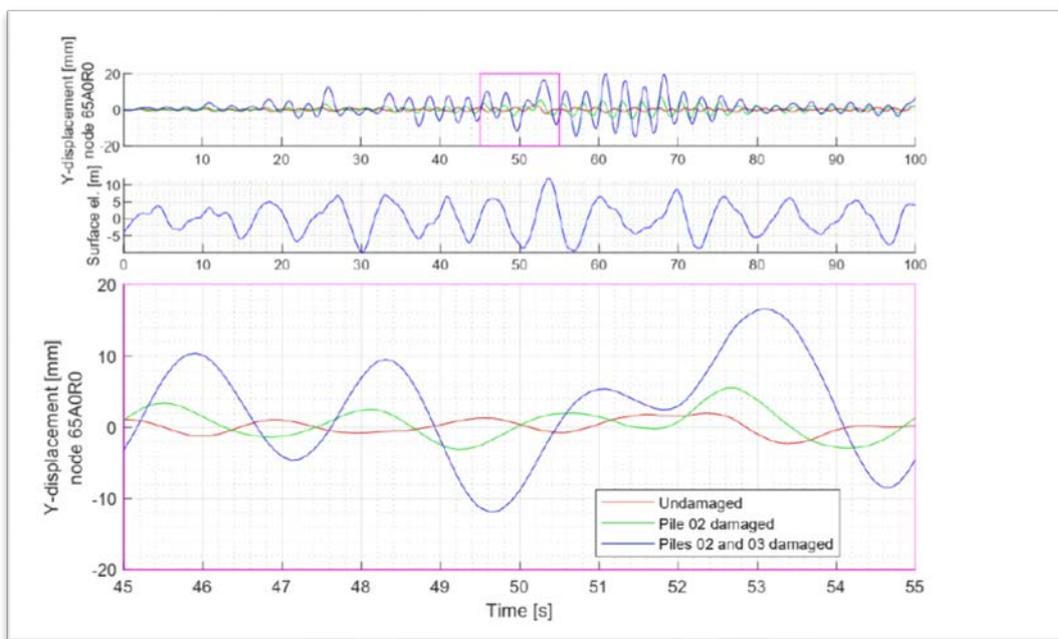
Figure 4-3 Data from simulations for Damage Case 2, where the two top curves is (top) the displacement in y direction with time at a defined node in the model, for the case of undamaged (green), 1 pile damaged (red), and 2 piles damaged (blue), when the corresponding surface elevation of the waves is as shown in middle graph. The lower graph is a zoomed view showing the displacements for a 10 second period. The displacements are in millimetres, the time scale is seconds and the wave surface elevation is in meters. Illustration from Ramboll.

As several issues are not sufficiently investigated yet it is assumed that the grouted connection is damaged to a point where the axial load and deformation behaviour in the connection can be described by a hysteresis loop similar to the ones shown in Figure 4-4, and assuming that wave loading in a given time series is large enough to cause plastic deformation and move through the hysteresis loop. The analysis performed for is based on non-linear, plastic model behaviour.

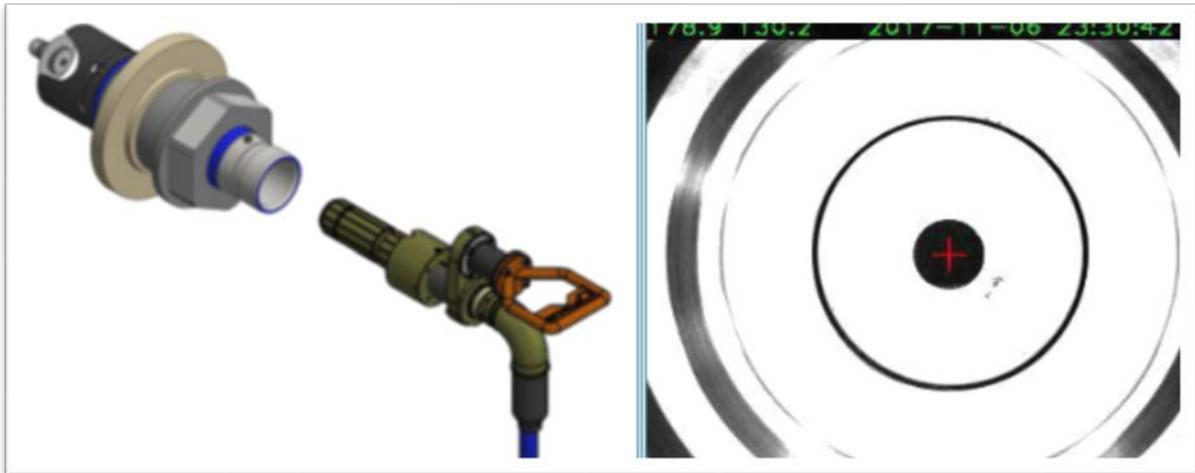
Figure 4-4 The ROV installable sensor with target, protection sleeve and fixation to the hole in the sleeve. Right the optical target showing the identified centre position of the target relative to the sensors, with coordinates top left and date and time, top right. Illustration from FORCE Technology.

Such a system has been developed and has been deployed subsea on a pile sleeve connection for 3 winter seasons measuring the local displacements, see illustration in Figure 4-4.

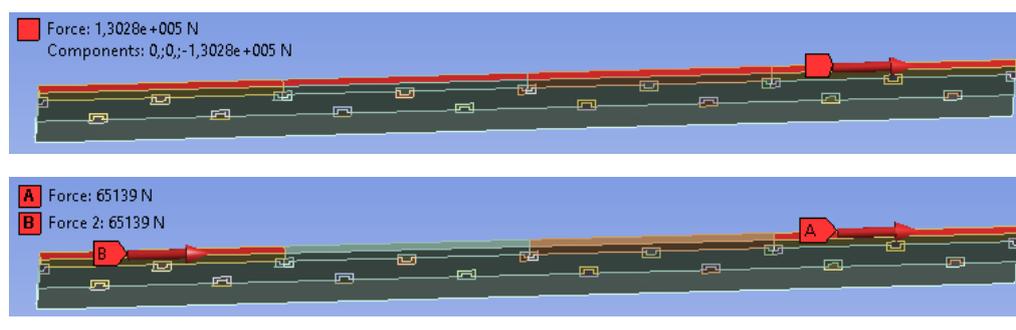
Figure 5-3 Grouted connection and loads

Two different loads are applied that shall represent two different kind of load transferee from the jacket. The first is simulating a shear plate and the second is simulation brace, see figure below. The load is based on 100-year storm condition, in this case $\sim 24.1\text{MN}$. But the load is adapted to the size of the section.

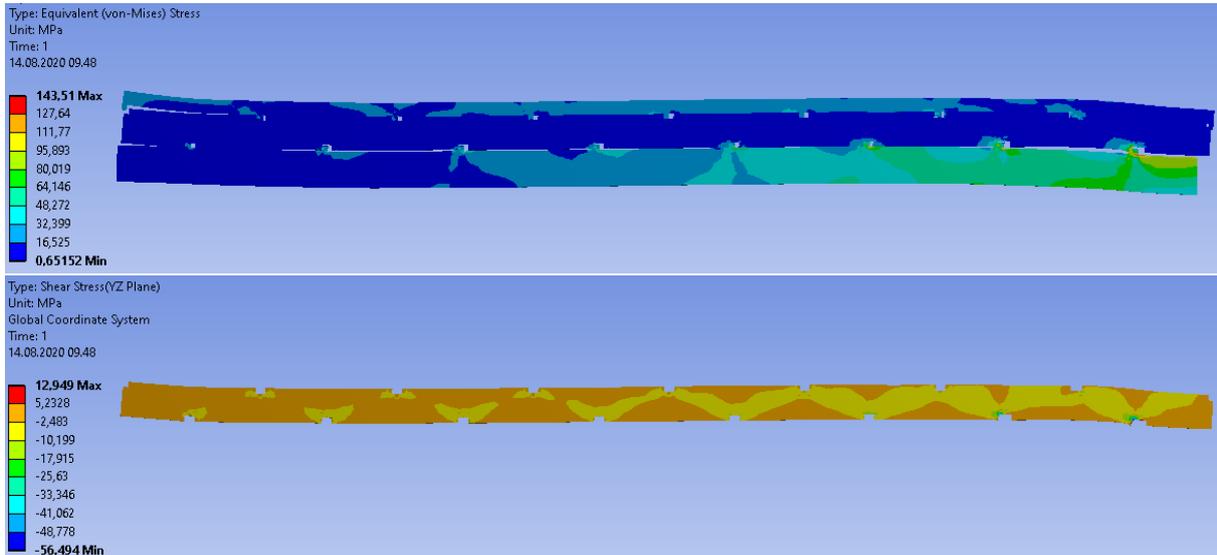
Figure 5-4 von Mises stress and shear stress grout based on shear plate

The resulting von Mises stress for the connection and the shear stress for the grout is showed in Figure 5-4 and Figure 5-5. As showed in the figures the highest stresses occurs at the bottom of the connection.

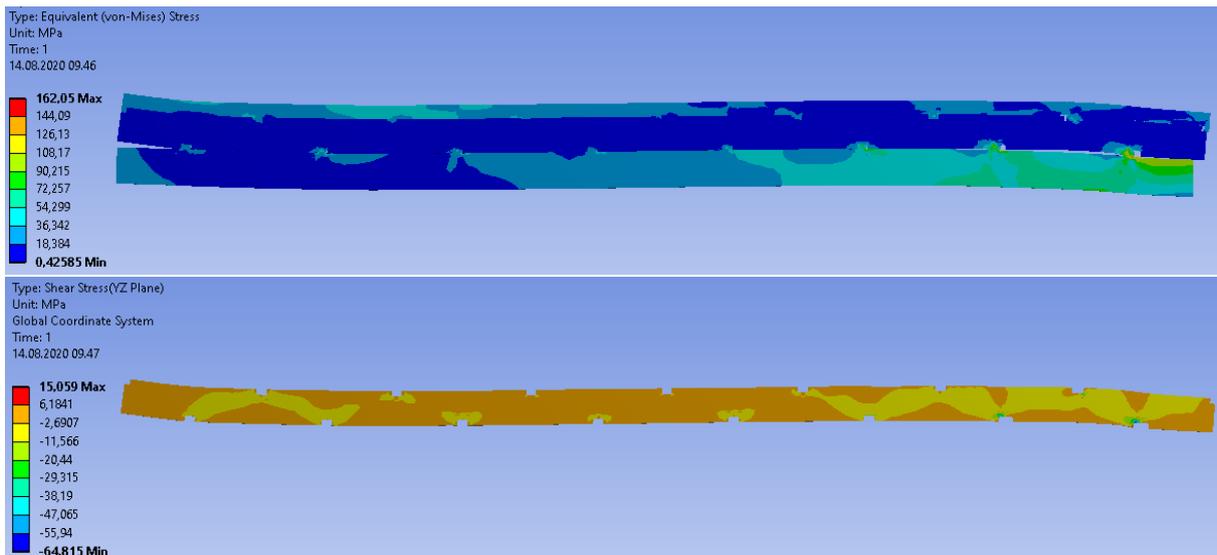
Figure 5-5 von Mises stress and shear stress grout based on brace

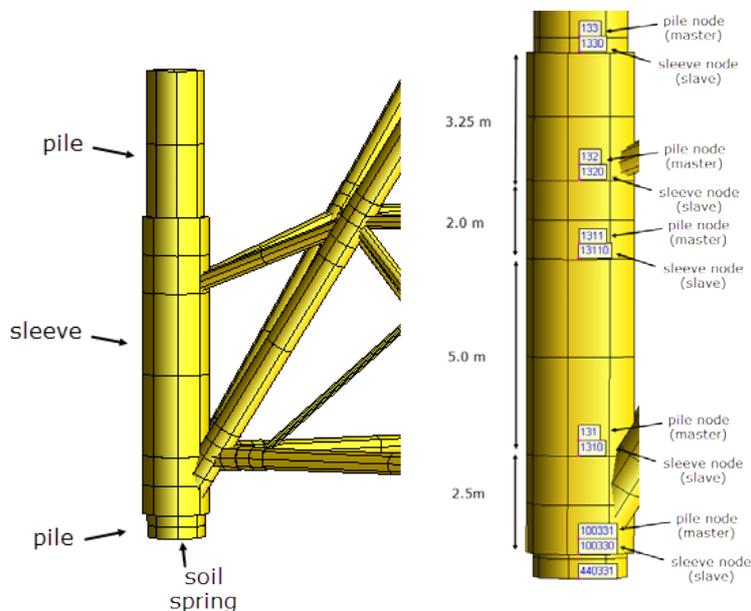
/ Figure 1-1 Pile model, and pile and sleeve nodes, 3-legged jacket

The sleeve, and the part of pile inside the sleeve was modelled by four elements and five nodes, as shown in Figure 1-1.

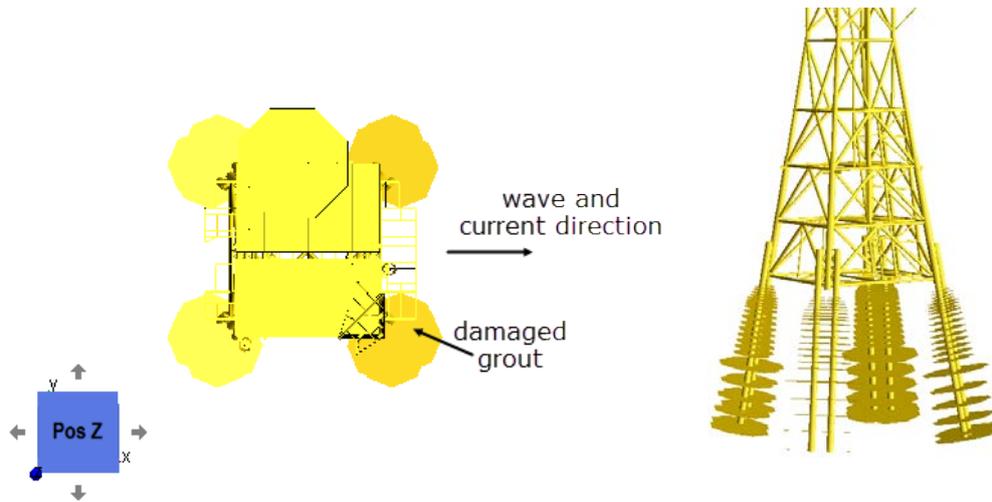
/ Figure 1-2 Analysis model, 4-legged jacket

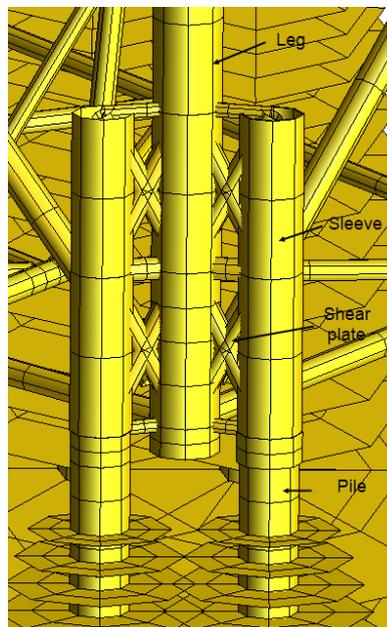
/ Figure 1-3 Pile model, 4-legged jacket

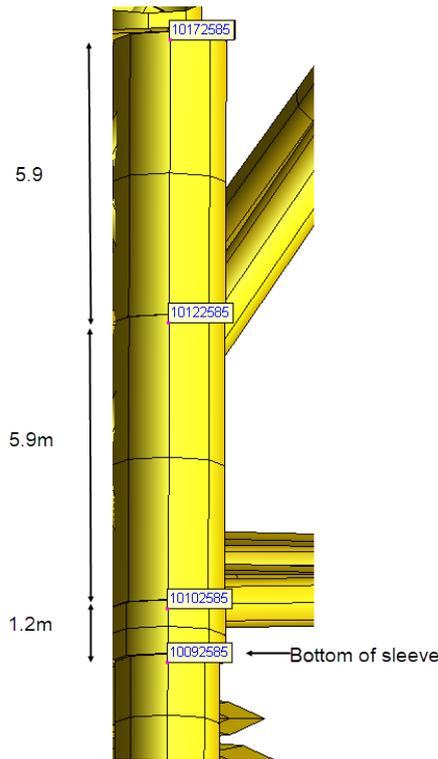
/ Figure 1-4 Sleeve nodes (slave)

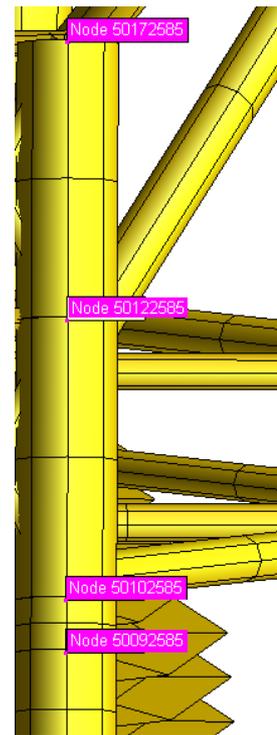
/ Figure 1-5 Pile nodes (master)

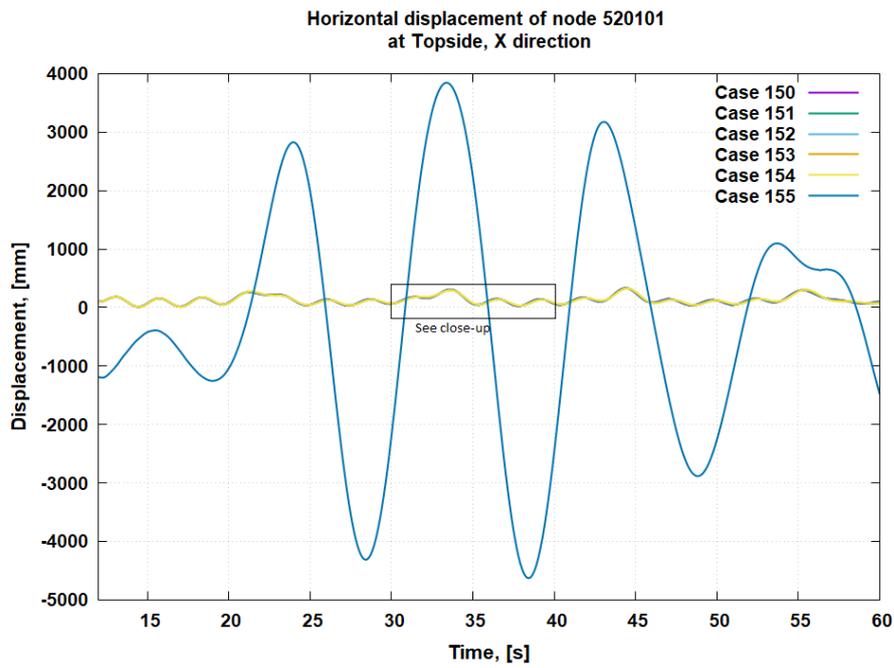
/ Figure 1-6 Horizontal displacement at Topside, X-direction, 3-legged jacket

The horizontal displacement at the Topside in X- and Y-direction for the six cases are shown in the graphs in Figure 1-11 through Figure 1-9 below. For the cases with partly damaged grout, the difference in displacement amplitude is in average 5-7 mm for each release. For full grout failure, the jacket has only two functional piles, and the displacement amplitude changes dramatically.

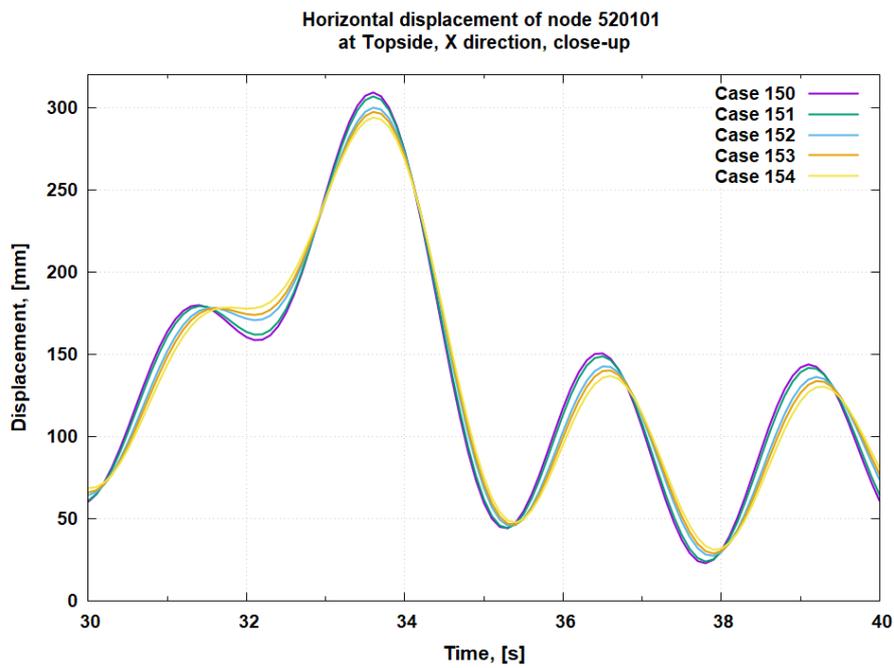
/ Figure 1-7 Horizontal displacement at Topside, X-direction, 3-legged jacket, close-up

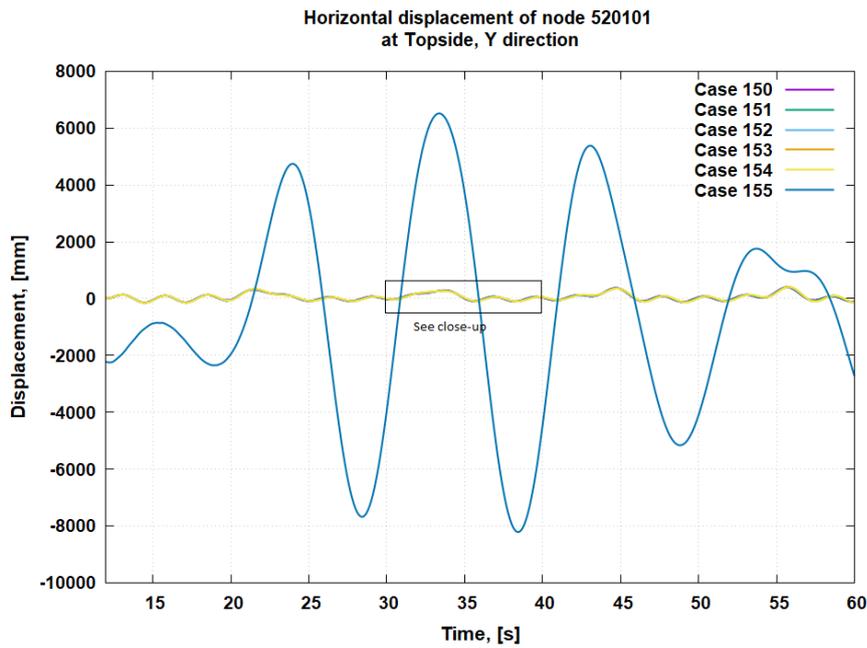
/ Figure 1-8 Horizontal displacement at Topside, Y-direction, 3-legged jacket

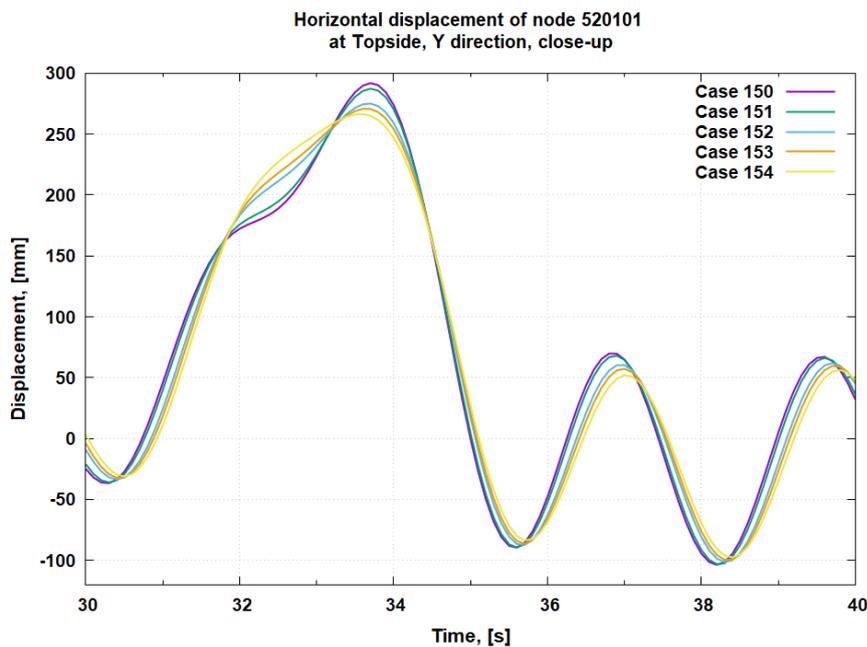
/ Figure 1-9 Horizontal displacement at Topside, Y-direction, 3-legged jacket, close-up

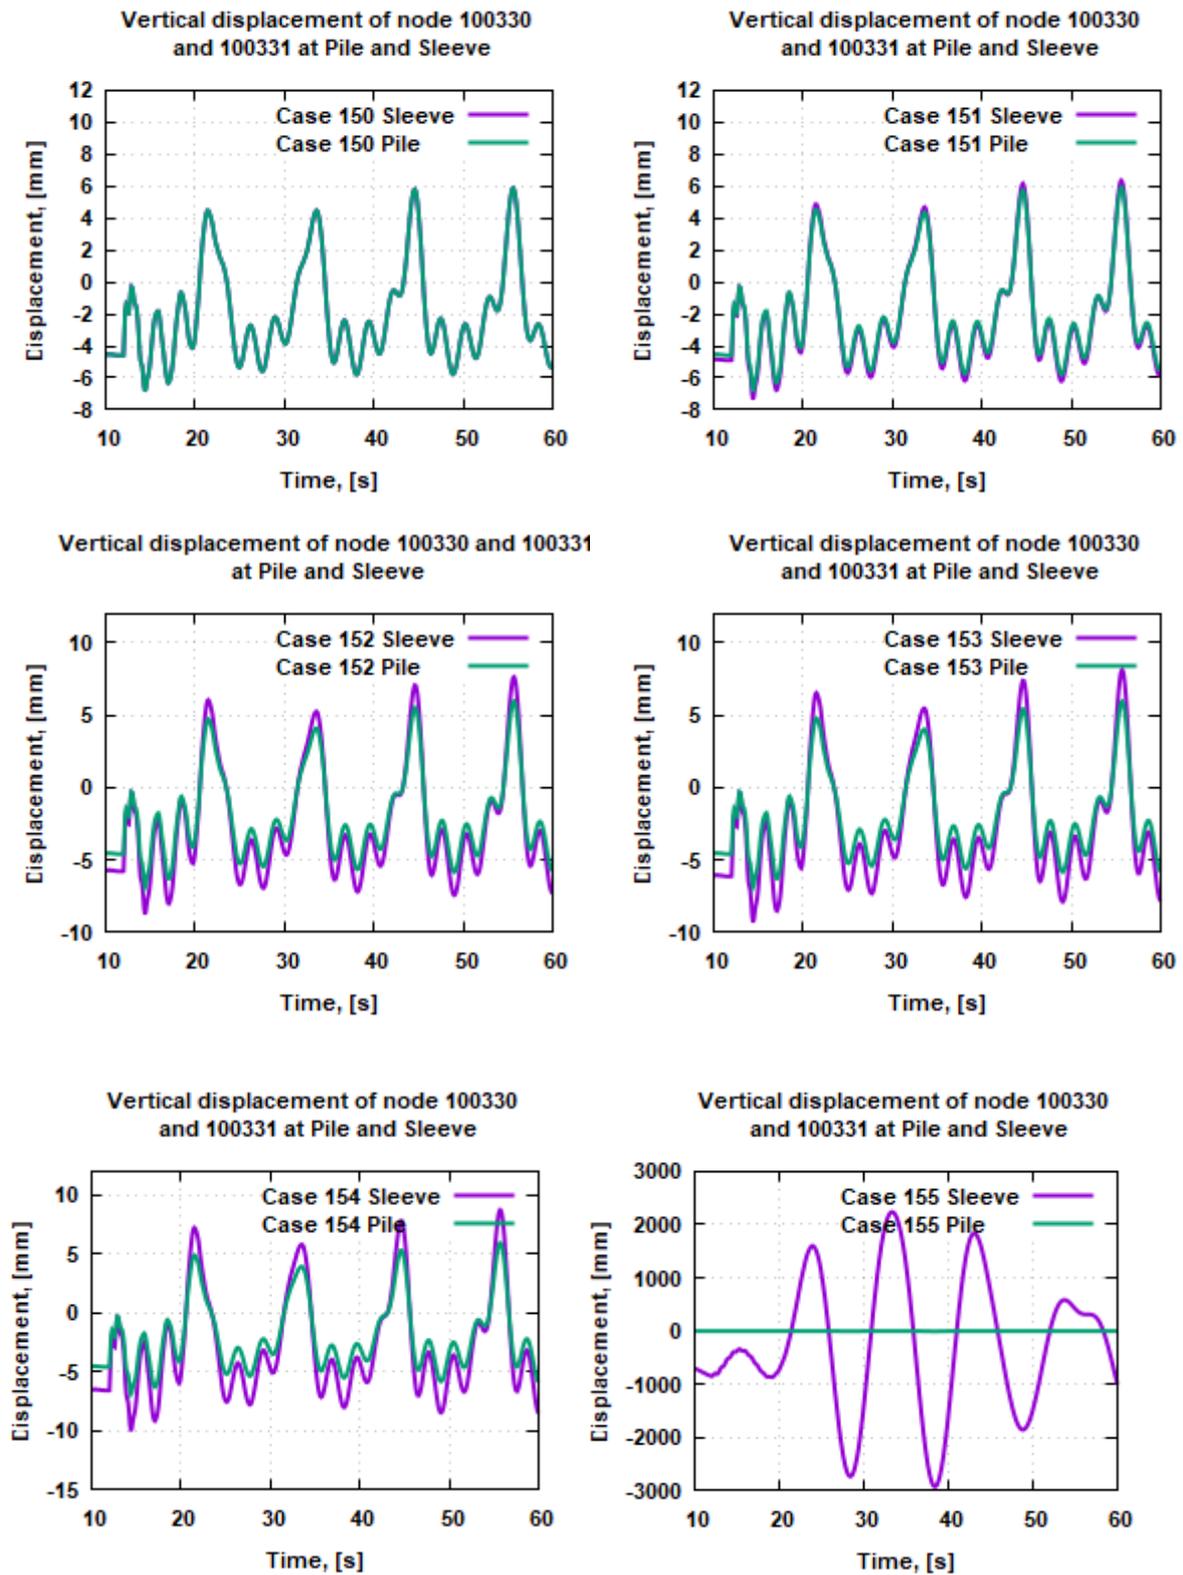
The vertical displacement of the pile sleeve and pile is plotted in the graphs below. When the grout is undamaged (Case 150), the pile and sleeve have identical displacement. The difference in the displacement between pile and sleeve increases gradually up to 3 mm as the damage increases. When the grout is fully damaged, the sleeve displacement amplitude is around 5 m, while the pile displacement is zero.

/ Figure 1-10 Vertical displacement of pile and sleeve, 3-legged jacket

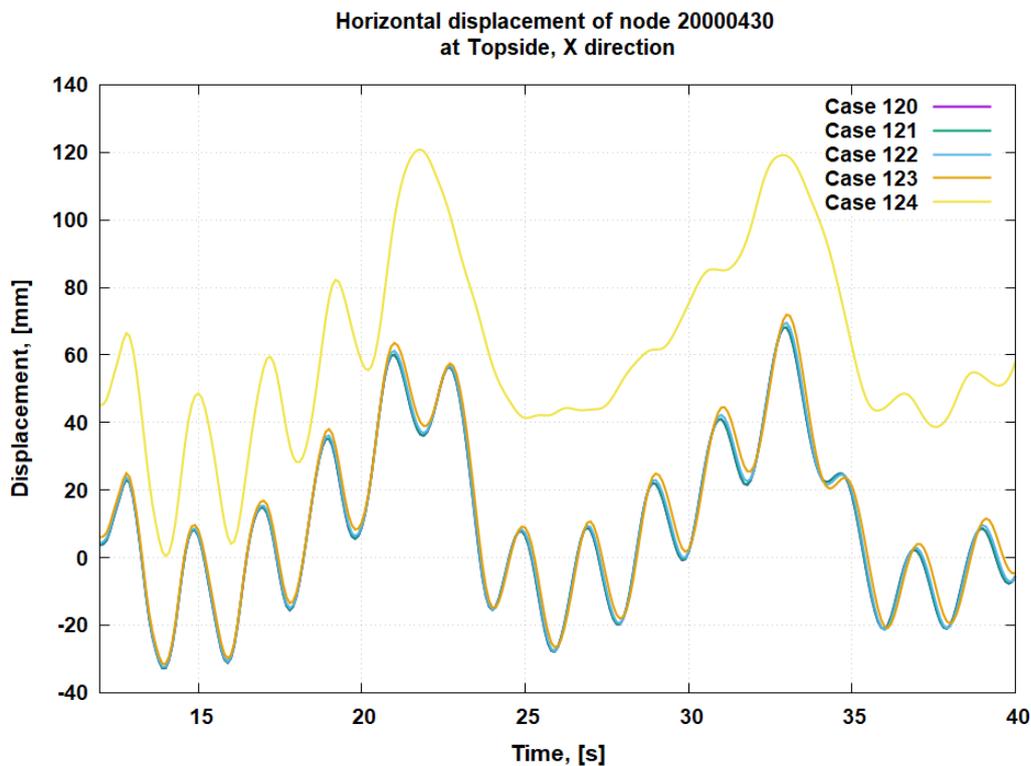
/ Figure 1-11 Horizontal displacement at Topside, X-direction

The horizontal displacement at the Topside in X- and Y-direction for the five cases are shown in the graphs in Figure 1-11 and Figure 1-12 below. For all the cases with partly damaged grout displacement changes approximately 0-5 millimetres. For the full grout failure, the displacement changes significantly.

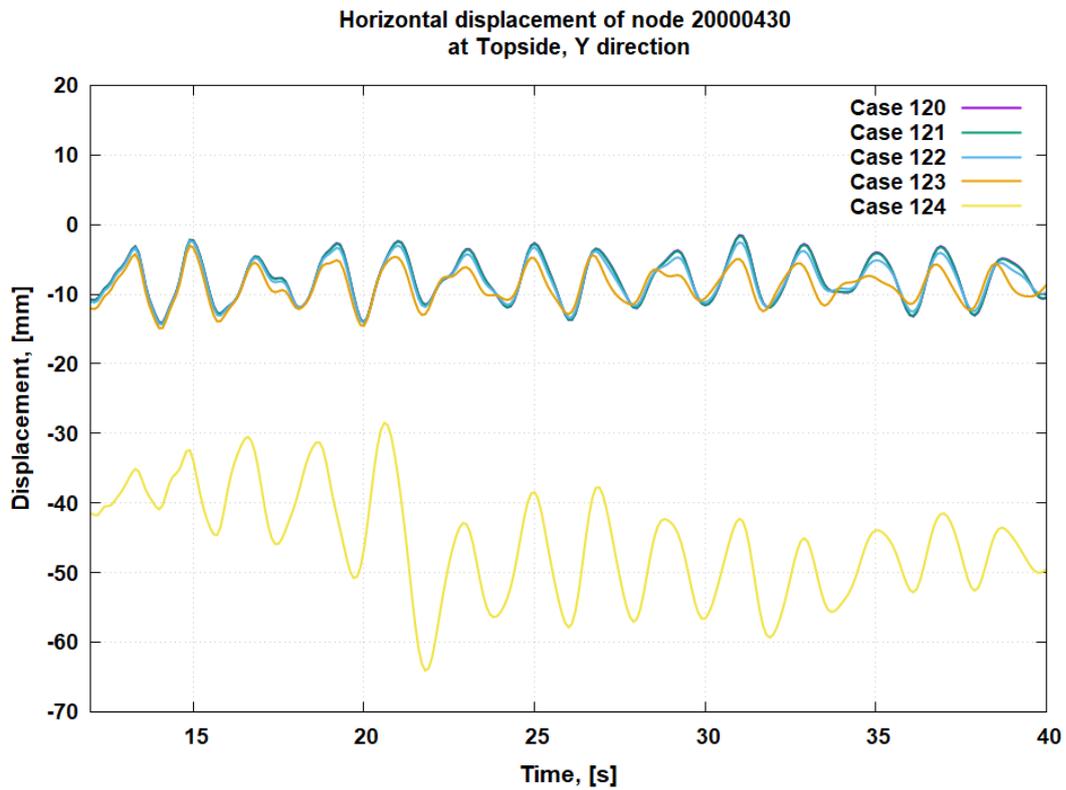
/ Figure 1-12 Horizontal displacement at Topside, Y-direction

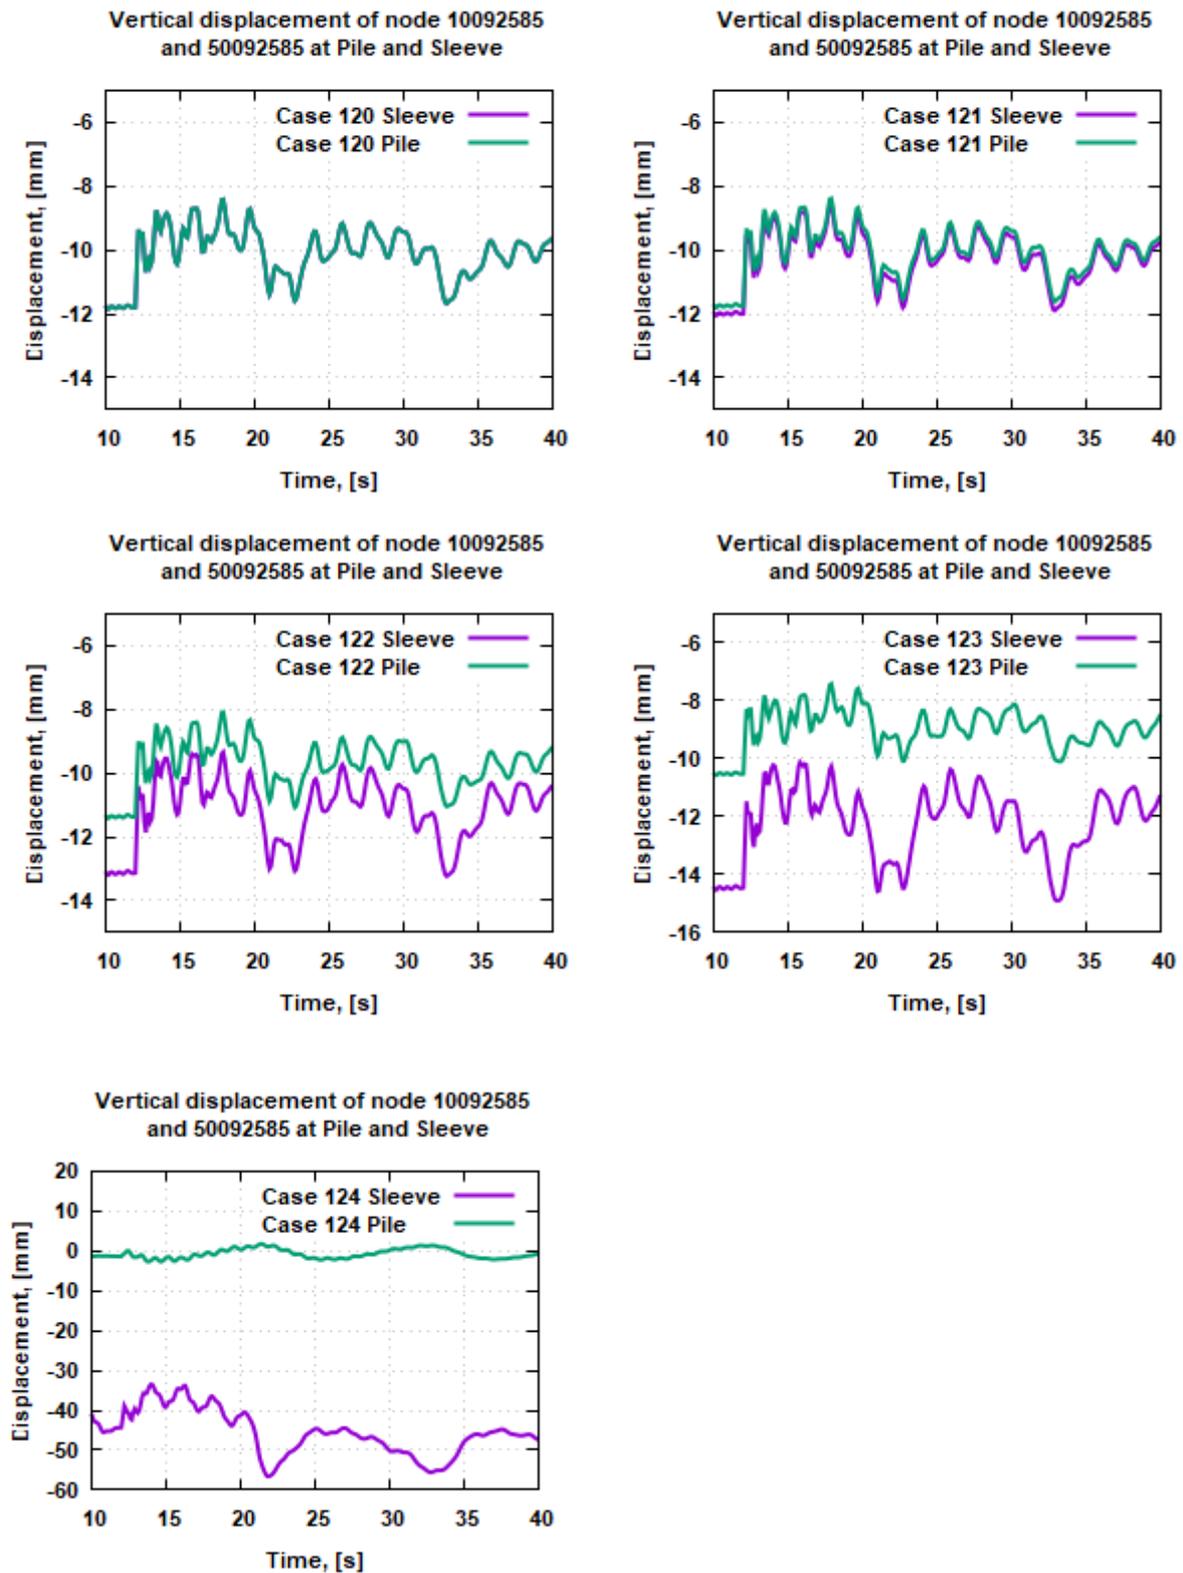
The vertical displacement of the pile sleeve and pile is plotted in the graphs below. When the grout is undamaged (Case 120), the pile and sleeve have identical displacement. The difference in the displacement between pile and sleeve increases gradually up to 6 mm as the damage increases. When the grout is fully damaged, the sleeve displacement is around 60 mm, and the pile displacement is close to zero.

/ Figure 1-13 Vertical displacement of pile and sleeve, 4-legged jacket
